# ARE THE NATIONAL ELECTRICAL CODE AND THE NATIONAL ELECTRICAL SAFETY CODE HAZARDOUS TO YOUR HEALTH?

## THE SHOCKING SWIMMING POOL

Copyright Material IEEE  
Paper No. I&CPS-99-XX

Donald W. Zipse, P.E.  
Life Fellow, IEEE

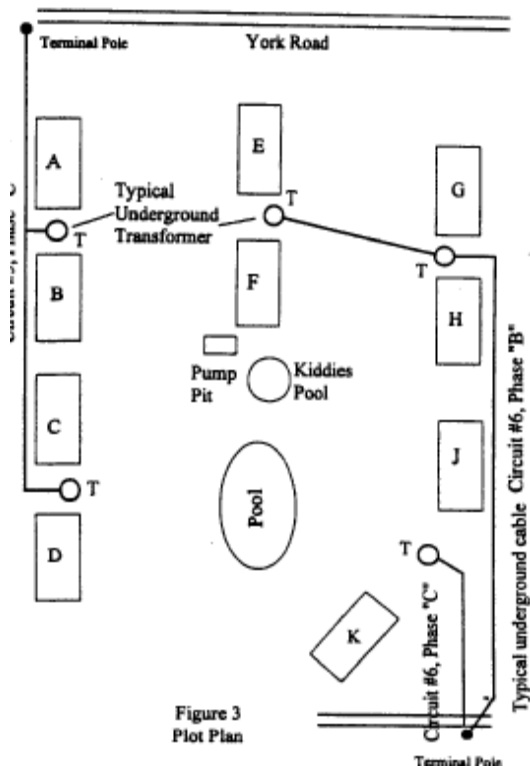
Figure 3  
Plot Plan

In late June a manager of an apartment complex converted into condominiums relate a shocking problem with the community swimming pool. (See Figure 3.) The past three years there had been sporadic complaints of persons receiving electric shocks while in the swimming pool. It was the start of the summer and complaints were beginning again.

They were brought up to date on the tests conducted that morning before they arrived. The layout of the electrical equipment was reviewed. Figure 3 shows the ten buildings surrounding the pool. Every two buildings are feed from an underground transformer. There are five transformers for the ten buildings.

The two transformers that supply power to Buildings A, B, C and D have a common feeder. This underground feeder is feed from York Road and is referred to as Circuit #5, Phase C.

Buildings E and F have an underground transformer that feeds the pool in addition to the buildings. On the same underground feeder as Building E and F are Buildings G and H. This circuit is Circuit #6, Phase B. This underground feeder is feed from a street behind the complex at the opposite end of the complex as the feeder for Buildings A, B, C, and D.

The final two buildings, J and K are feed from a third underground feeder, Circuit #6, Phase C. This underground feeder also originates from the street behind the complex.

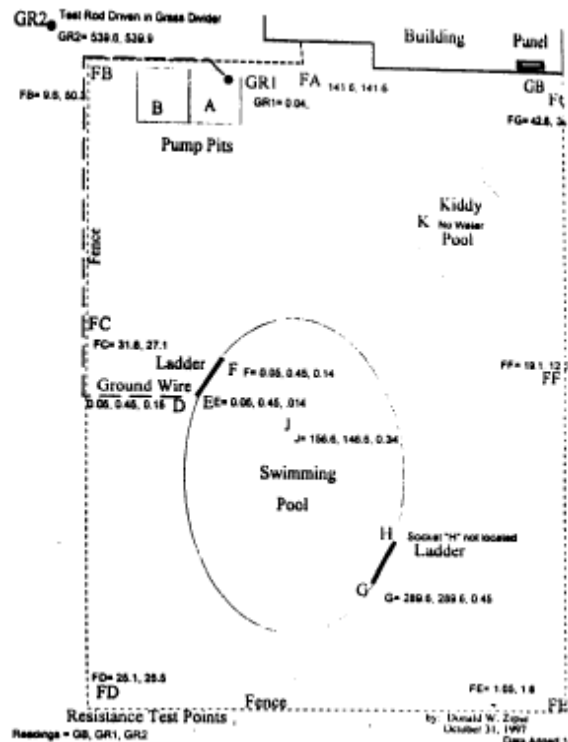
Figure 5  
Resistance Test Points and Readings

From each of the main three ground points, test points were selected. Points around the pool such as the ladder sockets, water in the pool, center of the kiddies pool, the corners and center of the fence, etc. A total of 38 readings were taken. See Table 2.

The fence was chain link and no special grounding connections had been made to it. It was difficult to obtain a good connection. The values did change while we watched. We went through taking the voltage and current reading. Then we took the resistance readings. Correlation between the reading was poor.

With the exception of a ladder socket in the pool, the resistance between points was acceptable except the utility still focused on the pool grounding as the problem.

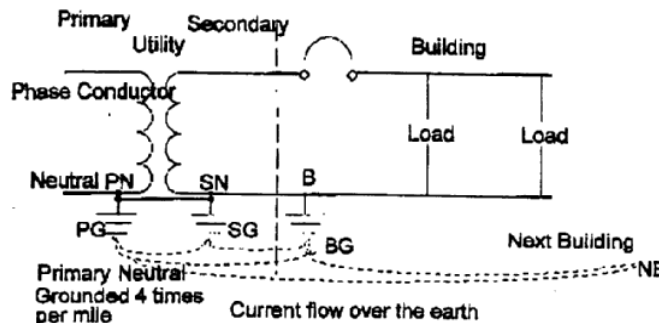
Figure 4  
Transformer Connections

It usually comes as a shock to electrical engineers not involved with utilities that the utilities actually solidly connect the primary return side of the distribution transformers to the secondary side neutral connection. See figure 4. The primary return, neutral terminal, PN is connected to the secondary neutral terminal, SN.

This connection of the primary to secondary is made in pole mounted, pad mounted or underground distribution transformers. This connection allows primary current to flow over the secondary neutral-ground conductor. The secondary neutral-ground conductor is grounded, earthed at the transformer, sometimes at the meter and required by the NEC to be connected to earth at the service entrance.

Neutral blockers are similar to a lightning arrester. It is placed between the primary neutral of a distribution transformer and the secondary neutral connection. See Figure 4, PN and SN terminals. The utilities connect the primary neutral to the secondary neutral. This connection allows stray, uncontrolled continuous current to flow over metallic piping, building steel, earth, etc. By installing a neutral blocker, the primary return current is prevented from flowing over the multiple connection to earth that are part of the NEC requirements.

The next request of the utility was to install an inexpensive electrical device used on farms to protect cows from electric shock. It was requested the utility install, in the underground transformer vaults, an \$ 850.00 neutral blocker between the primary neutral transformer winding and the secondary neutral winding.
