# **Residential Electrical System Aging Research Project**

## **Technical Report**

July 1, 2008

Prepared by:  
David A. Dini, P.E.  
Underwriters Laboratories Inc.

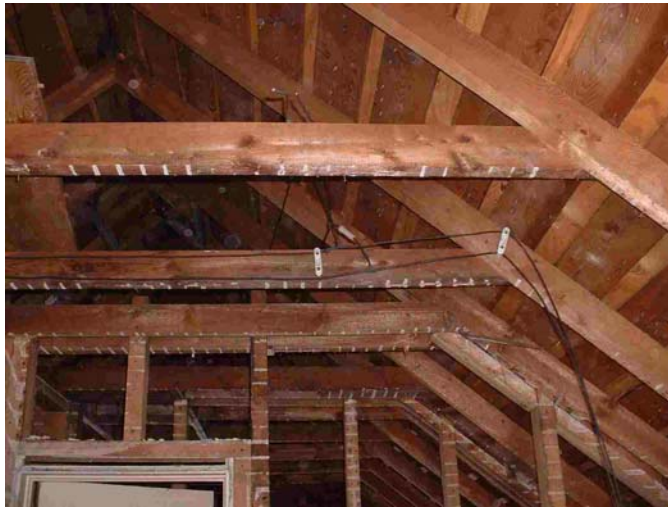
Fig. 1a – Knob-and-Tube Wiring From House IL-6

Fig. 1b – Knob-and-Tube Wiring From House IL-6

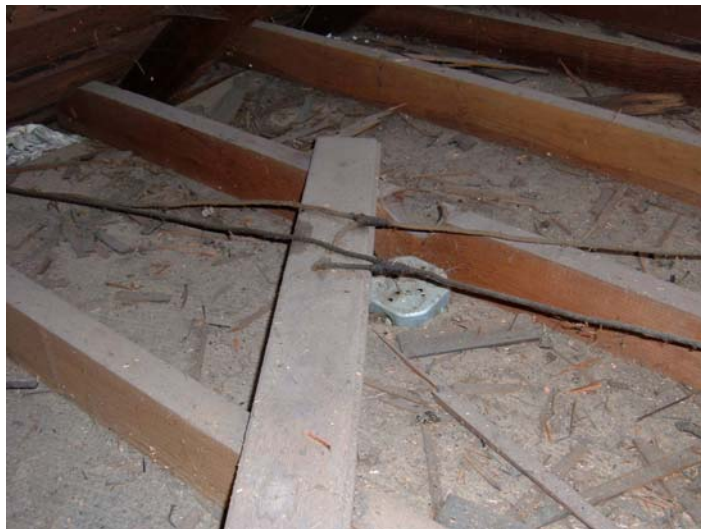
Fig. 2 – Knob-and-Tube Wiring From House OR-1

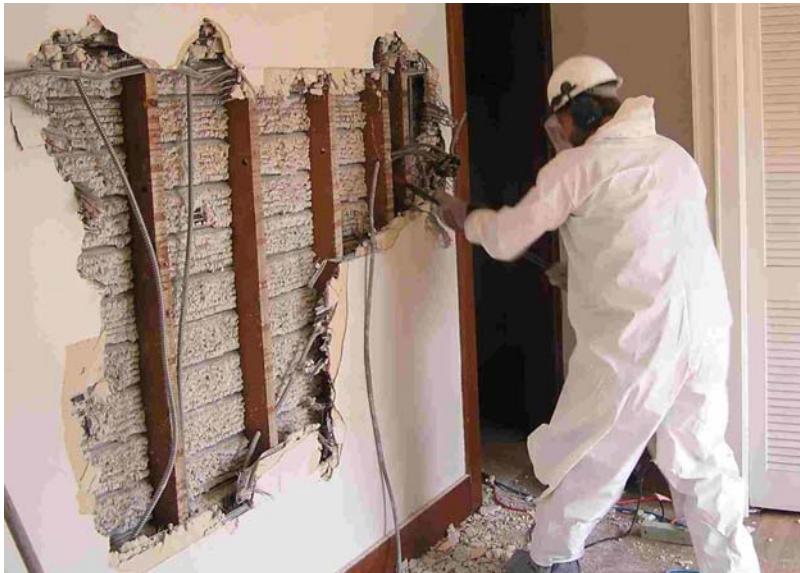
Fig 3 – Old Armored Cable Being Removed From House IL-1

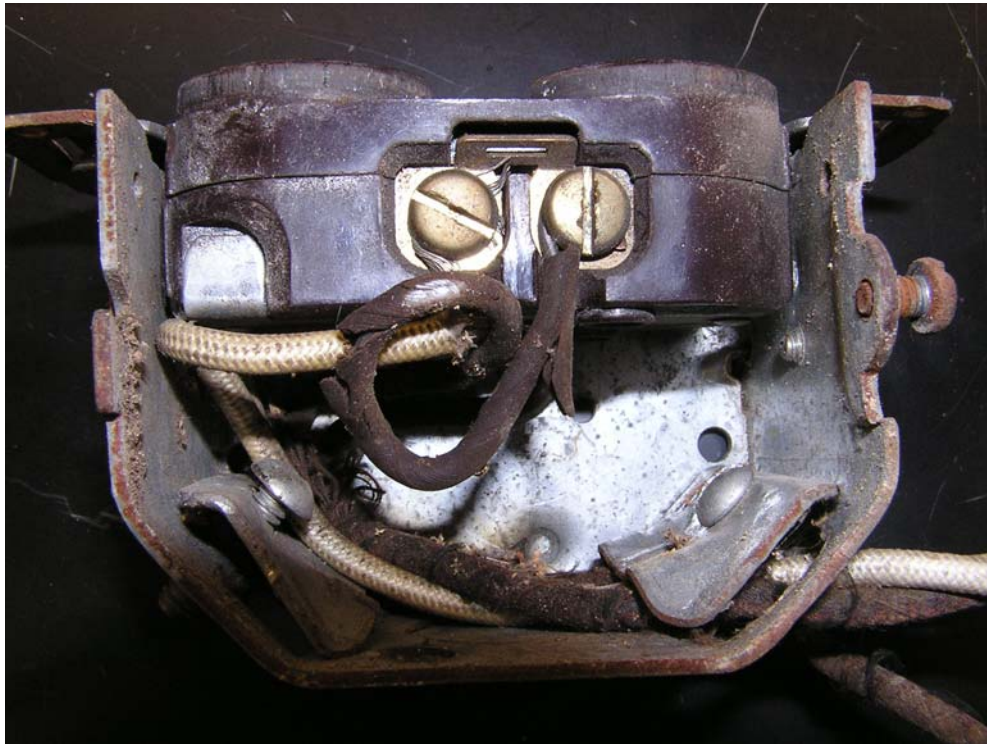
Fig. 7 – Brittle Conductor Rubber Insulation From House AL-7

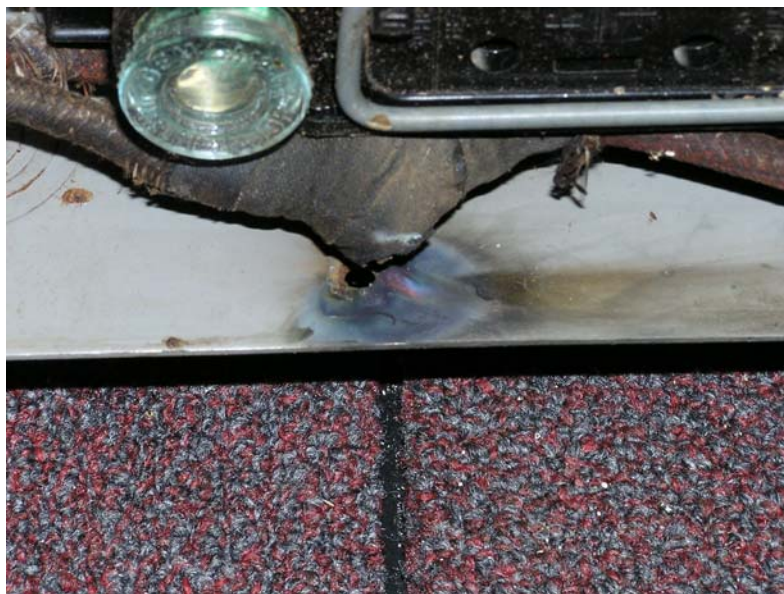
Fig. 9 – Arcing at Conductor Splice at House WI-1

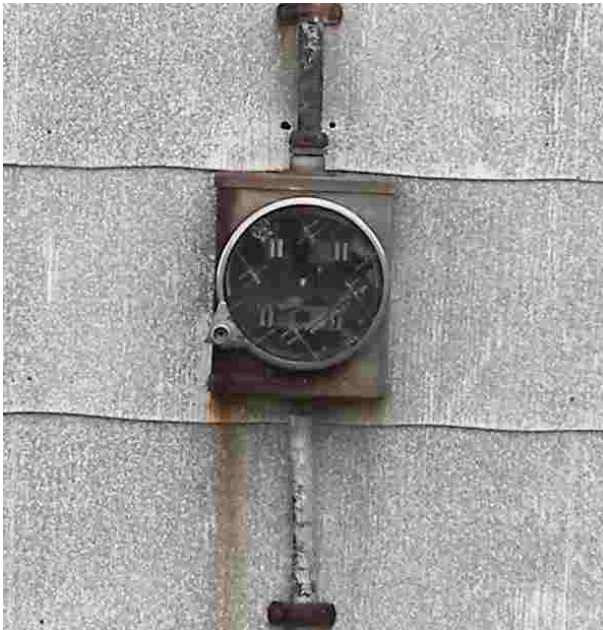
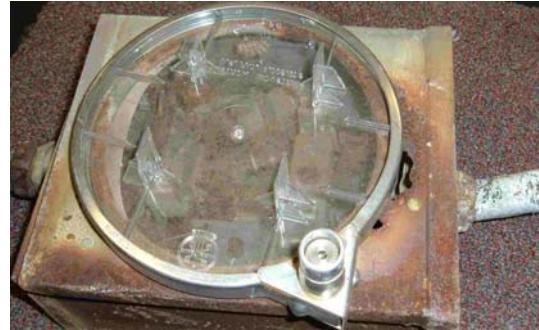
Fig. 10 – Meter Socket With Corrosion From House NY-1

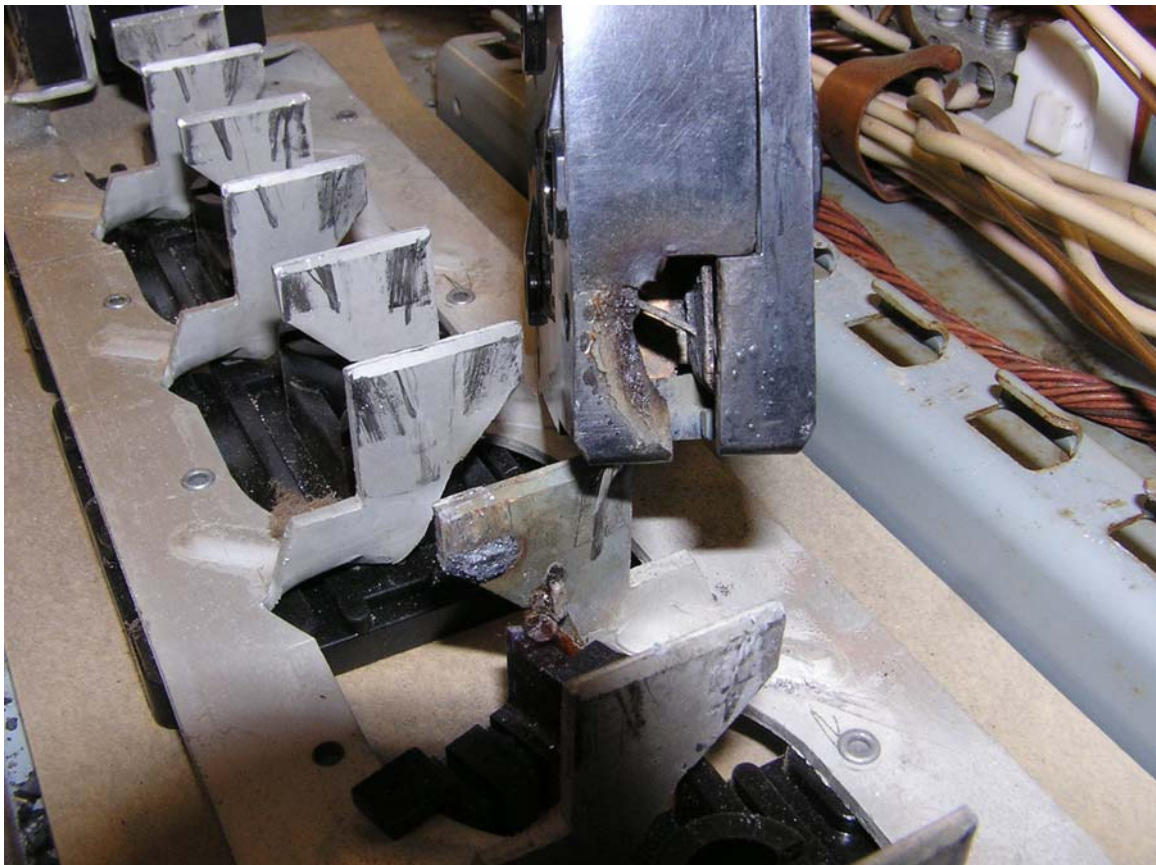
Fig. 11 – Arcing Damage at Breaker Stab at House MA-3

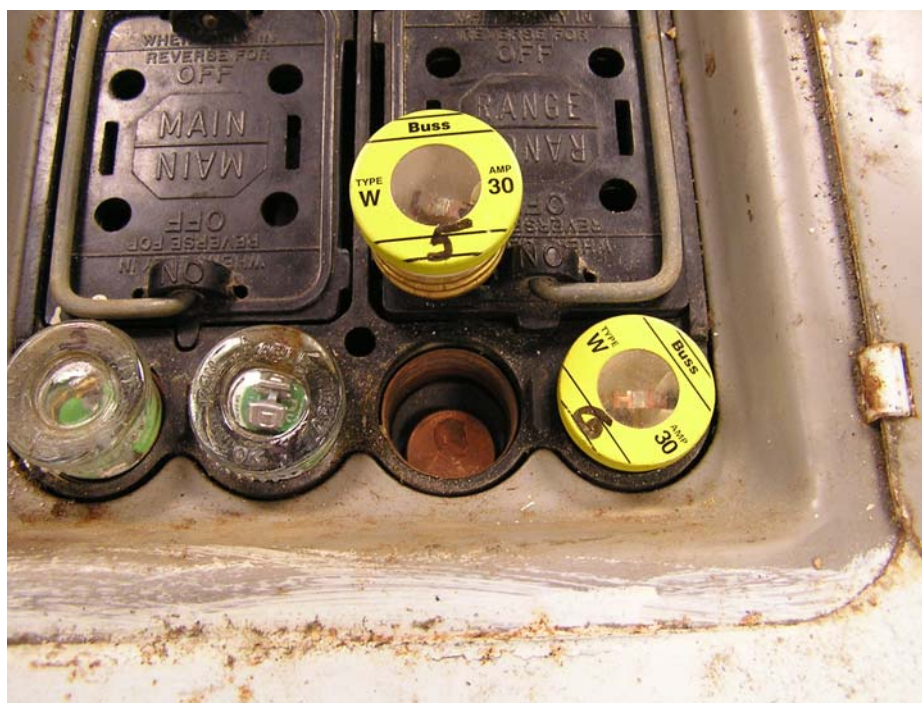
Fig. 13 – Penny Found Behind Blown Fuse at House AL-9

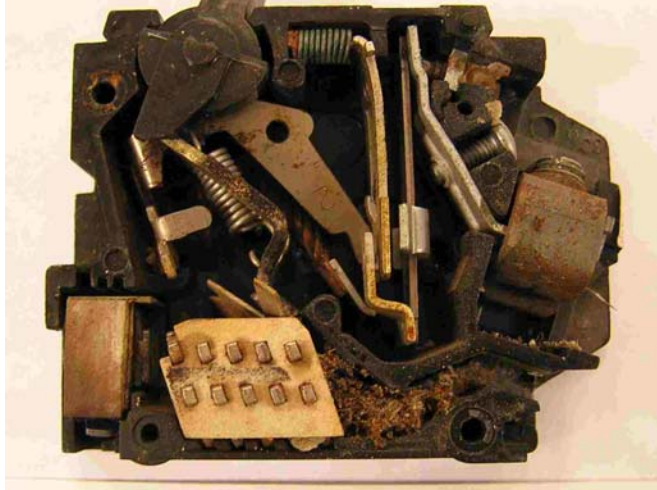
The other four circuit breakers, which were all made by manufacturer B, were examined by UL. A visual inspection of the opened molded cases identified extensive corrosion on many of the operating mechanism and spring parts. Remnants of insect infestation were also noticeable. Circuit breaker AL-9, 1-3, had the stationary and moveable contacts of one pole permanently welded together. All of the other breaker poles had contacts that would separate. Other than circuit breaker AL-9, 1-3, no definitive determination could be made as to the probable cause of the initial calibration failures.

Fig. 15 –House AL-8 Breaker 9-11, Corrosion Damage

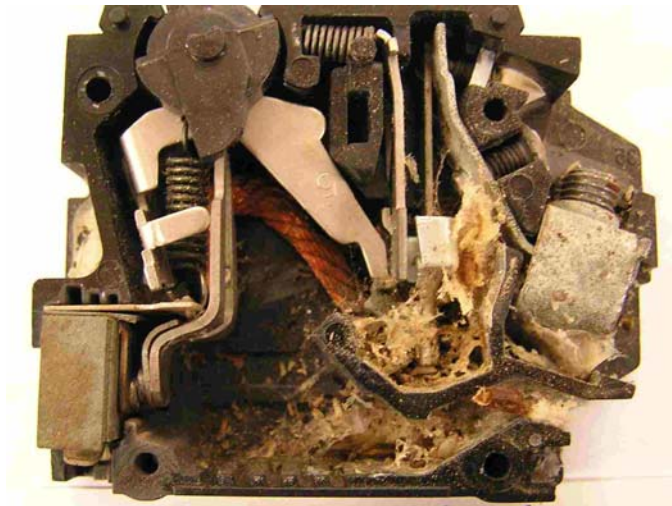
Fig. 16 –House AL-9 Breaker 5-7, Insect Nesting

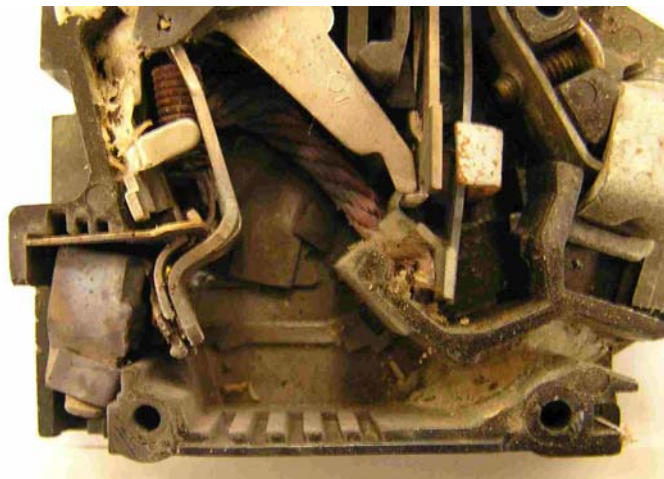
Fig. 17 –House AL-9 Breaker 1-3, Welded Contact

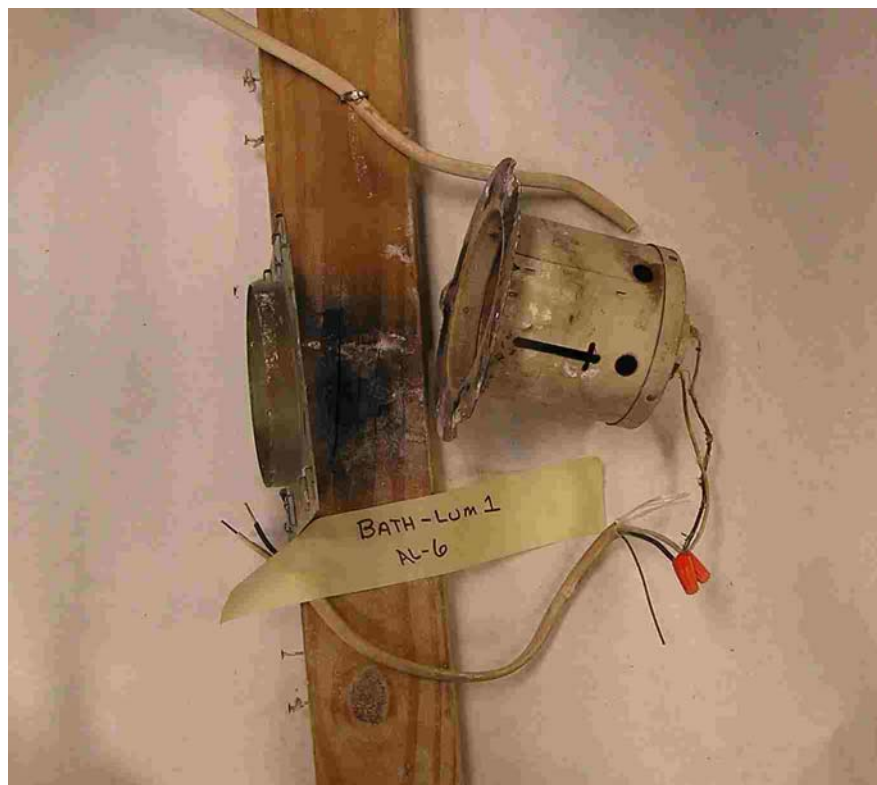
With house AL-6, a recessed ceiling luminaire was located in the shower area. It did not appear to be a complete recessed luminaire fixture, and markings were missing regarding its type, IC or NON-IC. However, there was insulation placed around the fixture and in contact with the metal housing. There was extensive corrosion and evidence of overheating on the painted metal housing and on the wood stud adjacent to the housing. The luminaire wires were brittle and some bare conductor was exposed. There was no junction box and no ground connection to the metal housing. The proper size maximum lamp (60 W) was found installed.

Fig. 22 – Recessed Luminaire From House AL-6

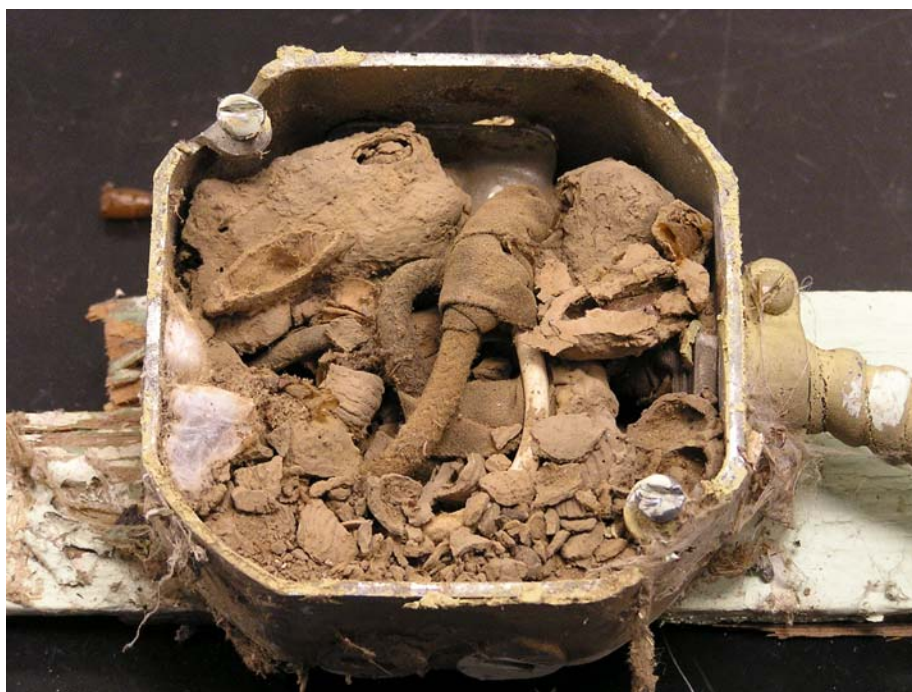
Fig. 23 – Junction Box From House OR-1

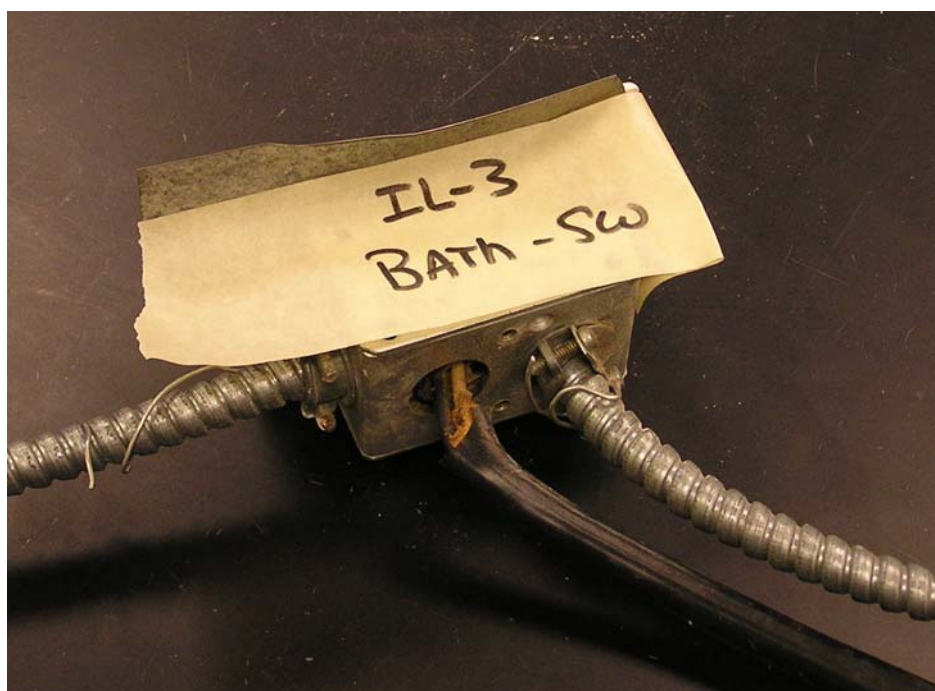
Fig. 24 – Cable Clamp Not Used At House IL-3

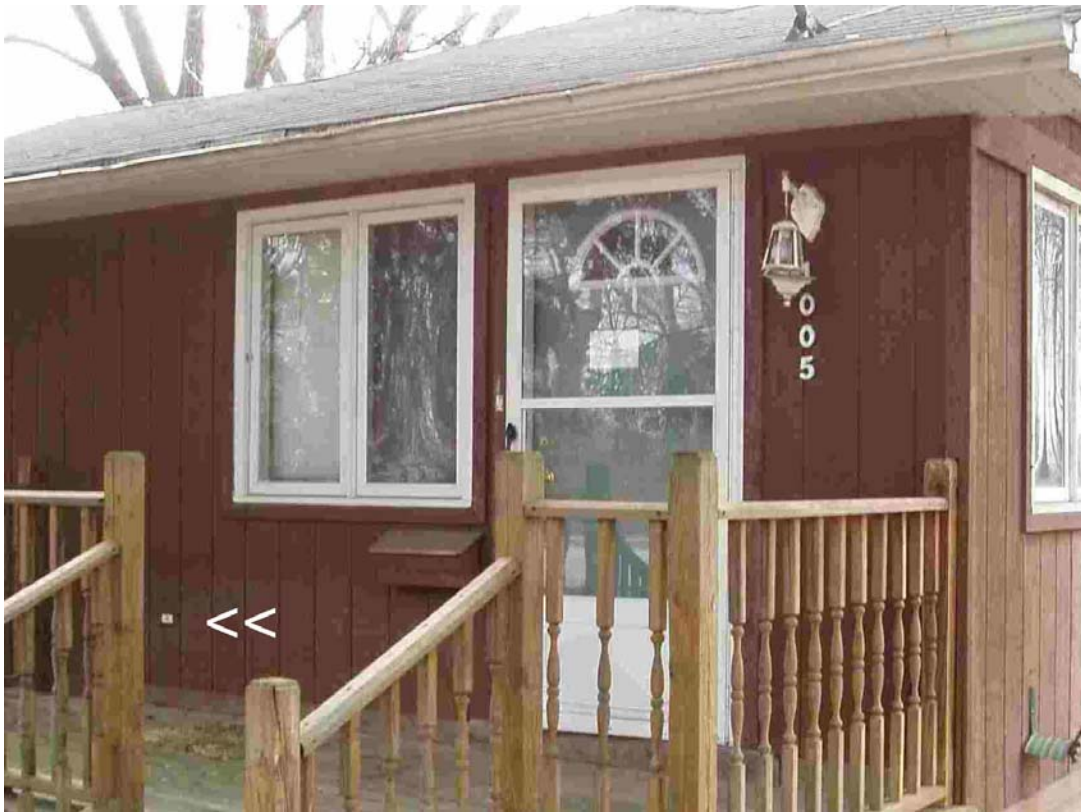
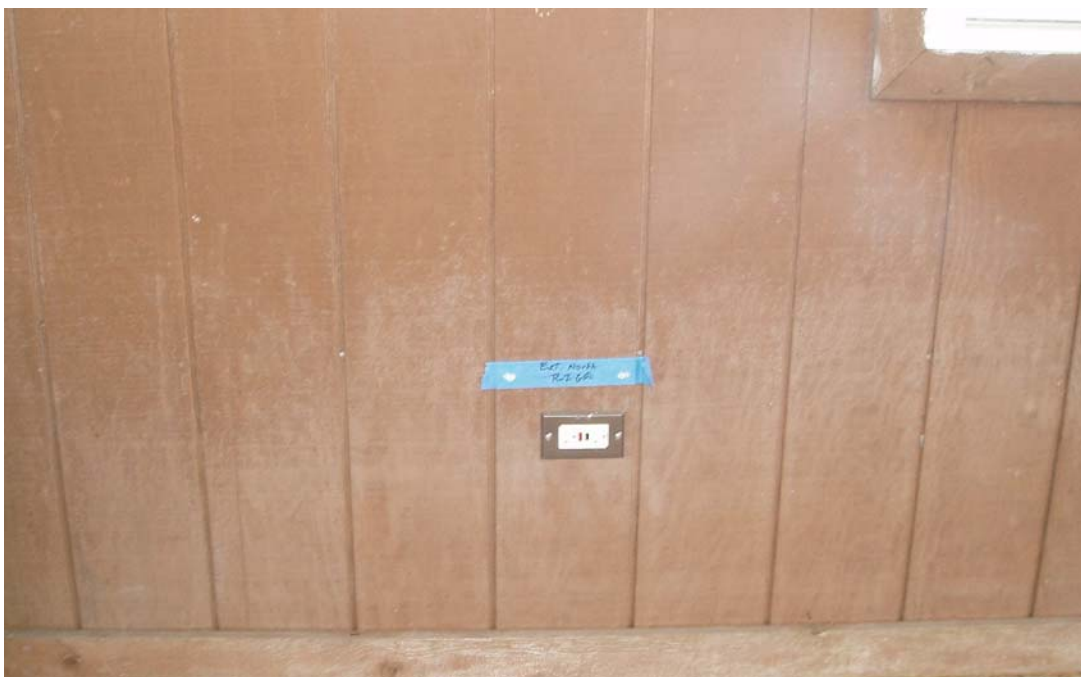
Fig. 25a– House IL-5, Non-Operational GFCI Receptacle With No Outdoor Faceplate or Box Cover

Fig. 25b– House IL-5, Non-Operational GFCI Receptacle With No Outdoor Faceplate or Box Cover (closer view of Fig. 25a)

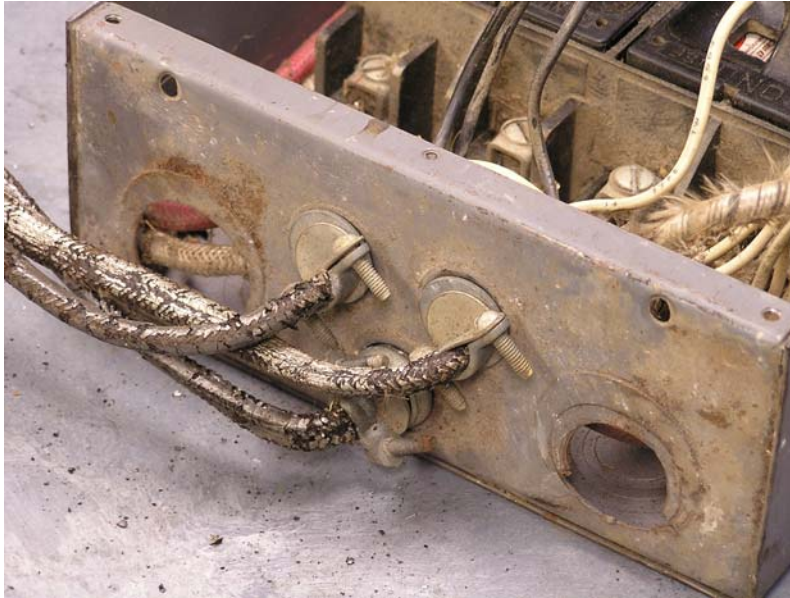
In Sec. 110.12(A) the *Code* says that unused openings shall be closed to afford protection substantially equivalent to the wall of the equipment. If not closed, these openings can be the source of a shock hazard, or concern for the spread of fire. Several houses (AL-3, AL-4, AL-9, VA-1, VA-2, and VA-3) had boxes with open knock-outs or similar openings.

Fig. 27 – House AL-3, Unused Openings in Enclosure

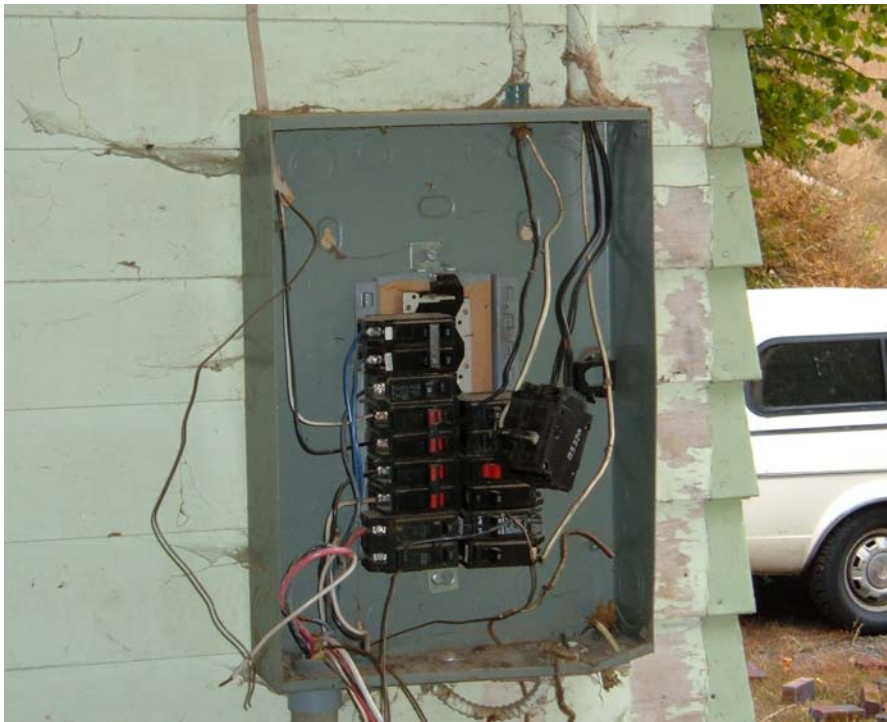
In Sec. 230.70(C) the *Code* says that a service disconnecting means shall be suitable for the prevailing conditions. The service disconnecting means may be the only means to deenergize the entire building in case of fire or other disaster. House OR-1 had the main service disconnect installed outdoors, but the enclosure was not suitable for outdoor use.

Fig. 30 – House OR-1, Main Disconnect Outdoors

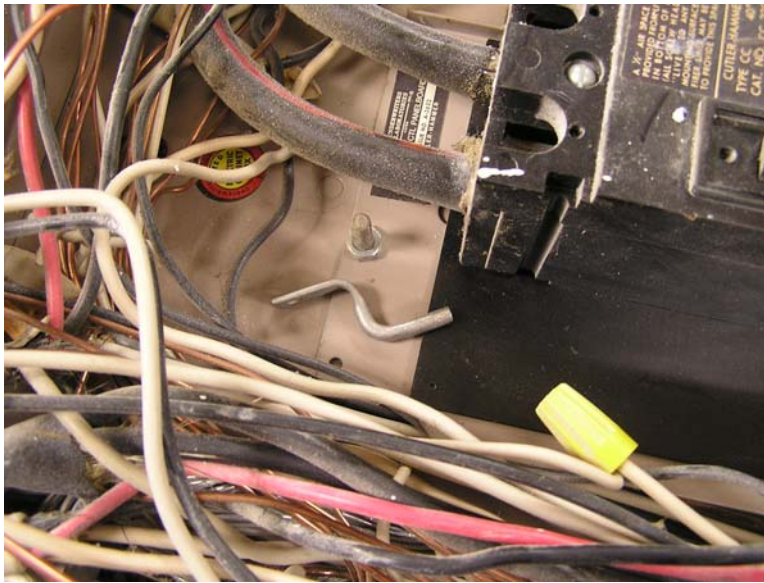
In Sec. 250.24(B) the *Code* says that a main bonding jumper shall be used to connect the equipment grounding conductor and the service-disconnect enclosure to the grounded conductor within the enclosure. Effective system grounding will limit voltage surges during abnormal events, such as lightning, and stabilize the voltage to earth during normal operation. Two houses (VA-1 and VA-3) did not have a main bonding jumper connection at the service.

Fig. 31 – House VA-3, Main Bonding Jumper Not Connected

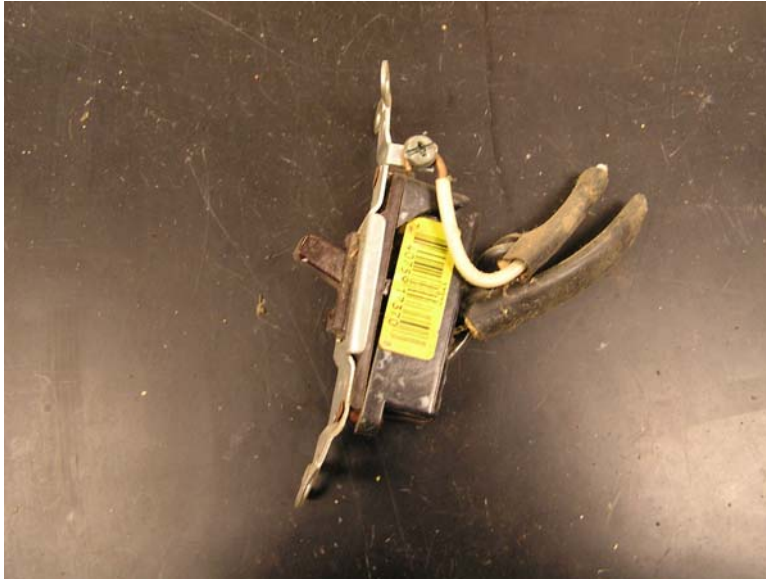
In Sec. 250.119 the *Code* says that equipment grounding conductors shall be bare or be insulated with a continuous green outer surface. It is important not to confuse equipment grounding conductors with other conductors, as a shock hazard could exist. Two houses (AL-2 and TX-1) had insulated equipment grounding conductors that were a color other than green.

Fig. 32 – House TX-1, White Colored Grounding Conductor

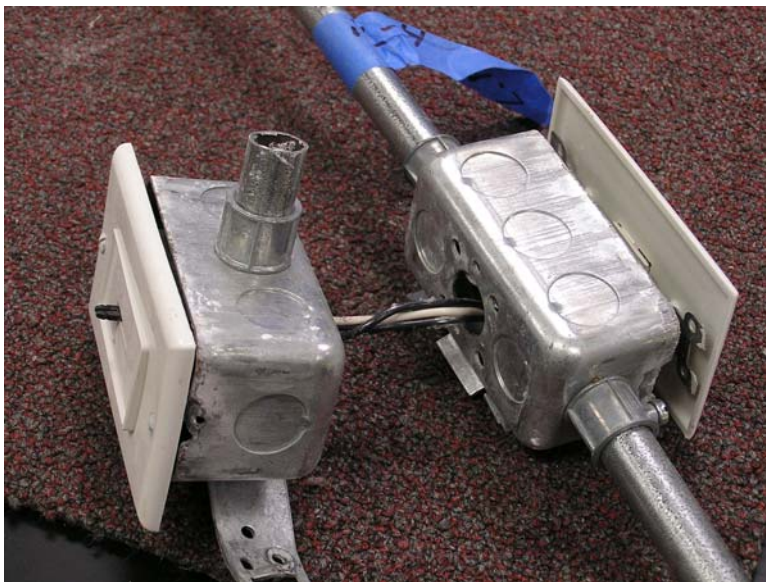
In Sec. 300.3 the *Code* says that single conductors shall only be installed where part of a recognized wiring method. Wires not installed in this manner can become a fire or shock hazard. Two houses (AL-7 and IL-4) had conductors that were open and not in a cable or raceway.

Fig. 33 – House IL-4, Open Conductors In Wall Between Boxes

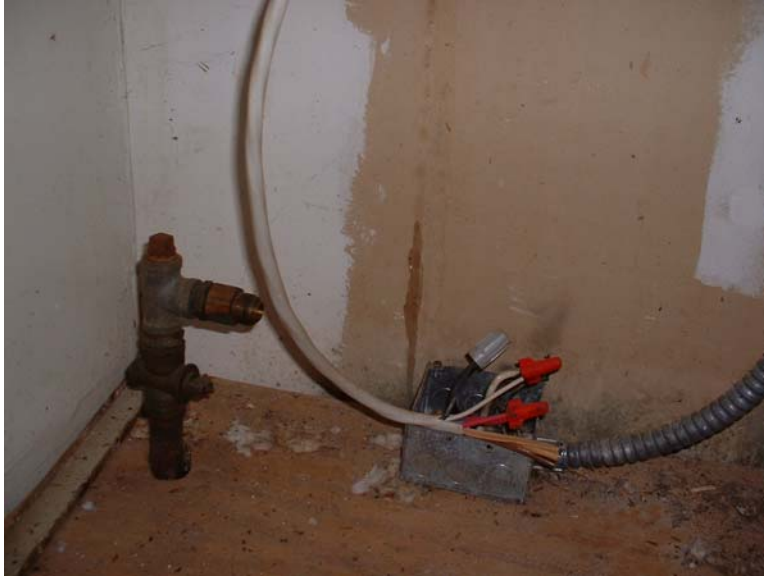
In Sec. 300.11 the *Code* says that boxes shall be securely fastened in place. If a box is not supported, strain could be placed on the wires, resulting in a fire or shock hazard. Two houses (AL-1 and WI-1) had outlet boxes that were unsecured.

Fig. 34– House AL-1, Unsupported Box (Also No Box Cover)

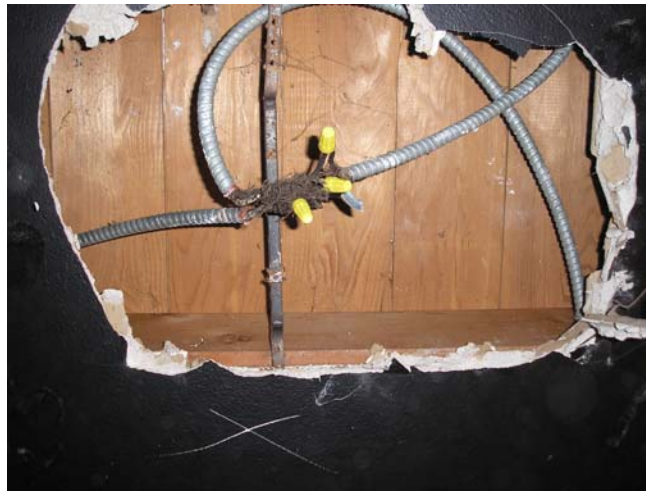
In Sec. 300.15 the *Code* says that a box or conduit body shall be installed for each conductor splice or outlet point. Open splices can be the cause of a fire or shock hazard. Several houses (AL-1, AL-5, AL-6, AL-8, OR-1, OR-2, and WI-1) had open splices in walls or ceilings without the use of outlet boxes.

Fig. 35 – House WI-1, Open Splices in Ceiling

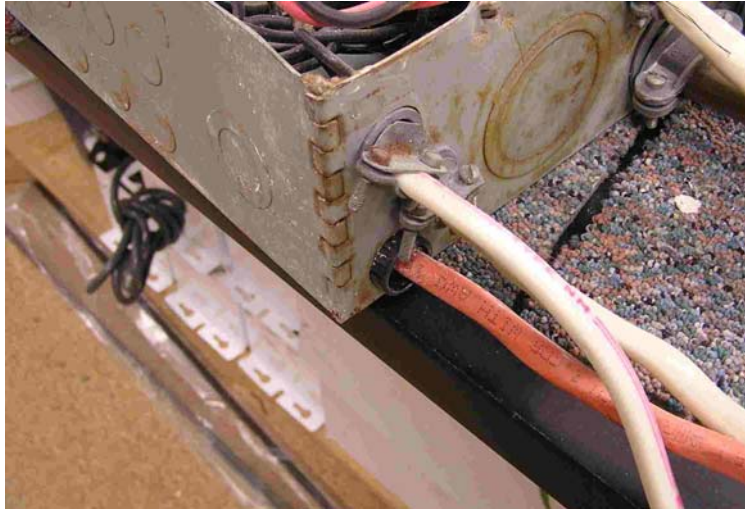
In Sec. 314.17(A) the *Code* says that an opening through which conductors enter boxes shall be adequately closed. In Sec. 312.5(C) the *Code* also says that where cable is used, each cable shall be secured to the cabinet or enclosure. Conductors or cables that are not adequately secured can cause strain to be put on the wires and its terminations. Several houses (AL-1, AL-3, AL-4, AL-8, AL-9, IL-3, MA-3, VA-1, VA-2) had one or more examples where cable clamps were not provided.

Fig. 36 – House MA-3, Cable Clamp Not Provided

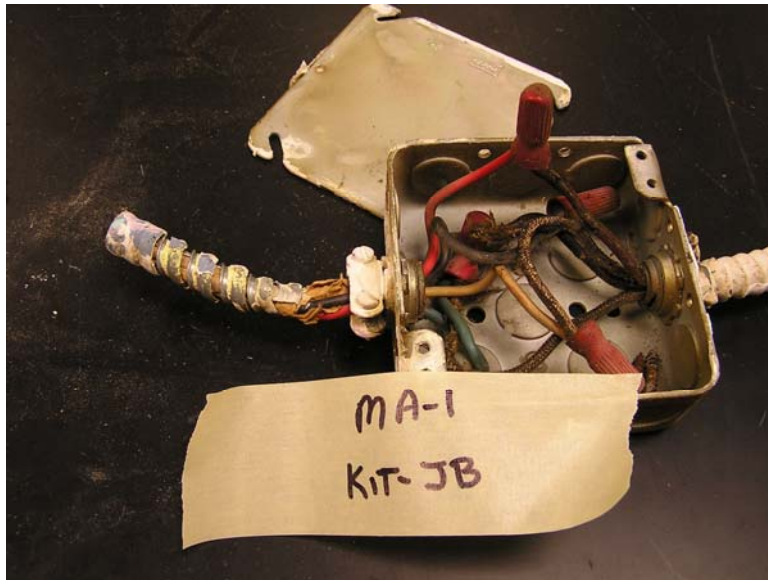
In Sec. 320.40 the *Code* says that AC cable at boxes and fittings shall be provided with an insulating bushing between the conductors and the armor. At a cut end the AC cable armor can be sharp, and this can damage the conductor insulation if not protected. Damaged conductor insulation can be the cause of a fire or shock hazard. Several houses (IL-1, IL-2, IL-3, MA-1, OR-1, and WI-1) had examples of AC cable being used without insulating bushings installed.

Fig. 38 – House MA-1, No Insulating Bushing Installed With AC Cable

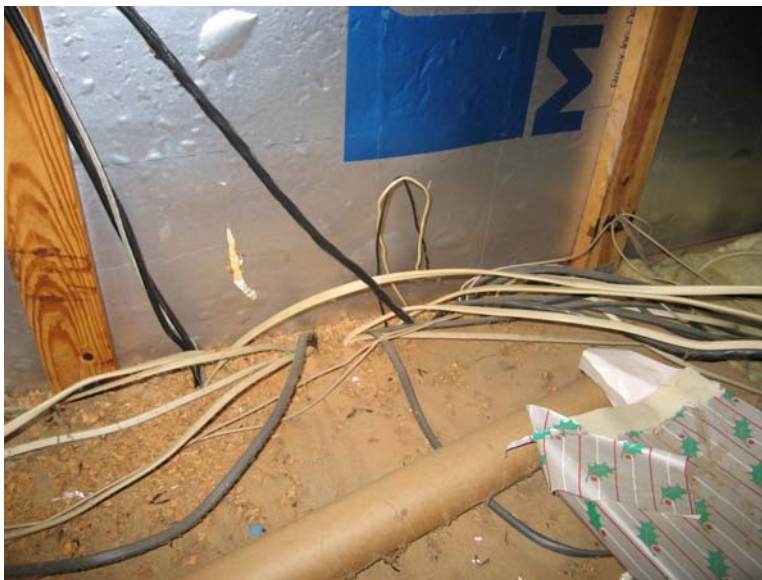
In Sec. 334.30 the *Code* says that NM cable shall be supported by staples or the like every 4-1/2 feet, and within 12 inches of every outlet box or cabinet. Unsupported cable can become damaged or strained, and become a shock or fire hazard. Several houses (AL-5, NY-2, OR-1, VA-1, and VA-3) had examples where NM cable was installed unsupported.

Fig. 39 – House VA-1, NM Cable Not Supported by Staples

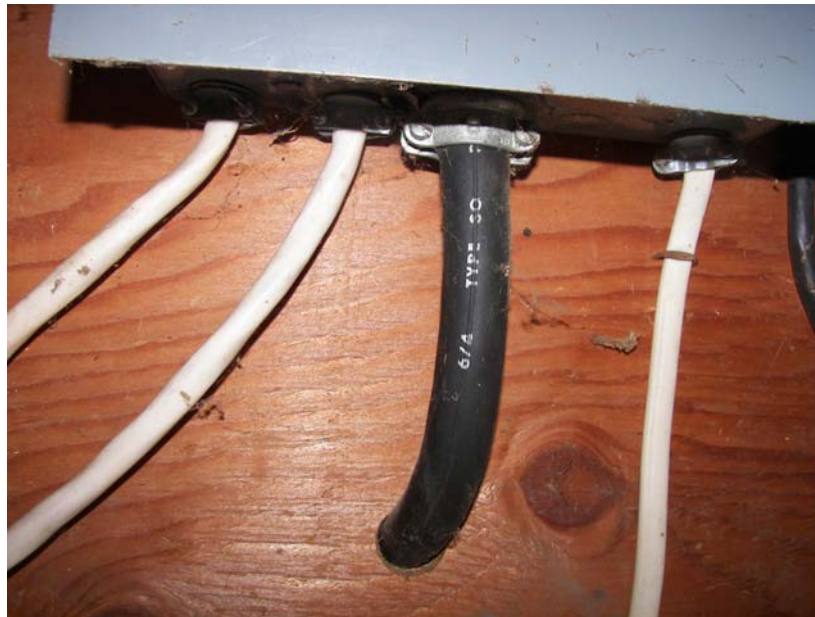
In Sec. 400.8 the *Code* says that flexible cords and cables shall not be used as a substitute for fixed wiring. It also states that they should not be run through holes in walls or ceilings, or attached to building surfaces. Flexible cords and cables are not subjected to the more rigid mechanical testing that fixed wiring methods, such as NM and AC cable or EMT, are subjected to. Several houses (AL-1, AL-4, AL-6, AL-7, AL-8, IL-3, NY-2, OR-1, and WI-1) used flexible cord or cable as a substitute for fixed wiring.

Fig. 40 – House NY-2, Type SO Flexible Cord From Panelboard

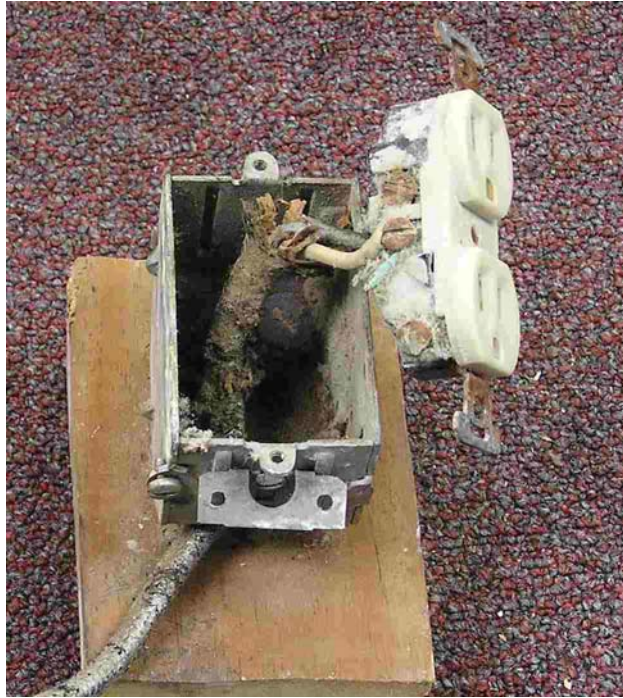
In Sec. 406.3(B) the *Code* says that receptacles that have equipment grounding contacts shall have those contacts connected to an equipment grounding conductor. If cord- and plug-connected equipment that is intended to be grounded is connected to a receptacle that does not provide a suitable equipment grounding path, a shock hazard could exist. Several houses (AL-1, AL-3, AL-8, AL-9, TX-1, and VA-1) had grounding type receptacles (3-prong) installed in a branch circuit that did not have an equipment grounding conductor.

Fig. 41 – House AL-4, Grounding Type Receptacle Without Ground

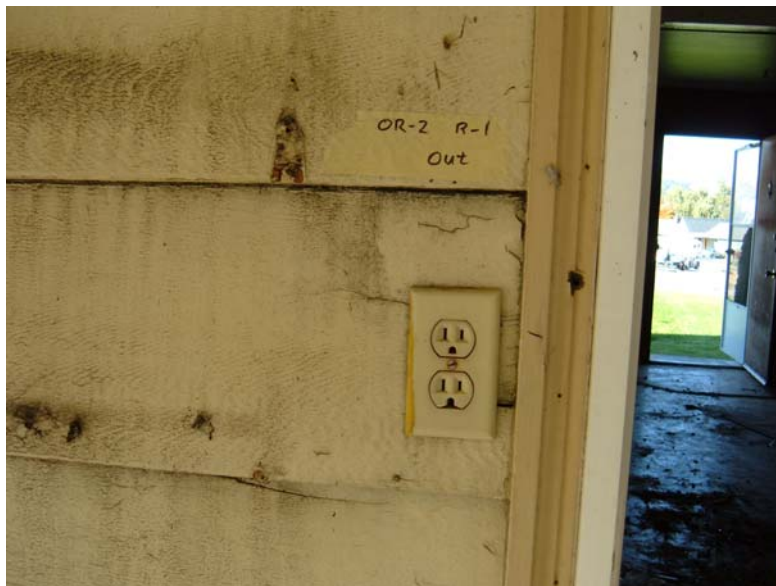
In Sec. 406.8 the *Code* says that receptacles installed outdoors shall have an enclosure that is weatherproof. If water gets into the contacts of a receptacle, it can become a fire or shock hazard. Several houses (IL-5, OR-1, and OR-2) had outdoor receptacles that were not in weatherproof enclosures.

Fig. 42 – House OR-2, Open Receptacle Outdoors

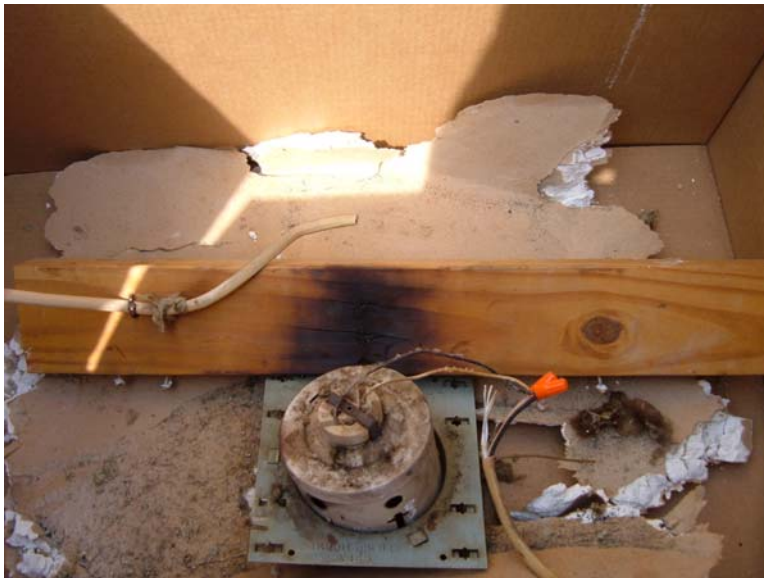
In Sec. 410.116(A) the *Code* says that a recessed luminaire that is not intended for contact with insulation shall have all recessed parts spaced  $\frac{1}{2}$  inch from combustible materials. It also says that thermal insulation shall not be installed above a recessed luminaire or within 3 inches of the enclosure unless identified for contact with insulation. Recessed luminaires that are not marked type IC are not temperature tested with surrounding thermal insulation, and can become a fire hazard if installed in this manner. House AL-6 had an unmarked recessed ceiling luminaire installed in a shower area against a wall stud and surrounded with insulation.

Fig. 43a – House AL-6, Thermal Insulation Above Recessed Luminaire

Fig. 43b – House AL-6, Recovered Recessed Ceiling Luminaire
