DC Voltage Induced Pinhole Piping Leaks

Gary R. Gabriel PE

Johnson Controls

The point of this paper is to offer design strategy to reduce the risk of pinhole piping leaks. In practice, once the pinhole leaks show up, it is too late for design changes to do any good. By then, the only answer is to replace the entire piping system. Often a failed copper or steel piping system is replaced with plastic pipe.

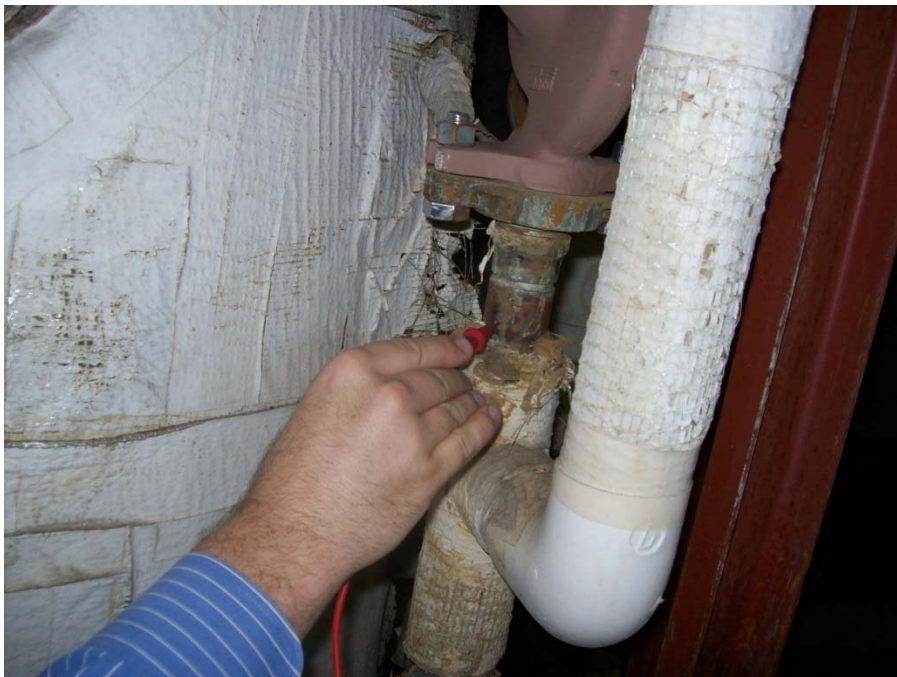
Figure (H1a): On a hunch, in the domestic hot water plant, we checked for DC voltage on the domestic water piping. A view of the red lead of the volt ohm meter. The black lead was pressed against a metal floor drain grate (wet).

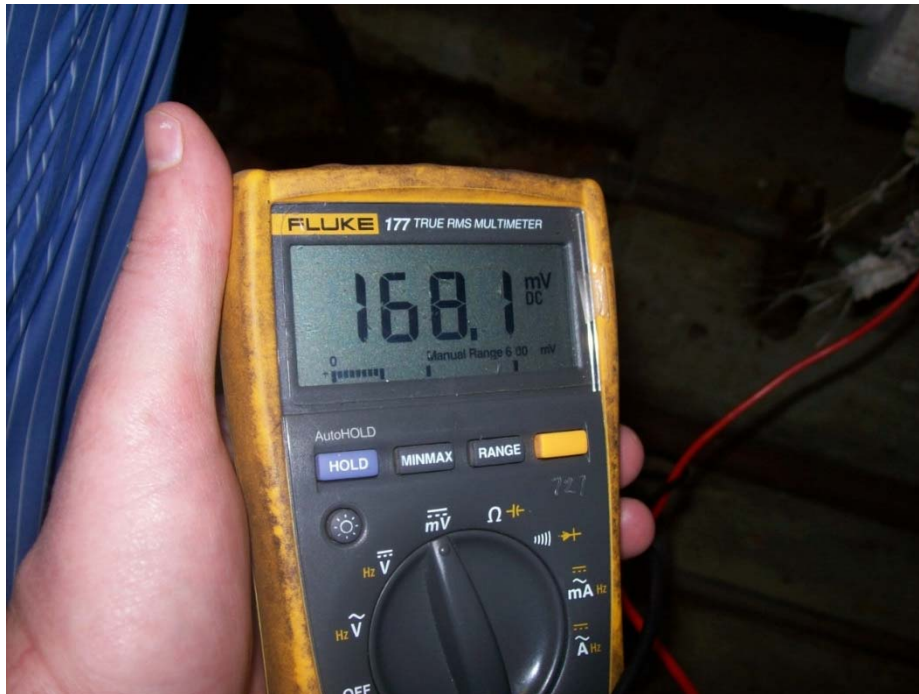
Figure (H1b): A view of the Fluke meter display at 0.168 volts DC, measured from pipe to earth ground.

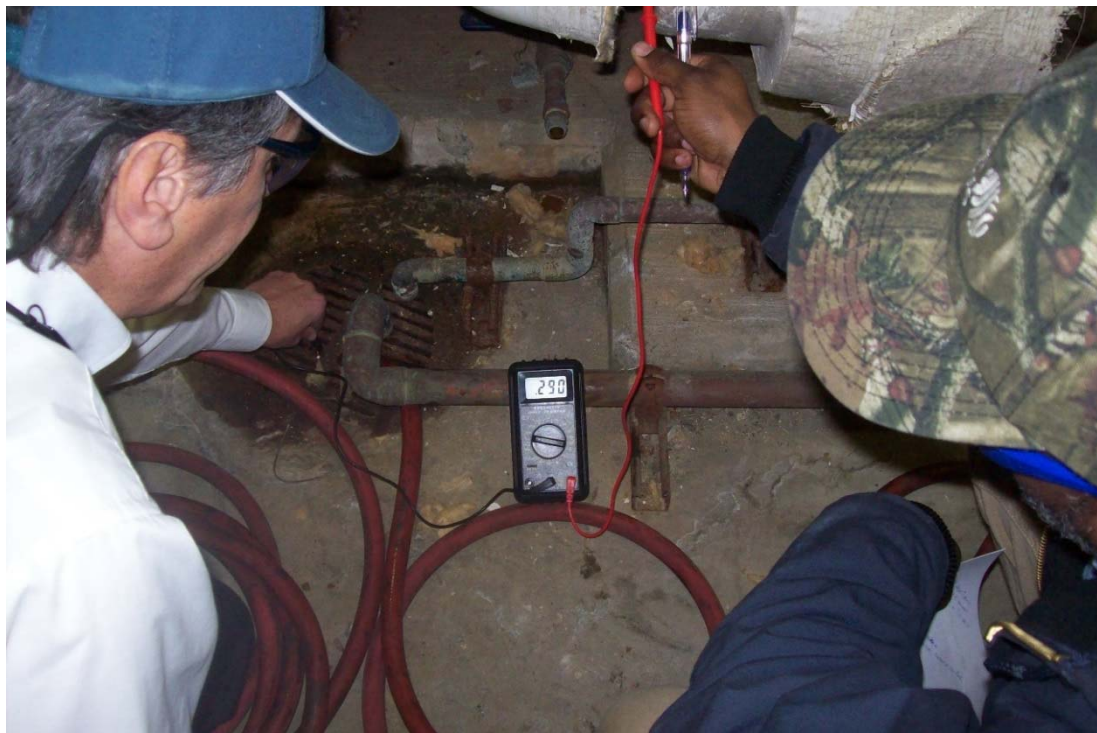
Figure (H1c): A view of another test on another day. With an Omega volt ohm meter, we measured 0.29 volts DC from pipe to wet floor drain grate (earth ground).

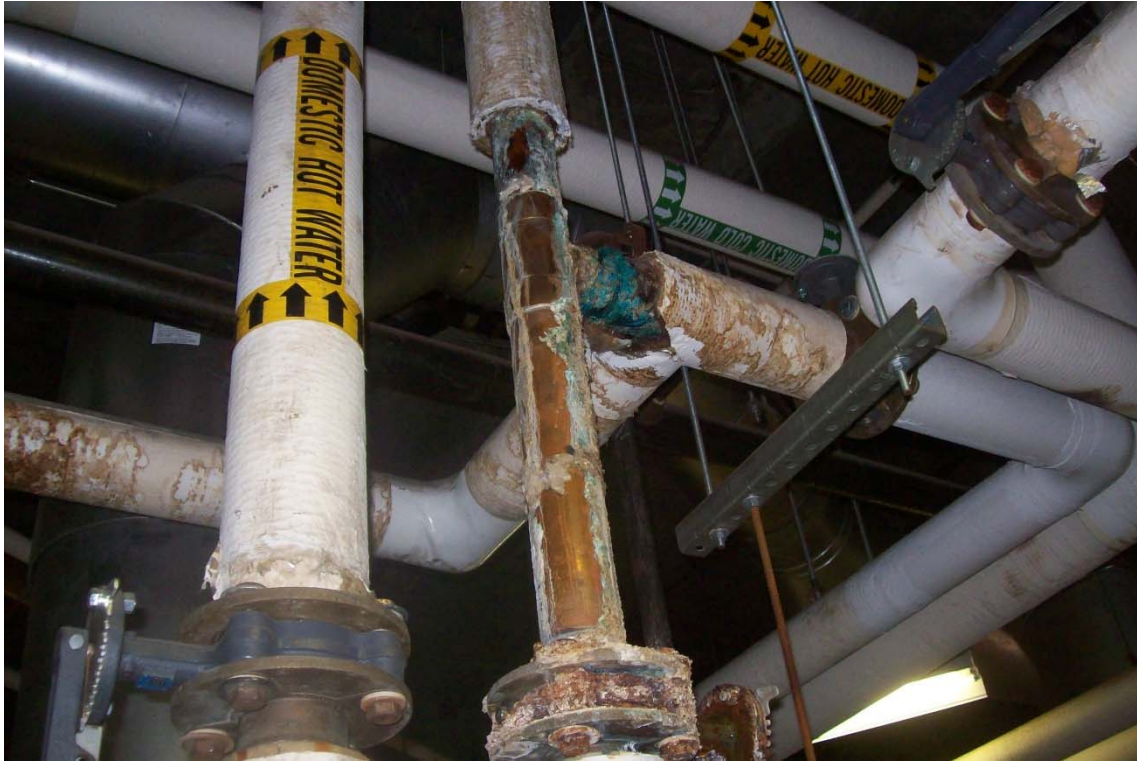
During 2012 we had an Atlanta Ga. customer (Jail #1) that had recurring domestic hot water copper piping leaks. Previously, each soldered domestic water piping joint in the central plant had been redone due to failed soldered joints. The soldered joints had failed again, and we visited the site to prepare the quotation for a turnkey repair job (H1). (H = History).

Figure (H1d): A view of typical piping corrosion where the solder joints had failed.

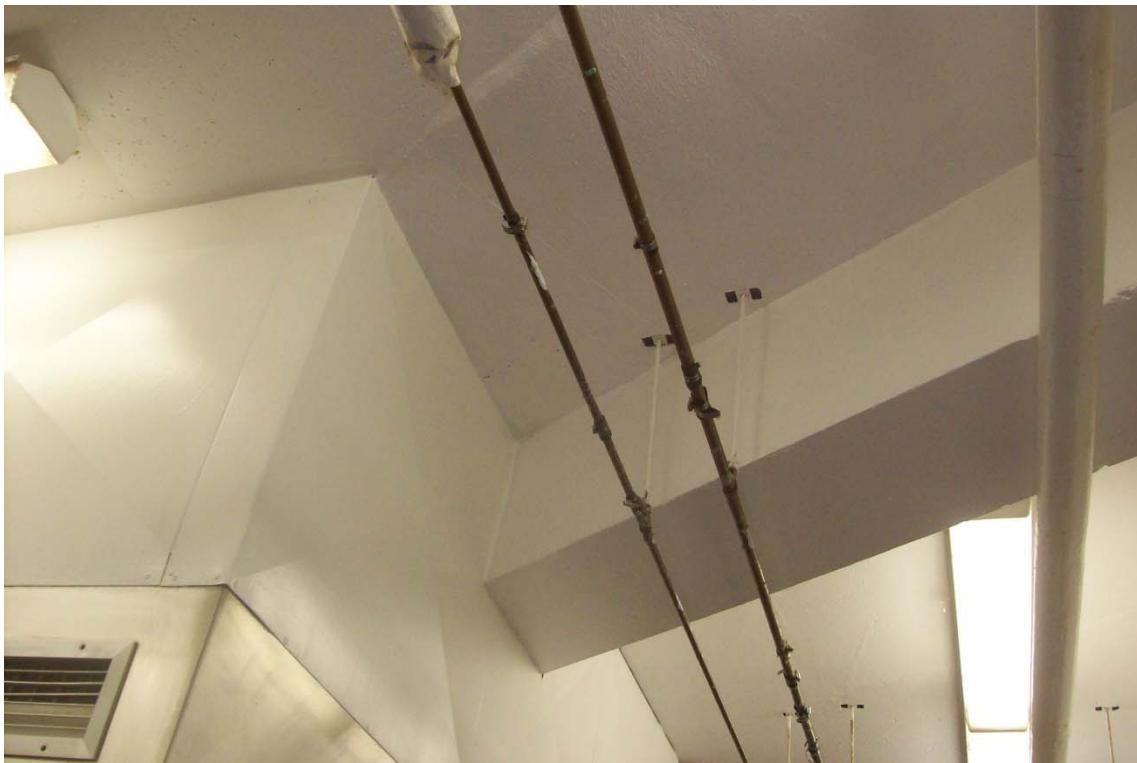
Figure (H2a): A view of copper domestic hot and cold water piping with pinhole leaks.

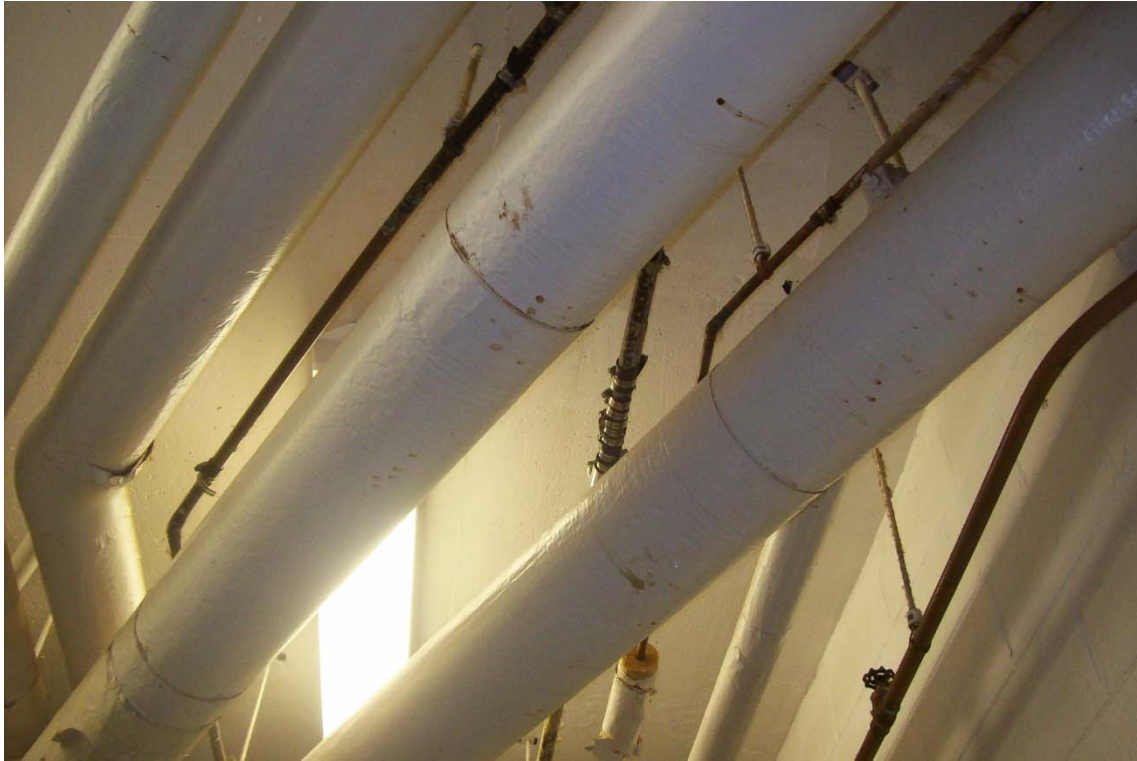
Figure (H2b): A closer view of typical pinhole leaks. At each pinhole leak, a rubber strip with hose clamp is applied, as a temporary repair.

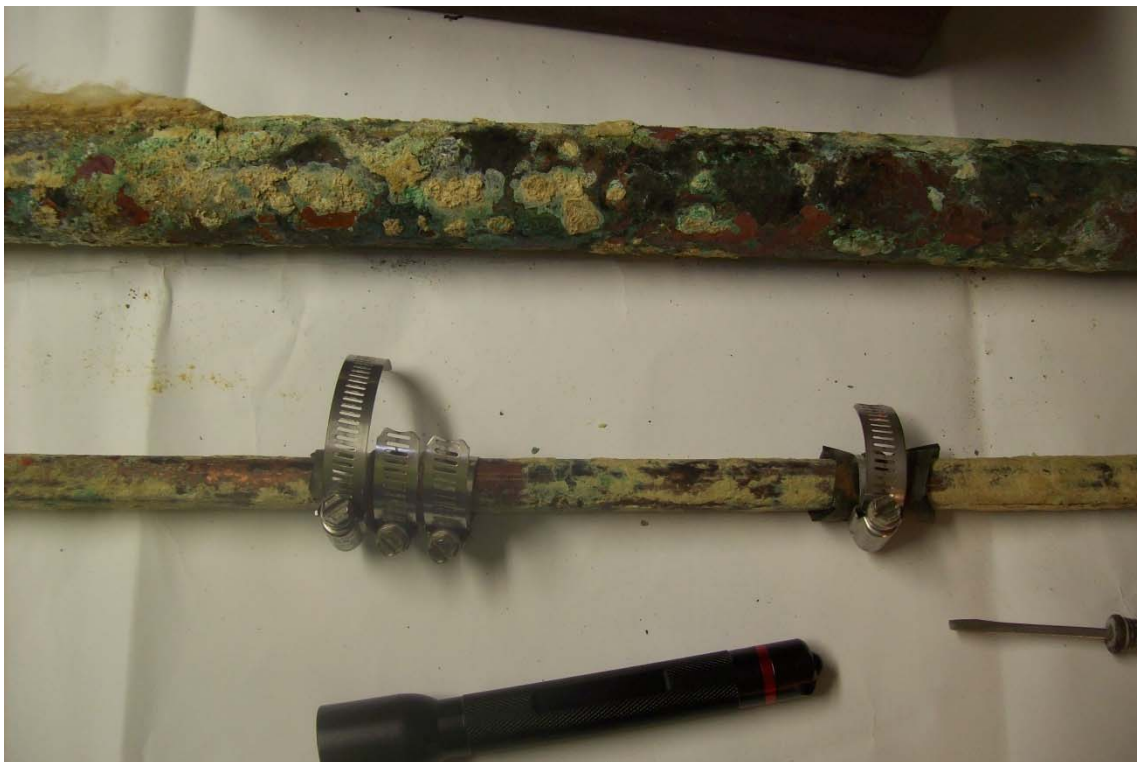
Figure (H2c): A view of removed copper piping with hose clamps in place.

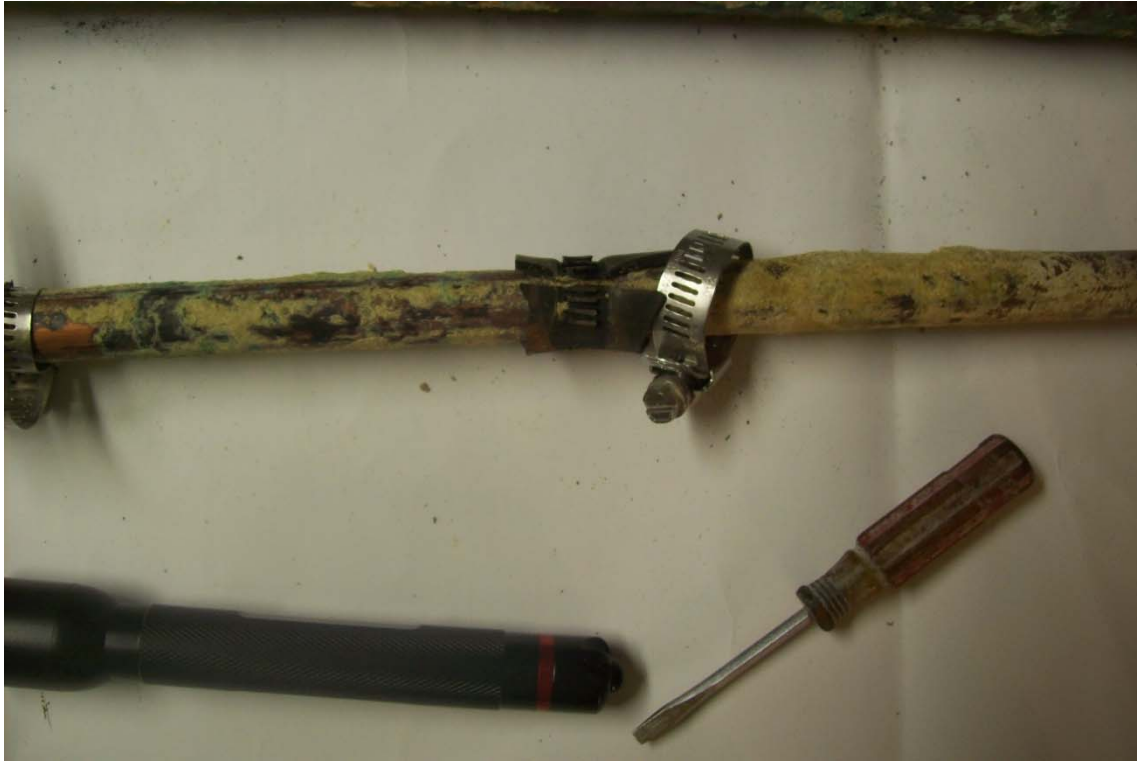
Figure (H2d): A view of the hose clamp removed.

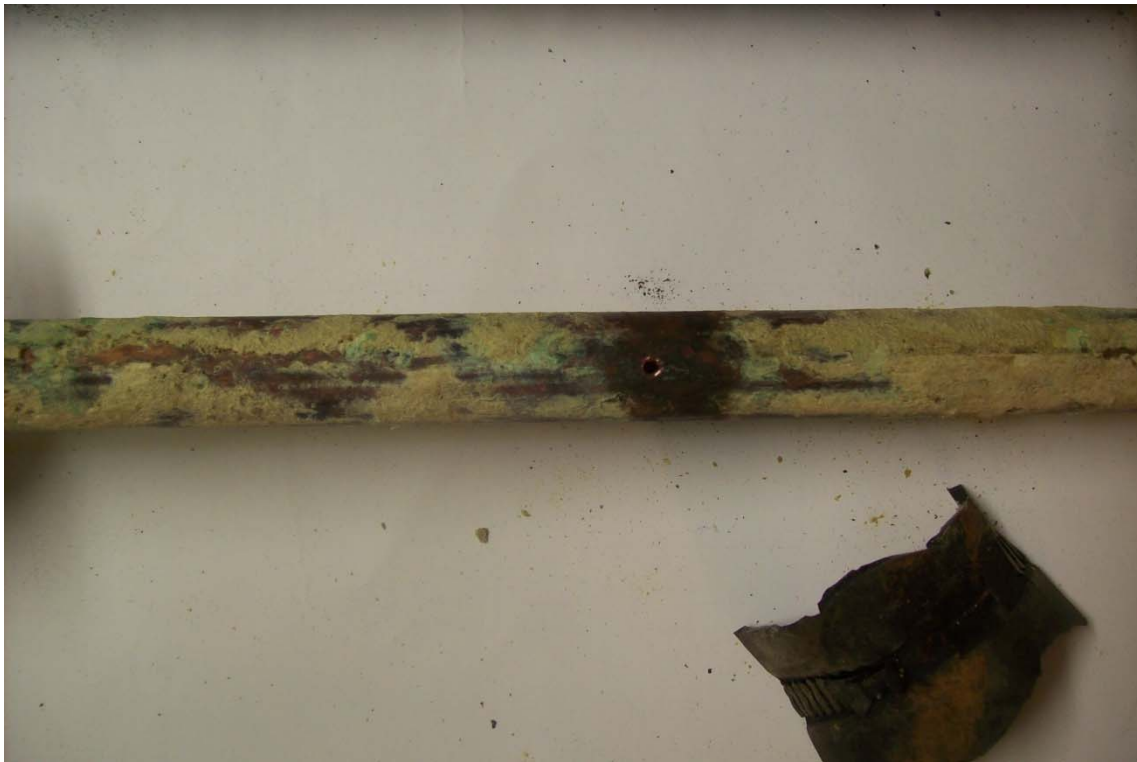
Figure (H2e): A view of the pinhole (when green nodule poked with screwdriver).

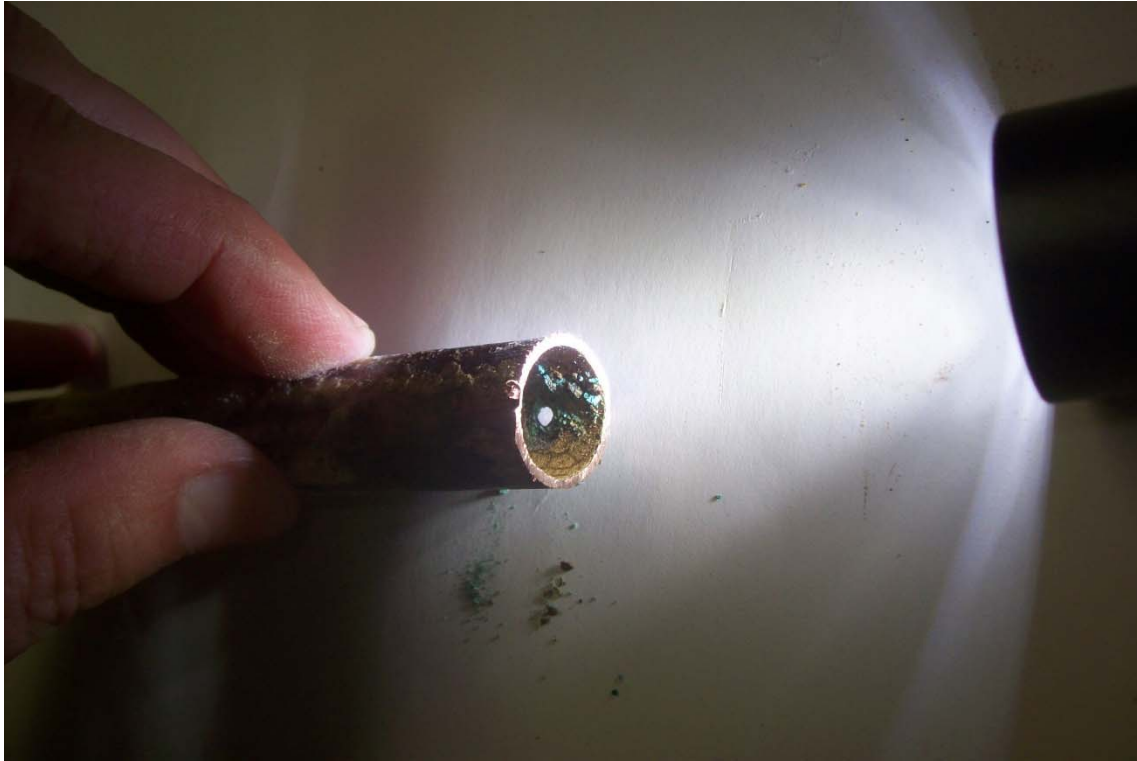
Figure (H2f): A view of a similar pinhole looking from the inside.

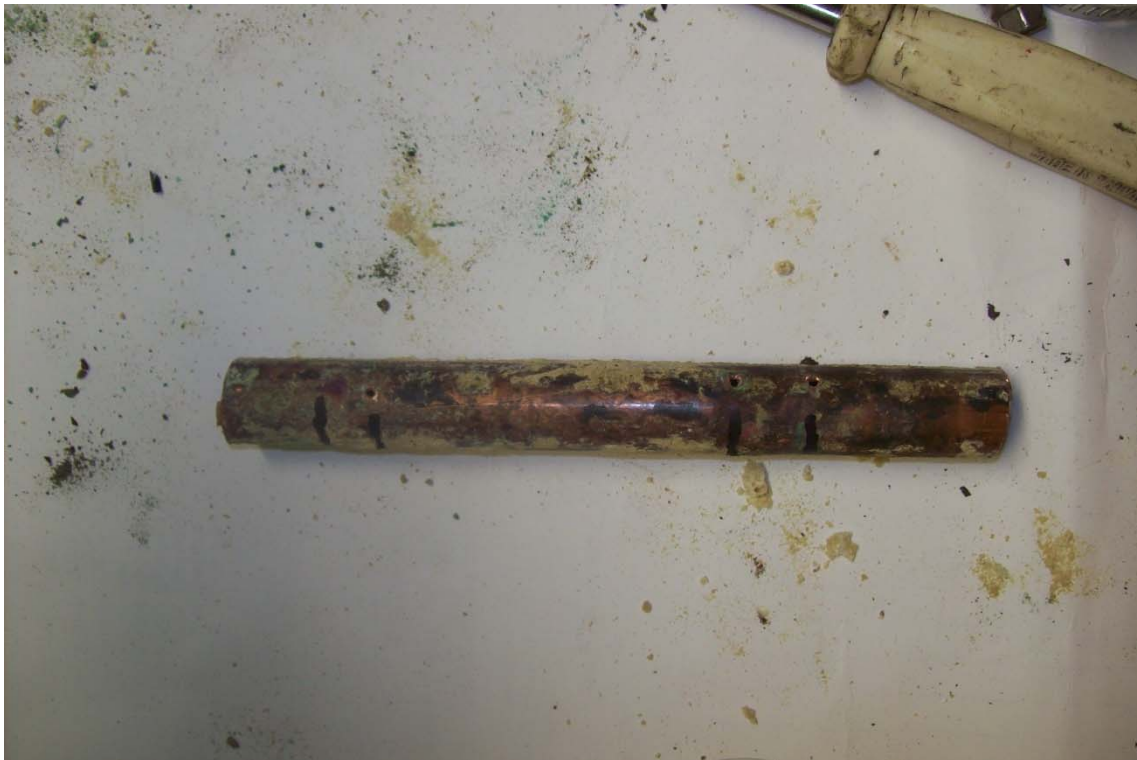
Figure (H2g): A view of a 6 inch section of pipe with 4 pinholes.

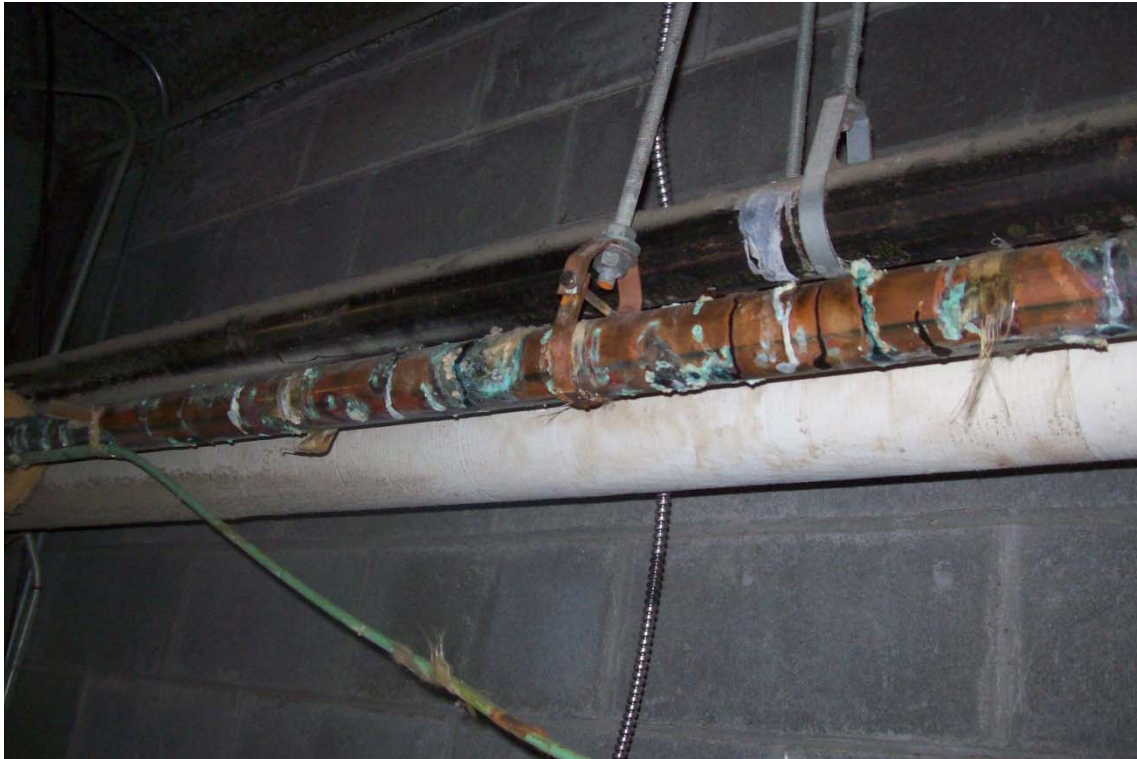
Figure (H3a): A view of pinhole piping failures that were typical throughout the facility.

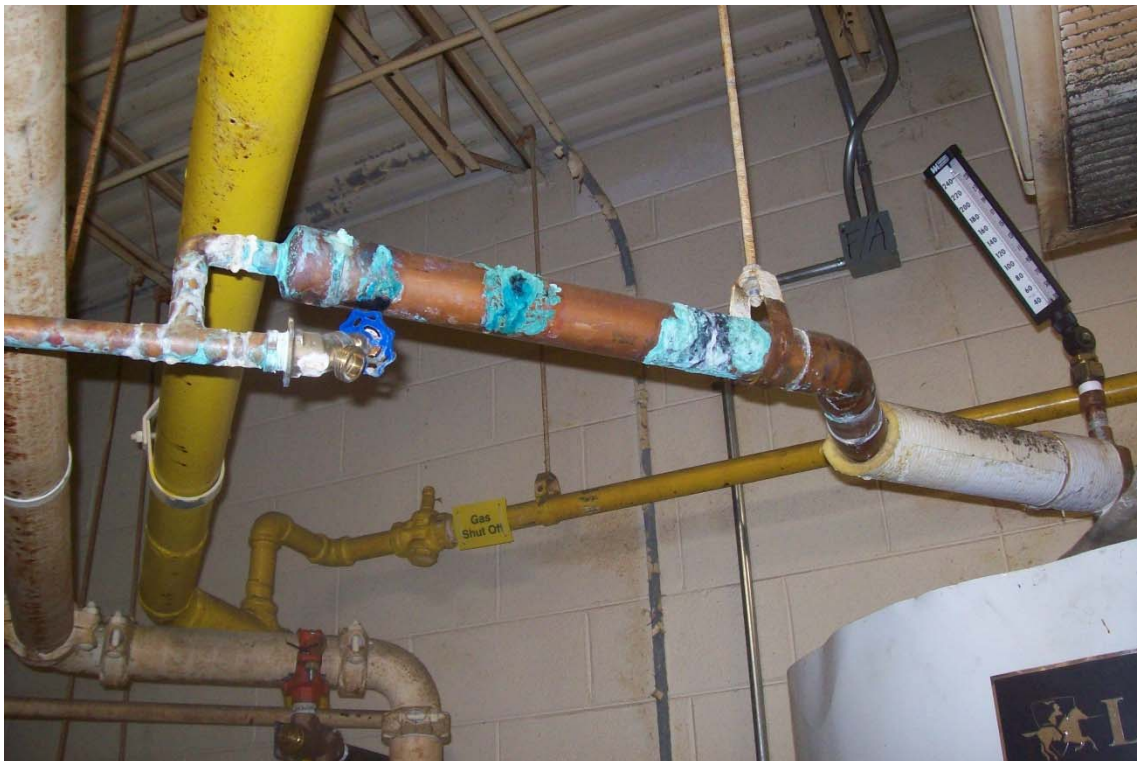
Figure (H3b): A view of pinhole leaks within a mechanical room.

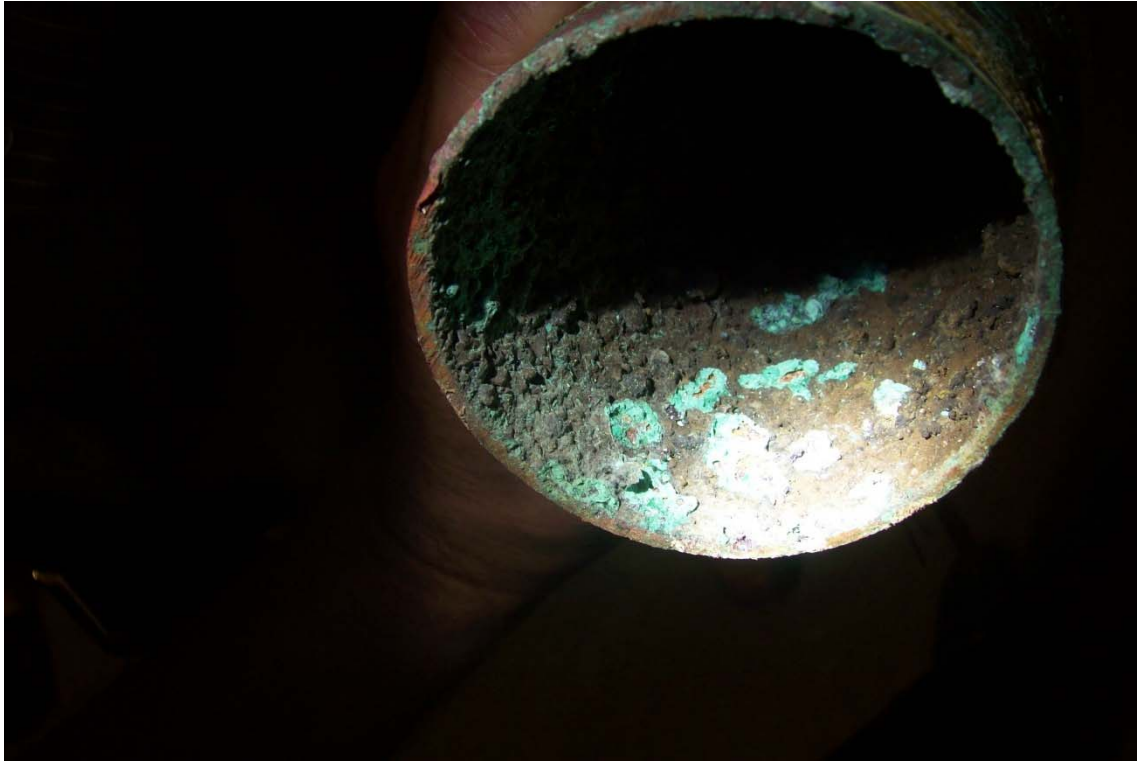
Figure (H3c): An interior view of a failed copper pipe.

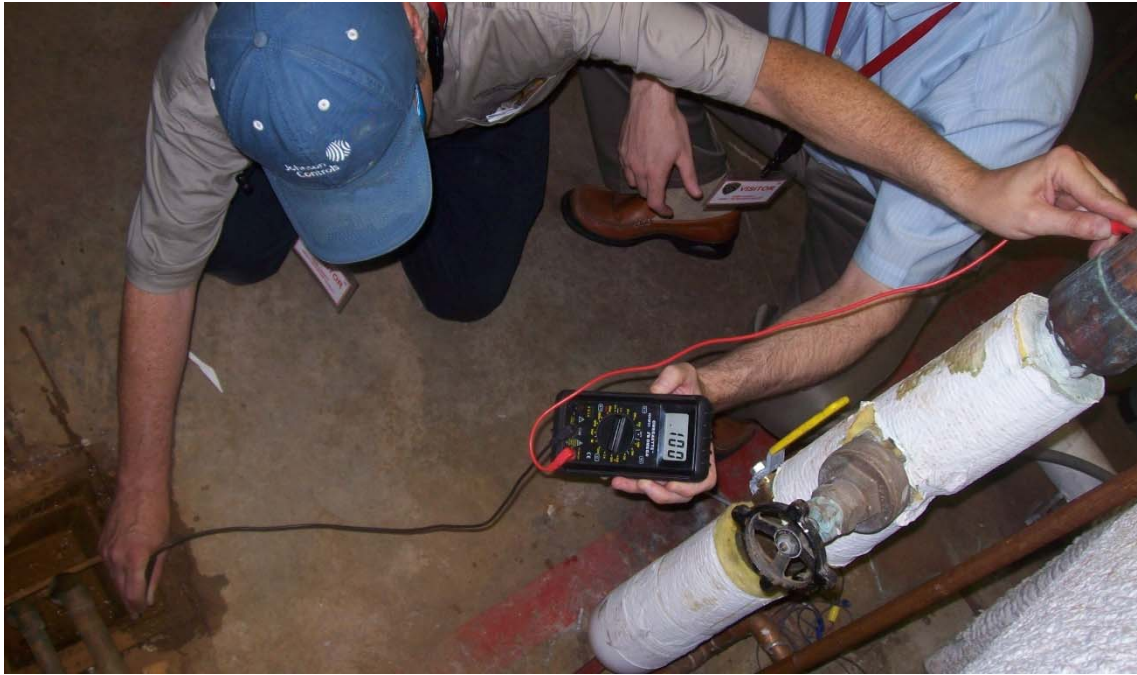
Figure (H3e): A view of DC voltage observed between pipe and floor drain, at Jail #3.

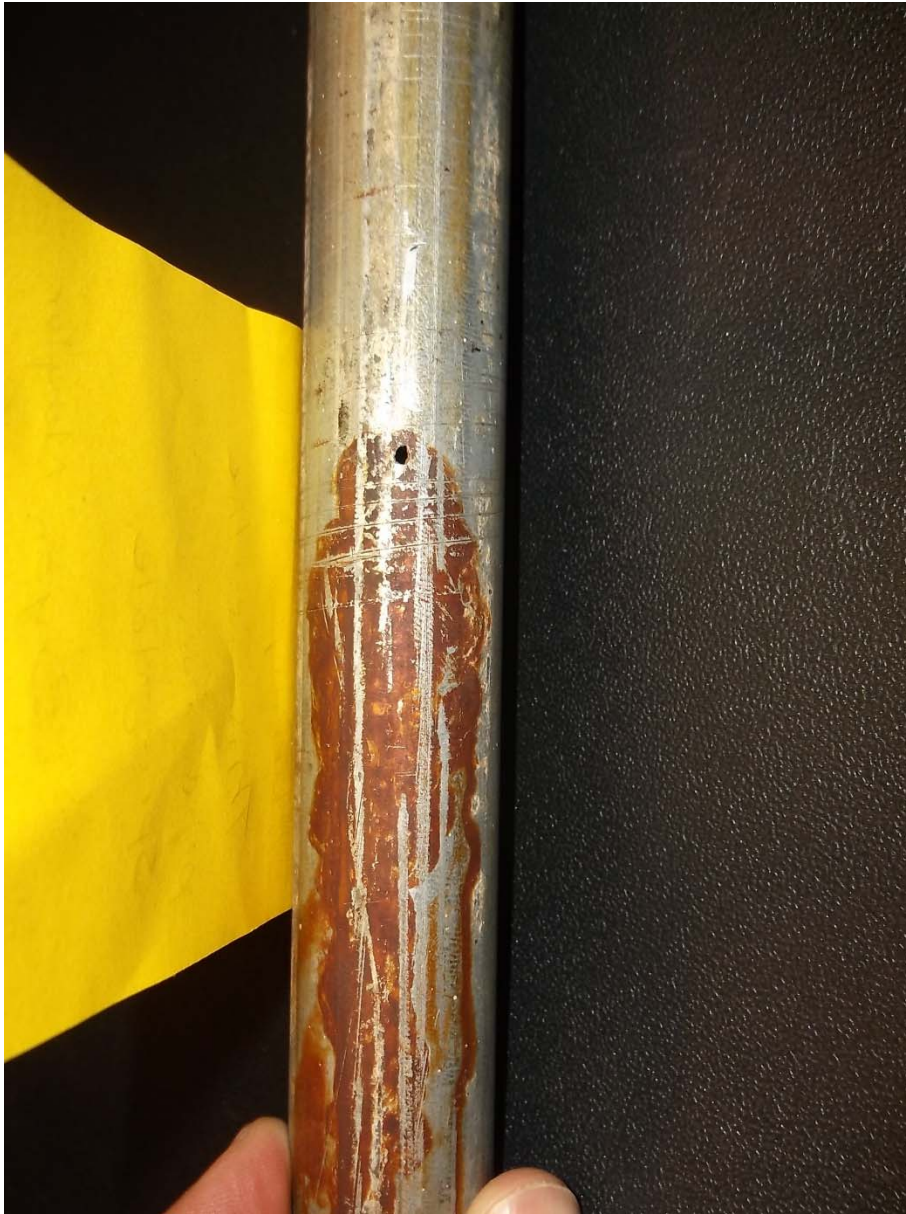
During 2018 we had an Atlanta Ga. Elementary School customer (School #1) that had pinhole leaks throughout the HVAC water source heat pump schedule 5 steel piping system. The piping system was 9 years old, much too young to fail (H4).

Figure (H4a): A view of a pinhole leak in steel schedule 5 piping. The rust stain is from leaked water. This piping served an HVAC water source heat pump system.

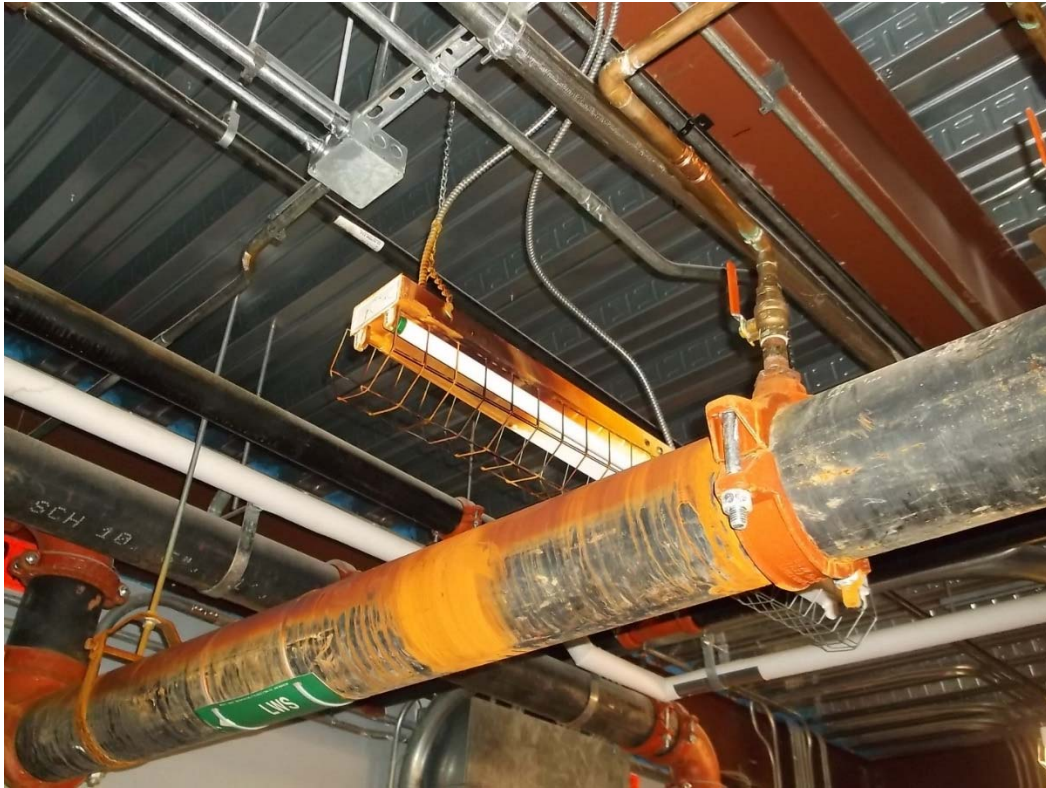
Figure (H4b): Another view of rust stains caused by pinhole leaks.

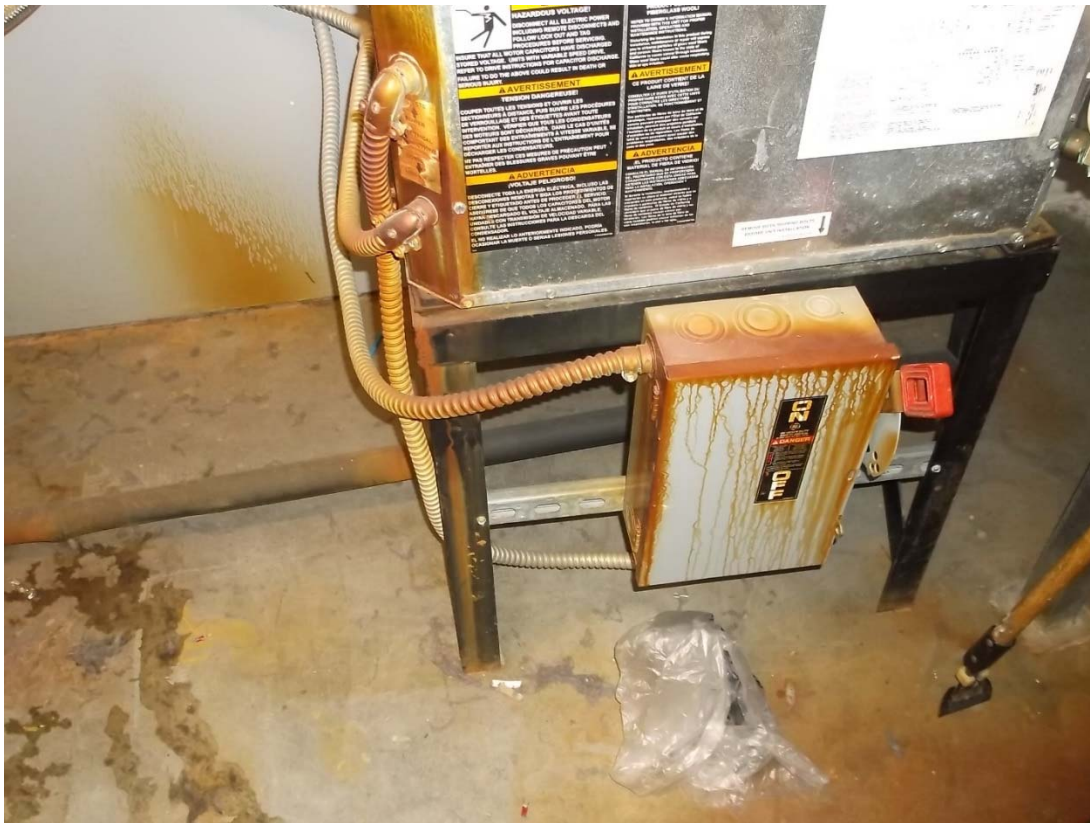
Figure (H4c): Another view of rust stains caused by pinhole leaks.

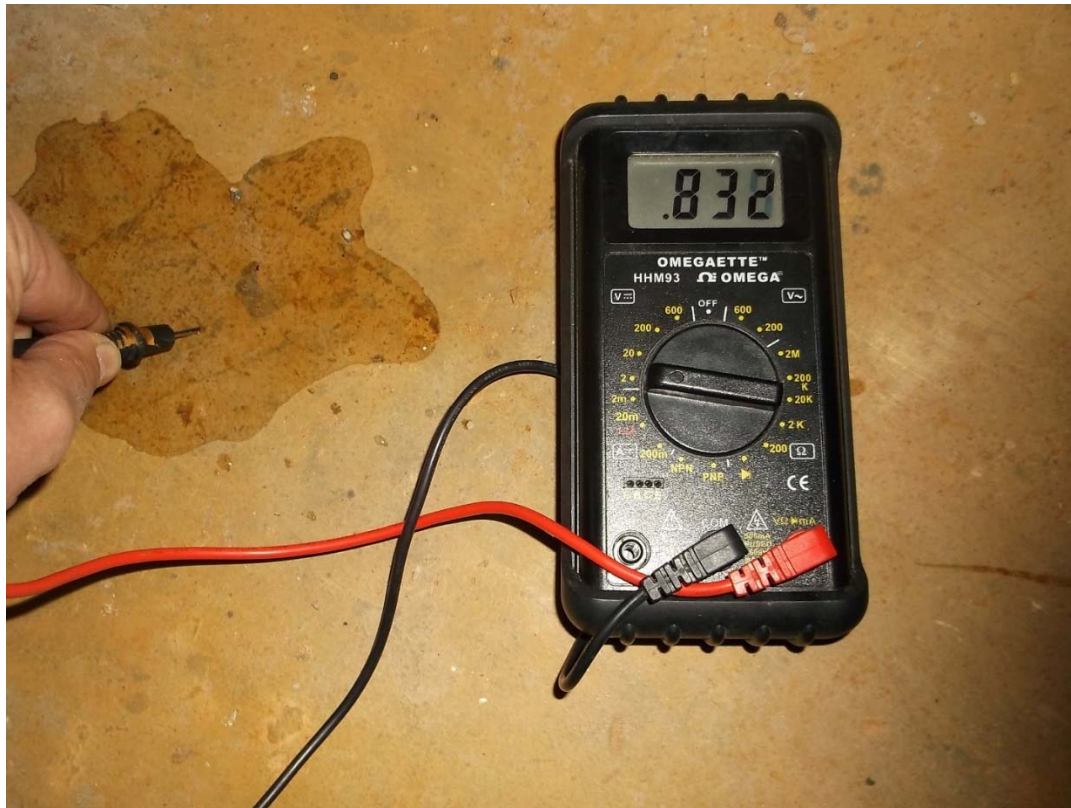
Figure (H4d): A view of DC voltage observed from pipe to wet floor slab.

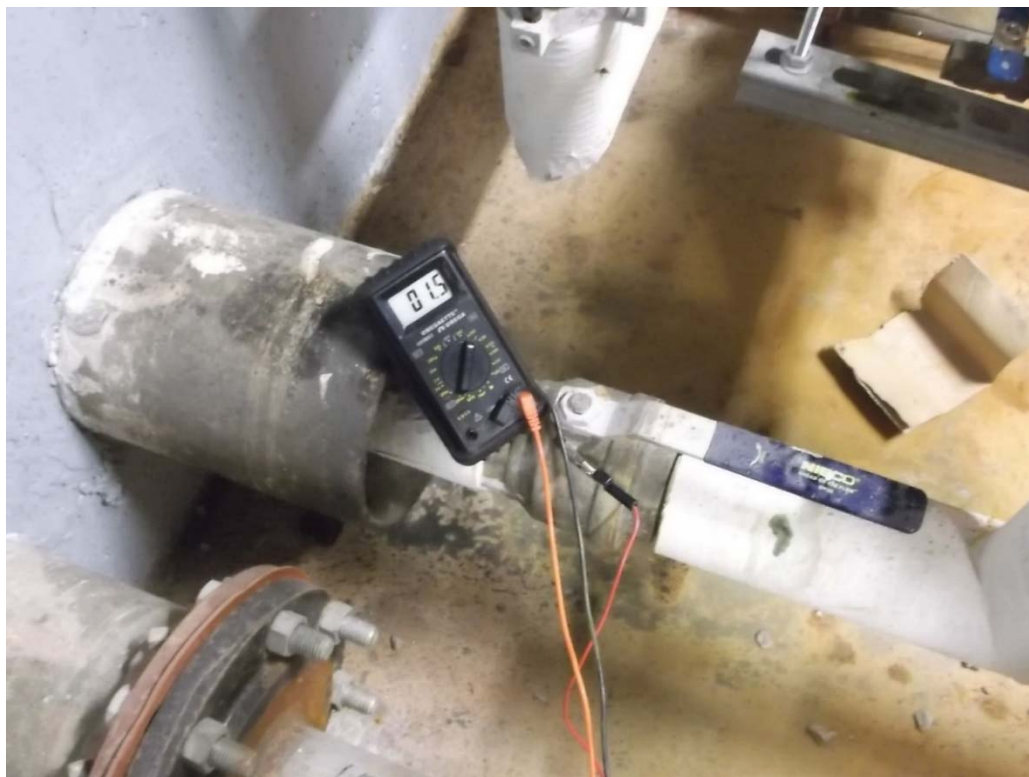
Figure (H4e): A view of 15 mA of DC flowing on the domestic water piping (pipe to building steel). Later that day we observed 20 mA.

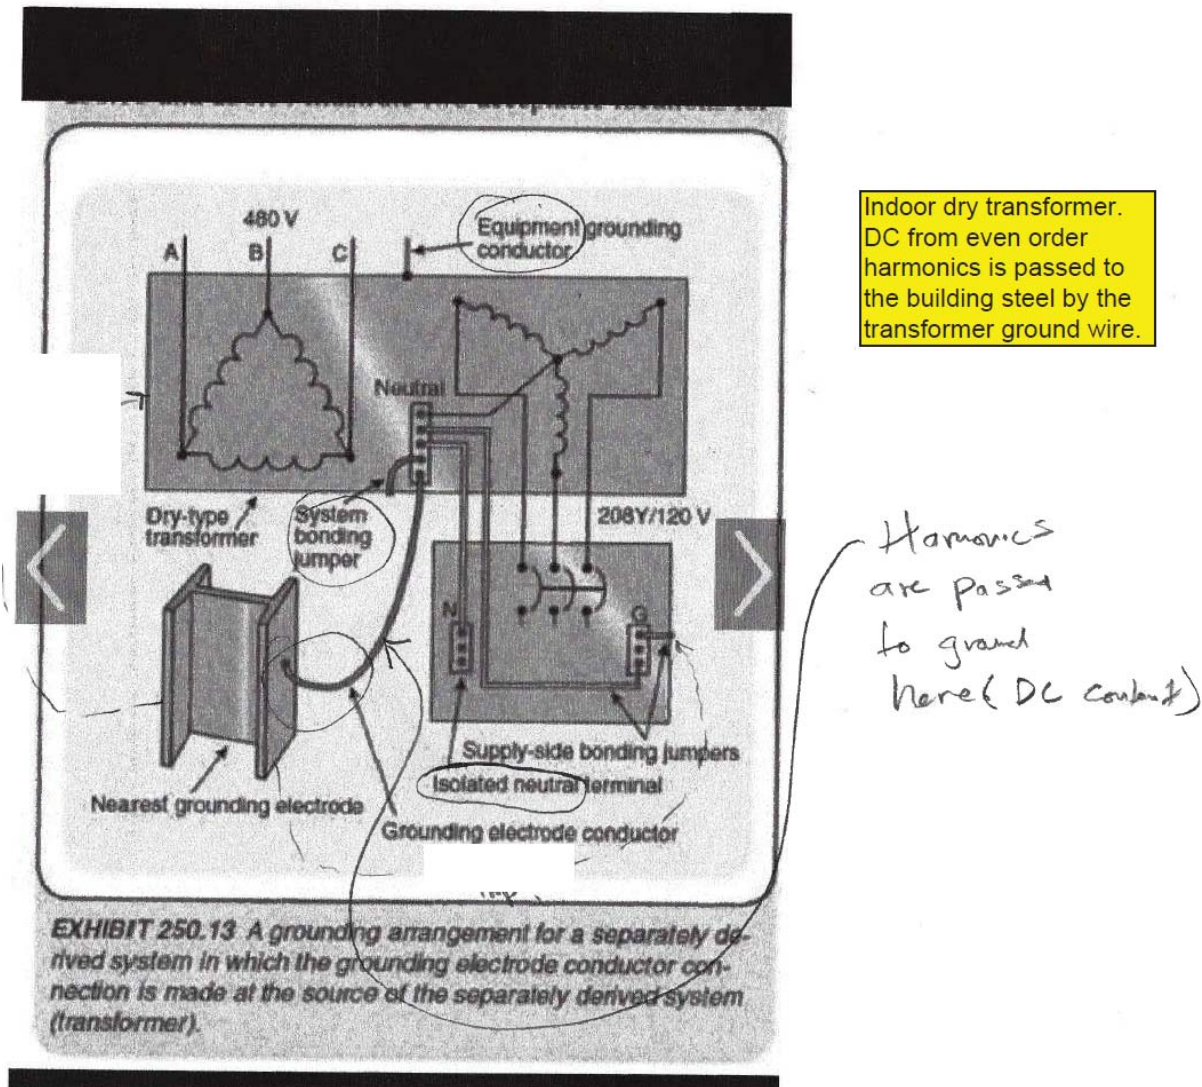
Figure (S2d): A view of a typical dry type indoor transformer. The even order harmonics are passed from the transformer neutral to the building ground as shown. The system bonding jumper from the dry transformer is typically conduit (not wire). Because the system bonding jumper grounding path is in parallel with the building steel, this places the piping system in parallel with the building steel, as a conductive grounding path. Especially if the dry transformer bonding jumper (conduit) is compromised. An idea is to go ahead and use wire for the bonding jumper rather than just using the conduit, so that the path of least resistance is the wired ground pathway rather than the building piping systems.

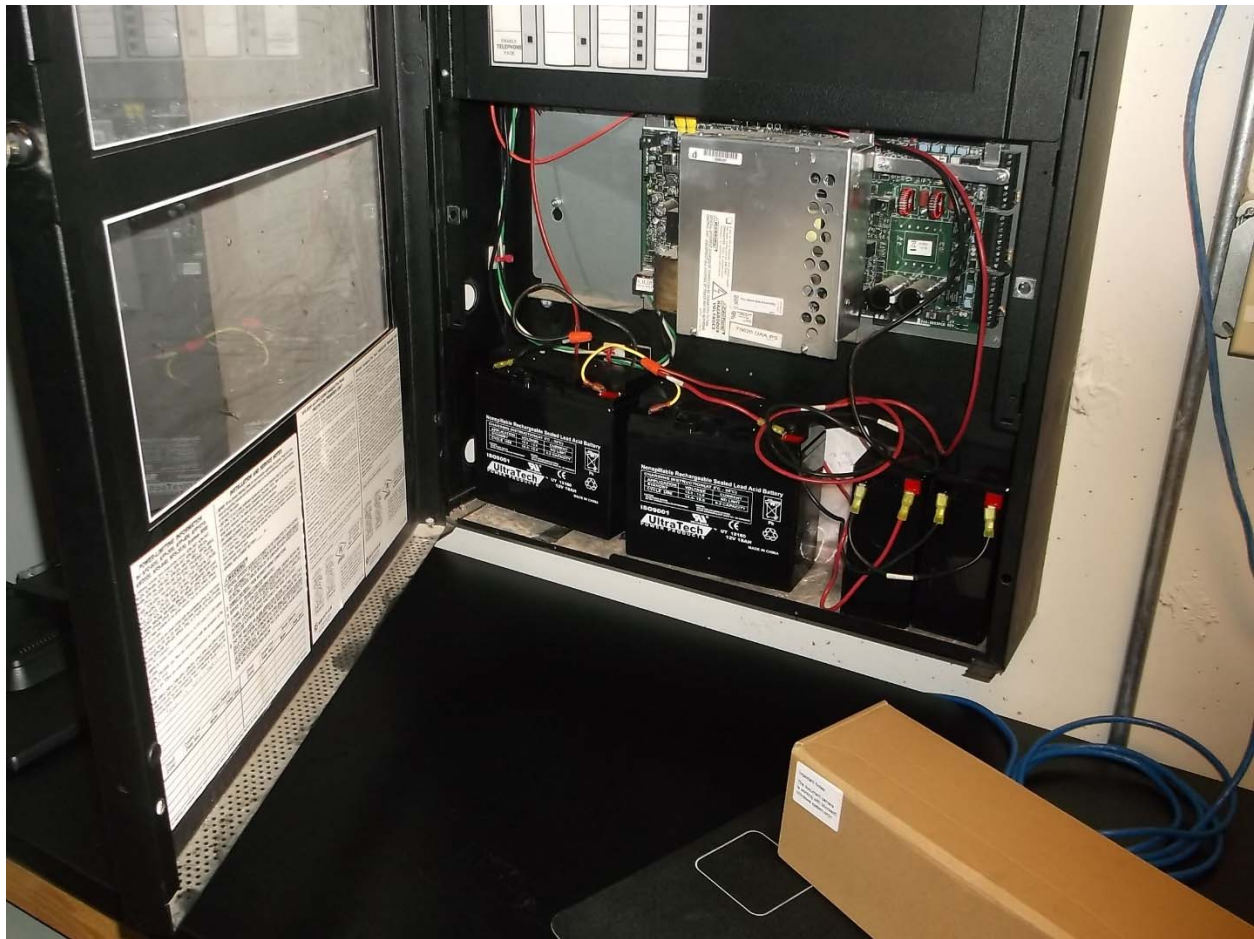
Figure (S2f): A view of another DC voltage source within a building. Originally, we thought the source of the DC voltage on the HVAC piping was DC ground faults in the fire alarm or security systems. Both the fire alarm system and the security system have lead acid batteries for backup. Each 12 volt DC battery is similar in size to a motorcycle battery. Other DC battery chargers in the building include laptop chargers, and the UPS battery charger for the IT servers. As a test, we pulled the leads from each lead acid battery. This had zero effect in reducing DC voltage on the piping.

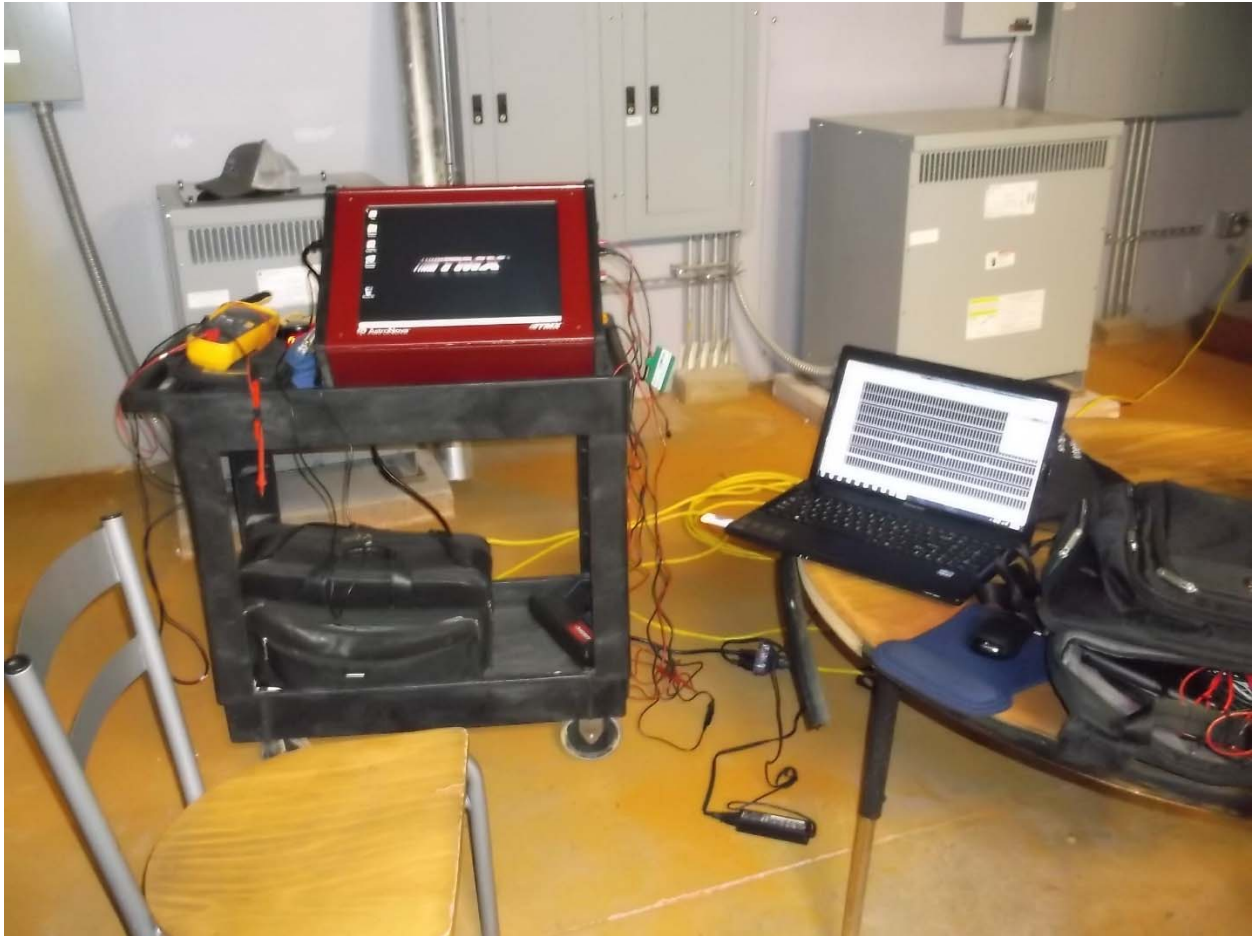
Figure (T1a): A view of the AstroNova testing equipment, set up on site. Initial testing was done with the Omega volt ohm meter. The measurement showed nominal 0.4 volts DC on the HVAC piping system (pipe to earth ground). Follow up electrical testing was done with a high end data logging system (AstroNova). The data logging was done for the HVAC piping system, as well as the plumbing piping system and the fire protection (sprinkler) piping system. Each AstroNova test was done for 3 minutes, collecting 900,000 electrical samples during each 3 minute test (180 seconds per test). This is 5,000 samples per second. For the HVAC piping system, the 3 minute test data indicated 0.409 volts DC. When zoomed in to display only 80 data points, the displayed data was also 0.409 volts DC. For the Plumbing piping system, the 3 minute test data indicated 0.898 volts DC. When zoomed in to display only 80 data points, the displayed data was 1.028 volts DC. For the Fire Protection piping system, the 3 minute test data indicated 0.423 volts DC. When zoomed in to display only 80 data points, the displayed data was 0.432 volts DC.

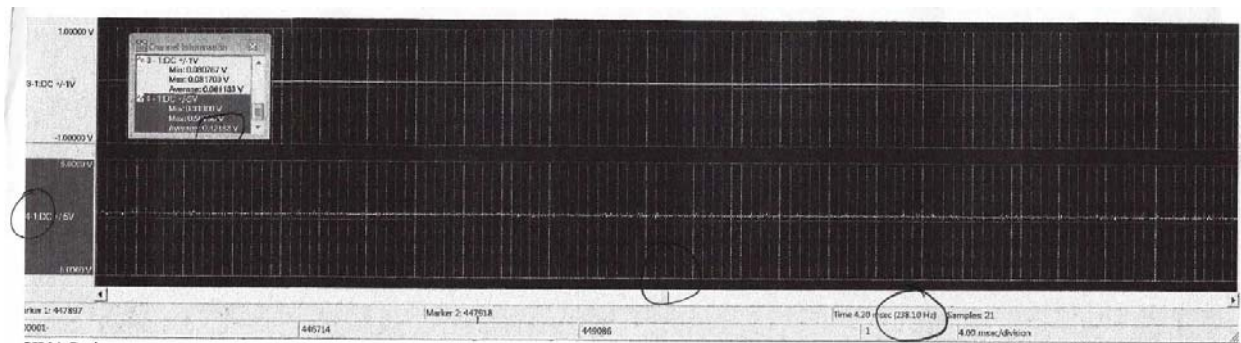
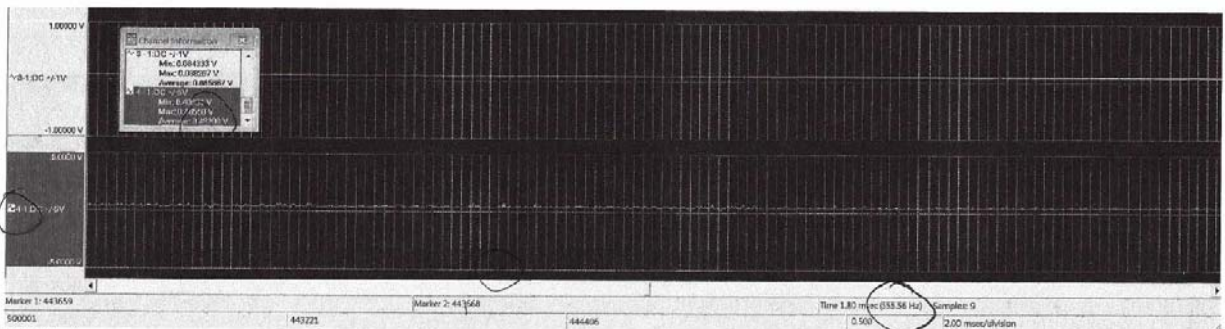
Figure (T1c): A view of even order harmonics found in the AstroNova data. Even order harmonics as compared to 60 hz are 120, 240, 360, 480, 600, etc. We found even order harmonics at both 240 hz and 600 hz (fourth order and tenth order).
