DC Voltage Induced Pinhole Piping Leaks

Gary R. Gabriel PE

Johnson Controls

The point of this paper is to offer design strategy to reduce the risk of pinhole piping leaks. In practice, once the pinhole leaks show up, it is too late for design changes to do any good. By then, the only answer is to replace the entire piping system. Often a failed copper or steel piping system is replaced with plastic pipe.

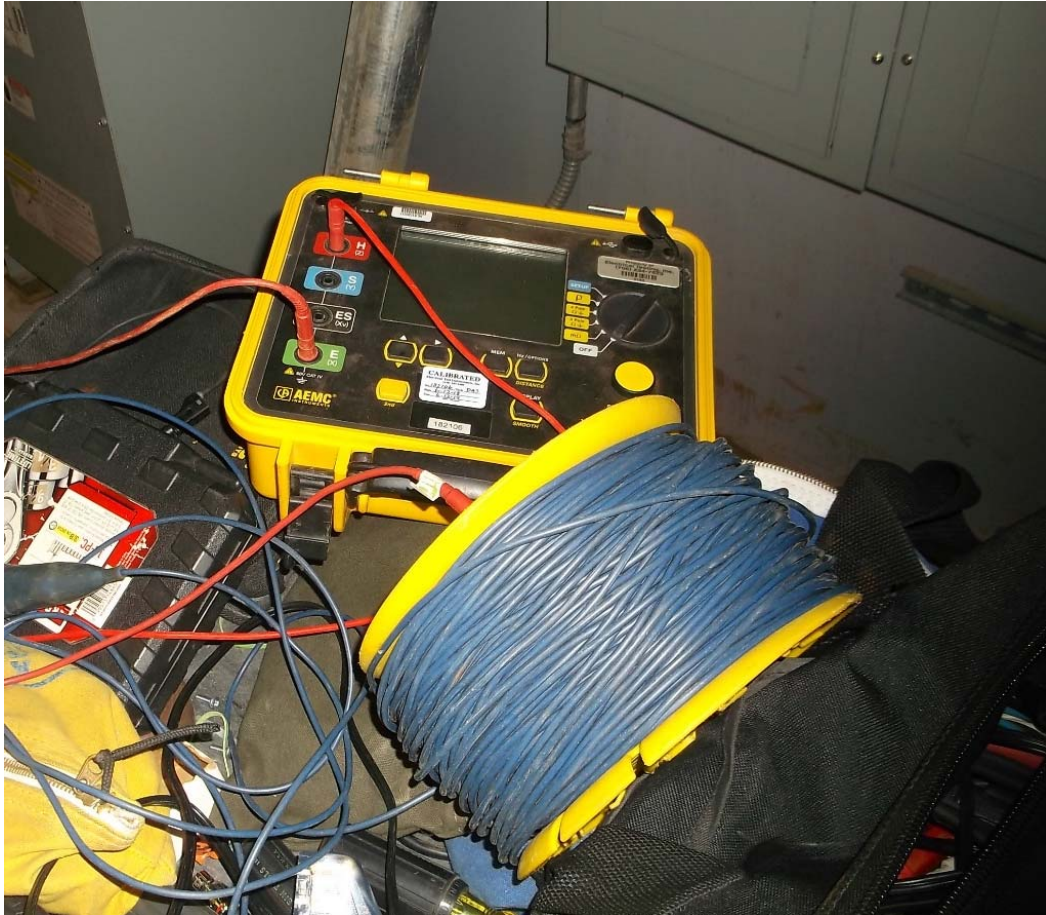
Figure (T1d): A fall of potential test was also done to test the earth triad. The test results in the report appeared to be within specification.
