ARE THE NATIONAL ELECTRICAL CODE AND THE NATIONAL ELECTRICAL SAFETY CODE HAZARDOUS TO YOUR HEALTH?

Donald W. Zipse, P.E.
Life Fellow, IEEE

Zipse Electrical Engineering, Inc.
671 Kadar Drive
West Chester, PA 19382-8123

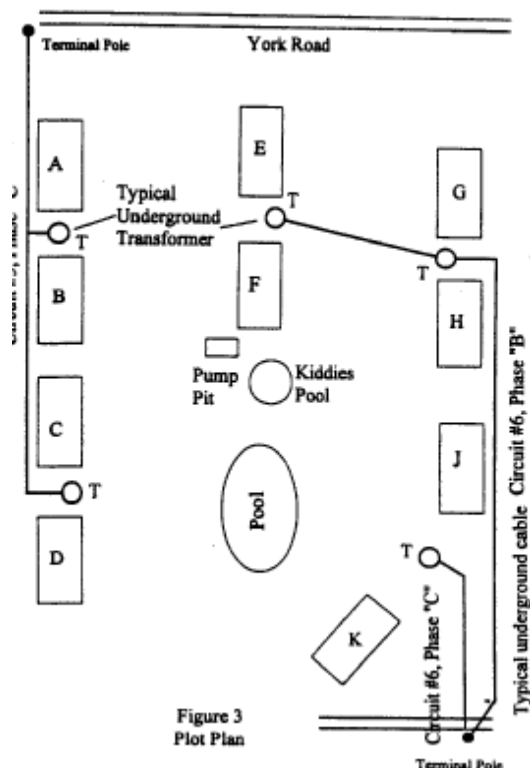
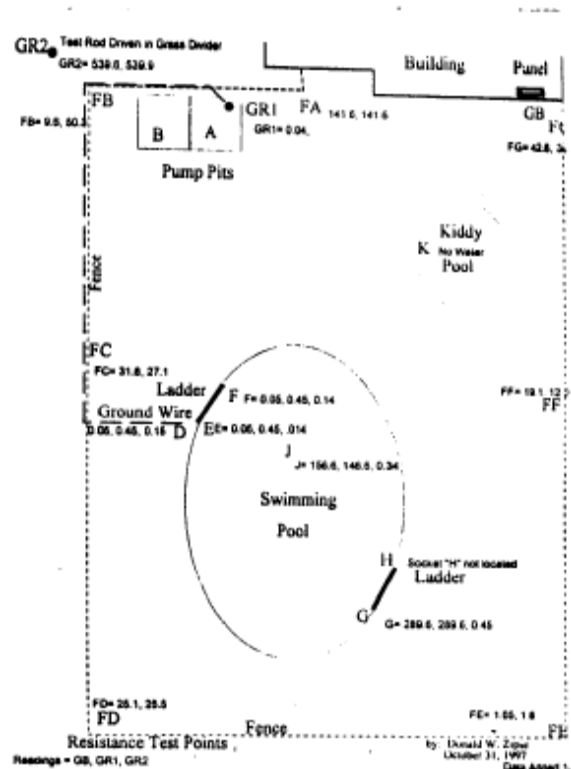
Figure 5
Resistance Test Points and Readings

From each of the main three ground points, test points were selected. Points around the pool such as the ladder sockets, water in the pool, center of the kiddies pool, the corners and center of the fence, etc. A total of 38 readings were taken. See Table 2.

The fence was chain link and no special grounding connections had been made to it. It was difficult to obtain a good connection. The values did change while we watched. We went through taking the voltage and current reading. Then we took the resistance readings. Correlation between the reading was poor.

With the exception of a ladder socket in the pool, the resistance between points was acceptable except the utility still focused on the pool grounding as the problem.

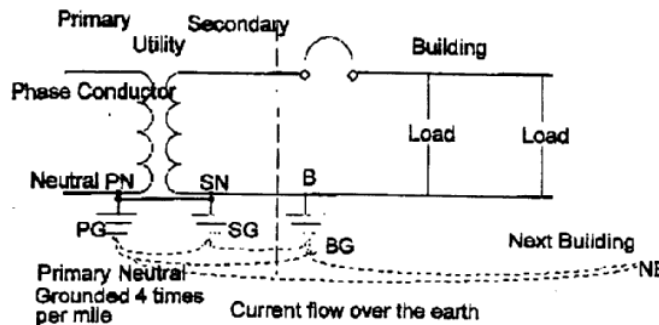
Figure 4
Transformer Connections

It usually comes as a shock to electrical engineers not involved with utilities that the utilities actually solidly connect the primary return side of the distribution transformers to the secondary side neutral connection. See figure 4. The primary return, neutral terminal, PN is connected to the secondary neutral terminal, SN.

This connection of the primary to secondary is made in pole mounted, pad mounted or underground distribution transformers. This connection allows primary current to flow over the secondary neutral-ground conductor. The secondary neutral-ground conductor is grounded, earthed at the transformer, sometimes at the meter and required by the NEC to be connected to earth at the service entrance.

In addition, since the neutral is connected to all the equipment ground connections at the service entrance panel, primary current is now permitted to flow over the equipment ground circuit. Now that we know that a parallel circuit always has some amount of current in all parallel paths, do you want this primary return current flowing uncontrolled over the equipment grounding circuit?

Neutral blockers are similar to a lightning arrester. It is placed between the primary neutral of a distribution transformer and the secondary neutral connection. See Figure 4, PN and SN terminals. The utilities connect the primary neutral to the secondary neutral. This connection allows stray, uncontrolled continuous current to flow over metallic piping, building steel, earth, etc. By installing a neutral blocker, the primary return current is prevented from flowing over the multiple connection to earth that are part of the NEC requirements.

The next request of the utility was to install an inexpensive electrical device used on farms to protect cows from electric shock. It was requested the utility install, in the underground transformer vaults, an \$ 850.00 neutral blocker between the primary neutral transformer winding and the secondary neutral winding.

Neutral blockers are normally used on distribution transformers serving dairy farms to eliminate the shocking potential generated by the flow of uncontrolled current over the dairy barns metallic equipment and the earth.
