Stray & Contact Voltage Case Studies

IEEE Working Group January 2008, San Antonio

Craig D. Frommelt PE, CPQ, CEM AmerenCILCO

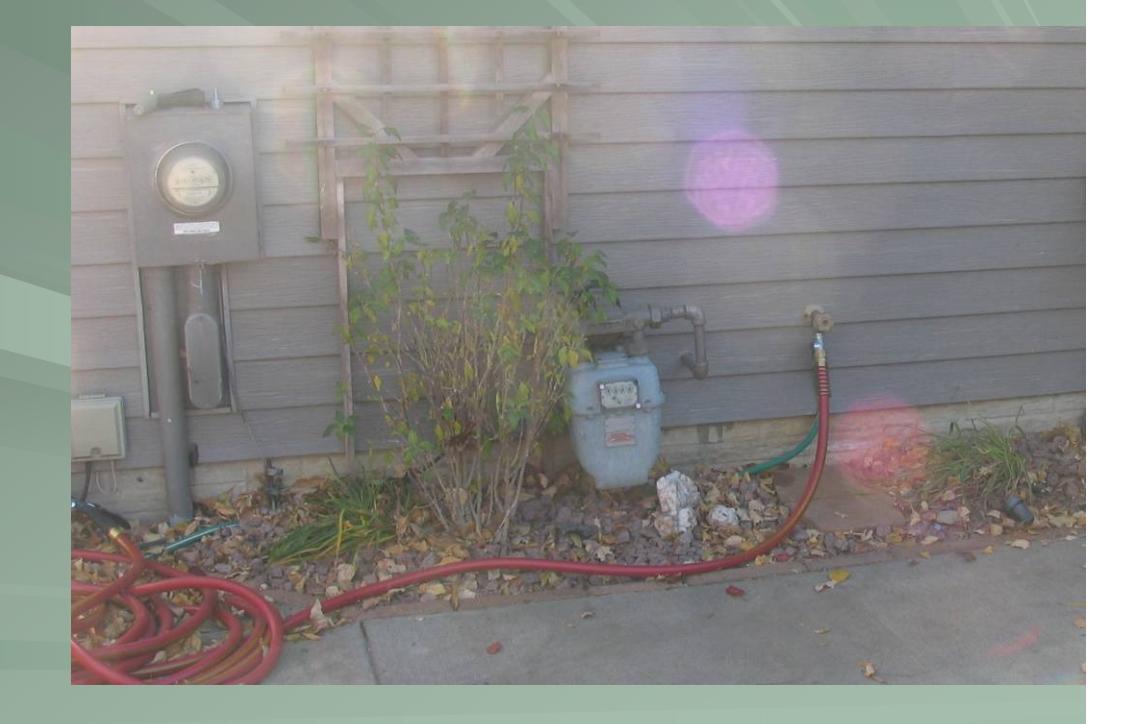
- Kids getting "Tingled" while filling water balloons at outdoor faucet
- Customer measured voltages as high as 10 VAC

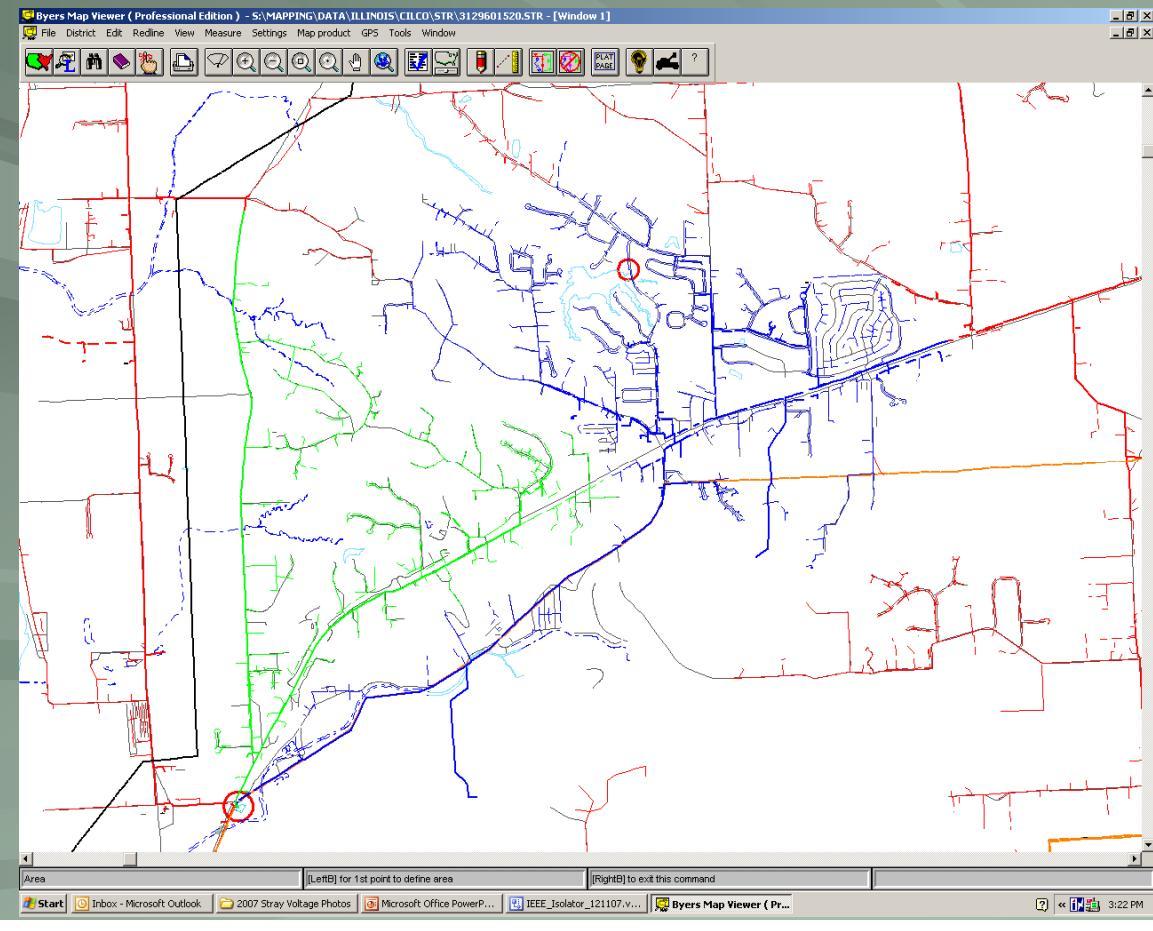
- Location is near end of 1-ph Tap, 4 miles from Substation.

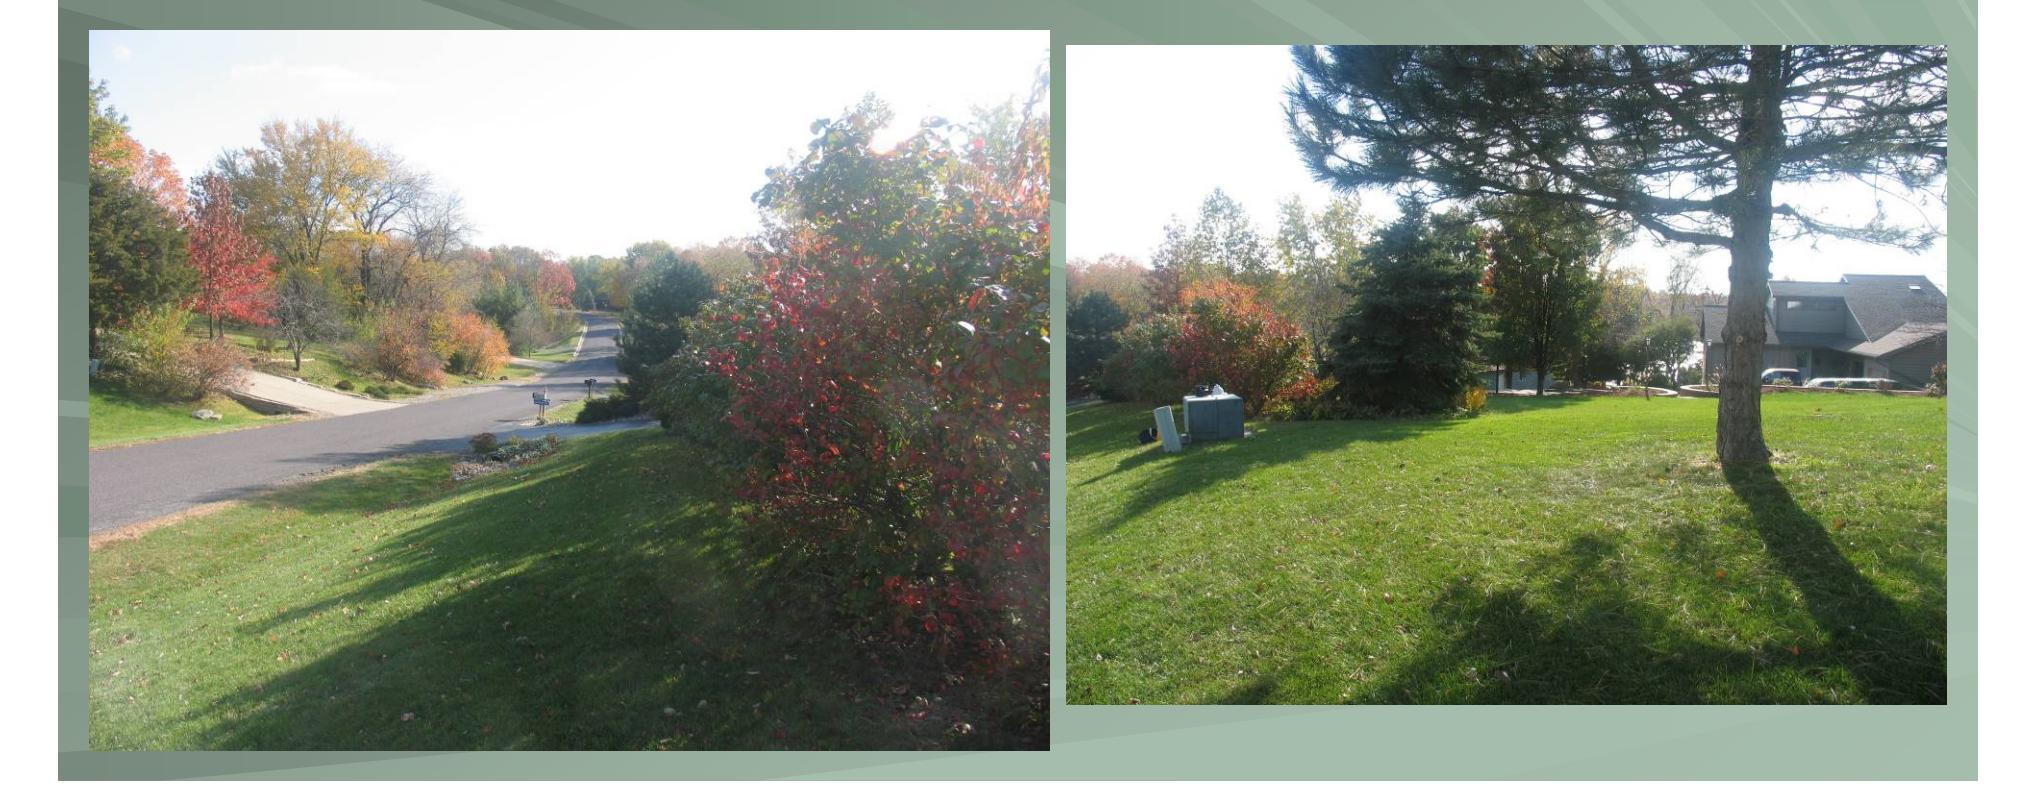
- Location is near end of 1-ph Tap, distant from Substation.
- Significant 1-ph loads downstream of this customer.

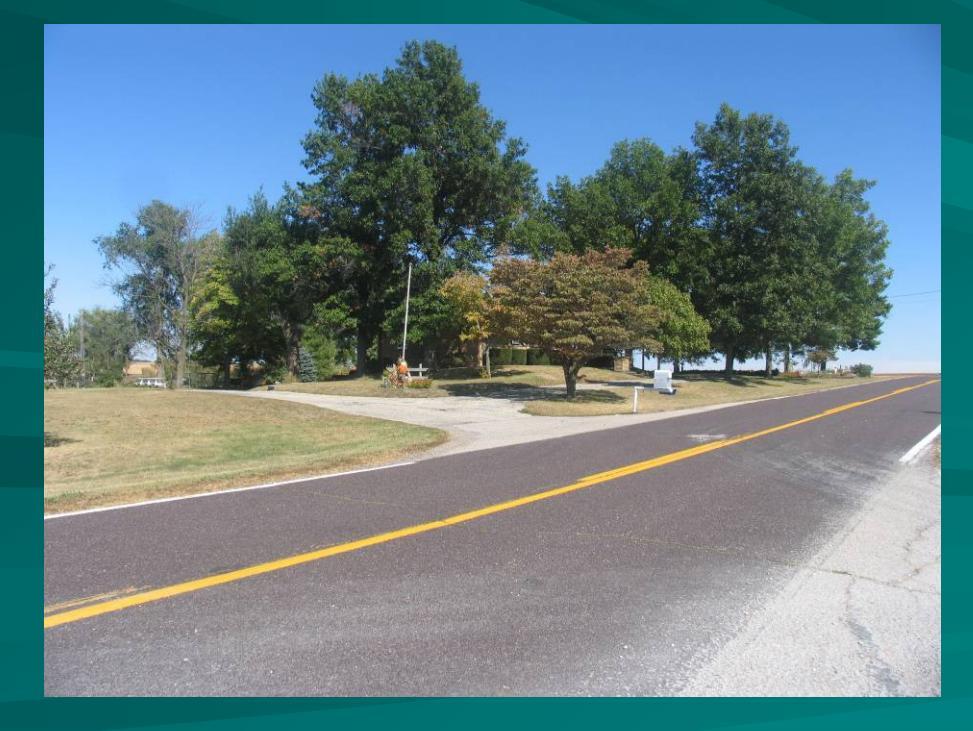
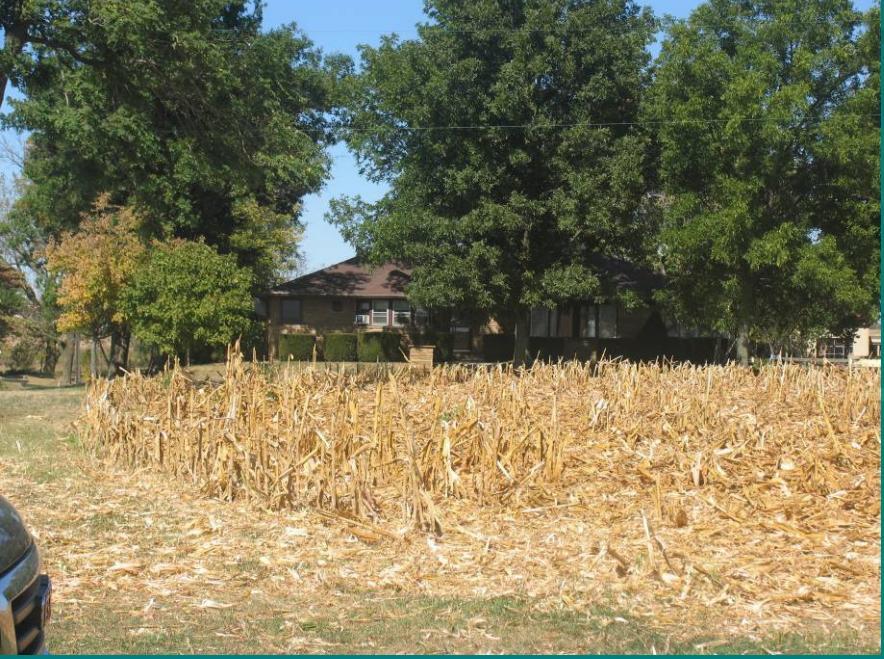
Rural home. Getting shocked in basement shower, when touch water valves. Started 2-3 weeks before investigation.

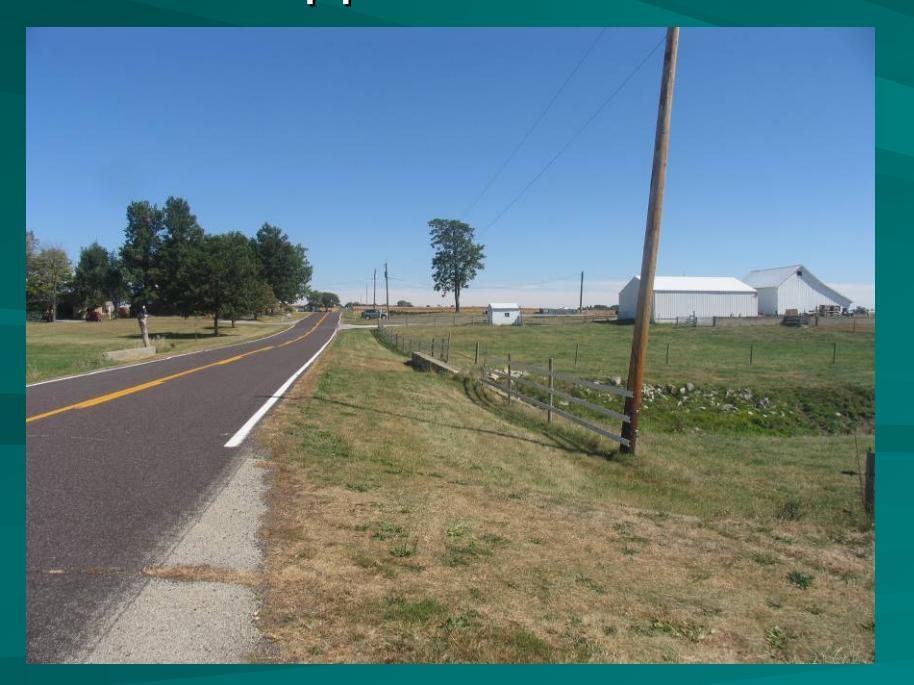
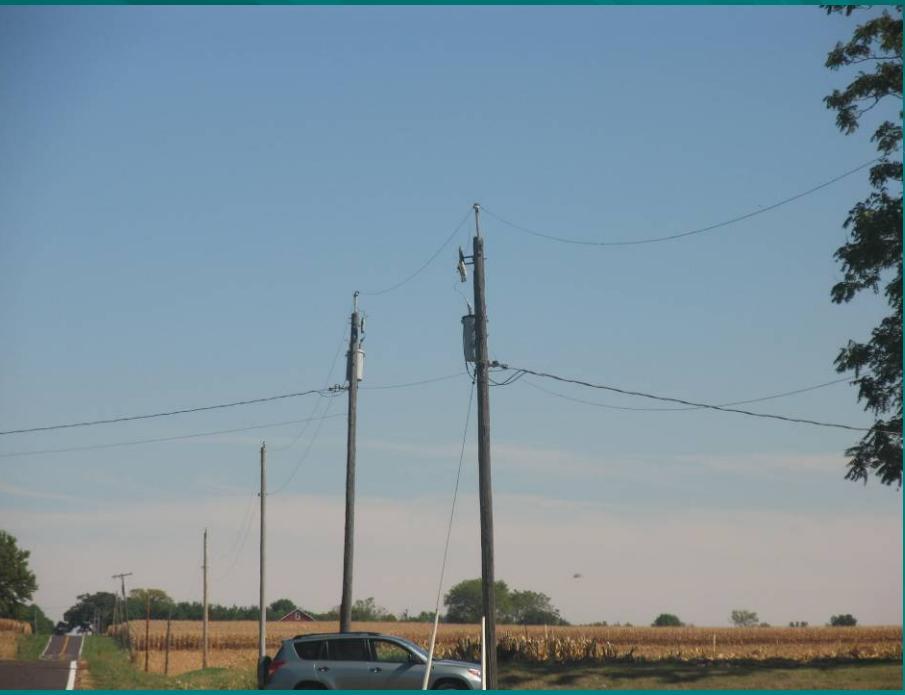
Pulled cut-out for the complaint location, with no affect.
 Pulled cut-out for neighbor across street, stray voltage disappeared.

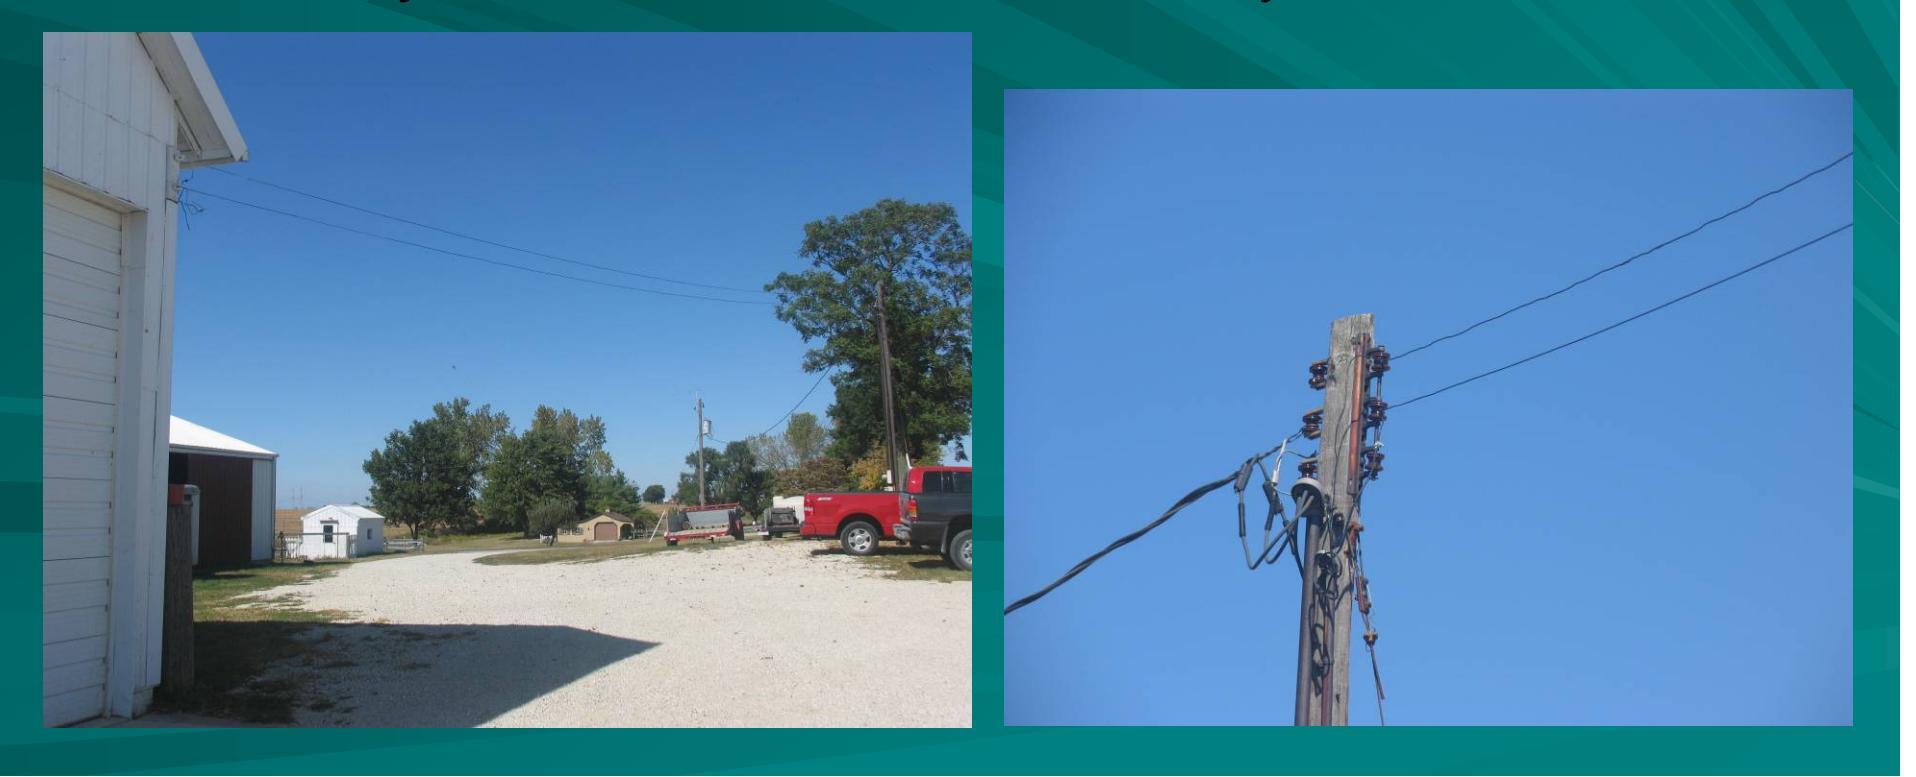
Engineering Diagnostic Actions & Findings – Customer suggested overhead circuit, which had been torn down by a combine, and reattached by the farmer.

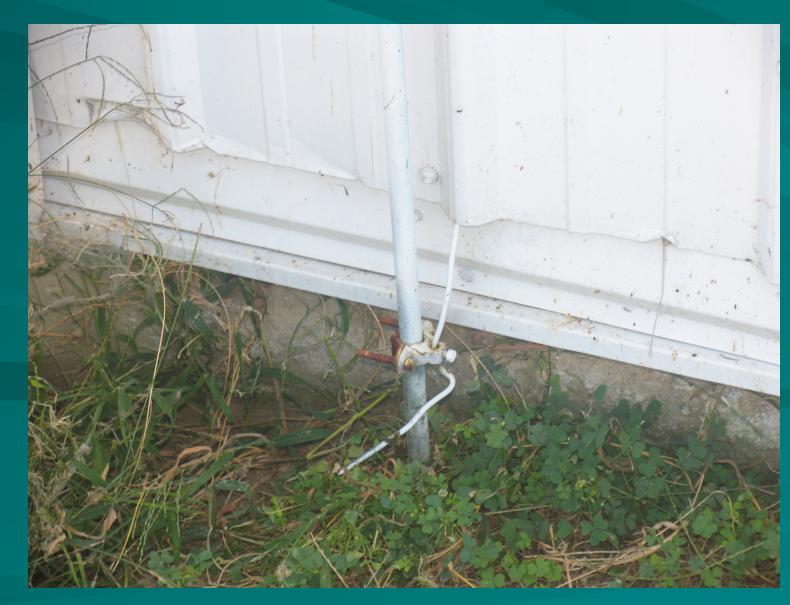
- Lights and garage door opener worked OK
- Checked ground rod for good bonding
- Could not get an impedance measurement (meter error)
- 3-4 amps in ground rod, even with breaker open
- Did NOT feel any voltage on the ground rod

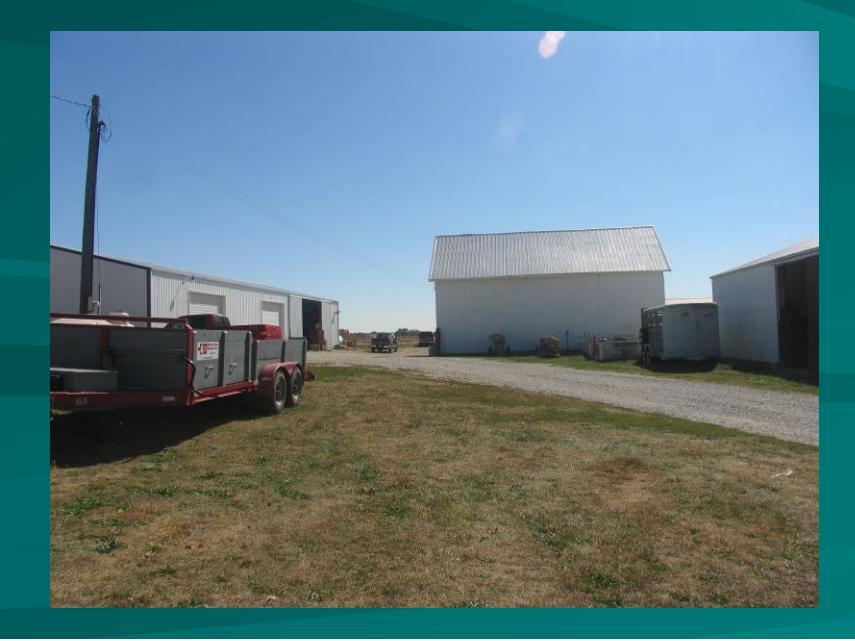
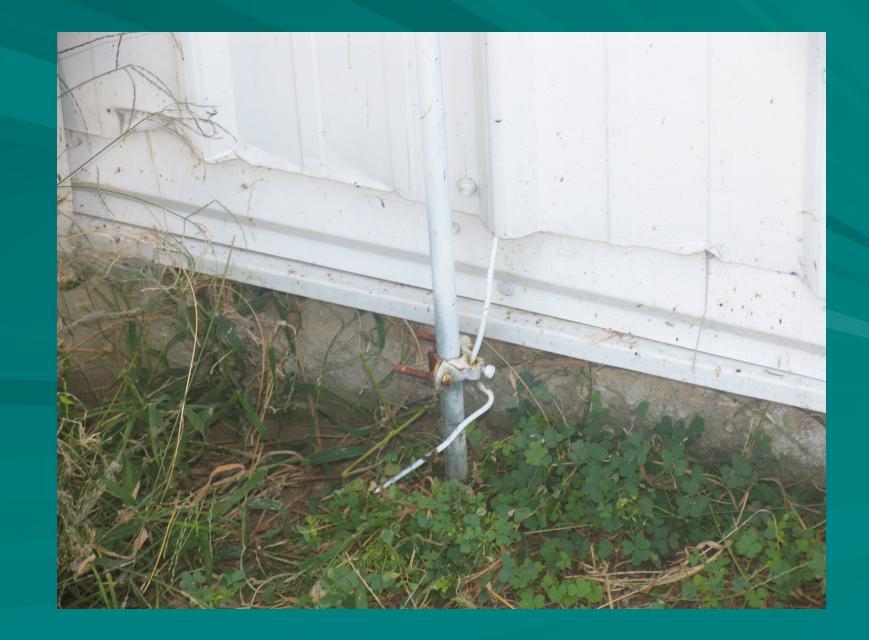
- Checked continuity of the 2 branch circuit conductors

Verified that they had been REVERSED when reconnected by the farmer after the accident with the combine.

The overhead service wires to the barn were returned to their correct connections by the Troubleman.

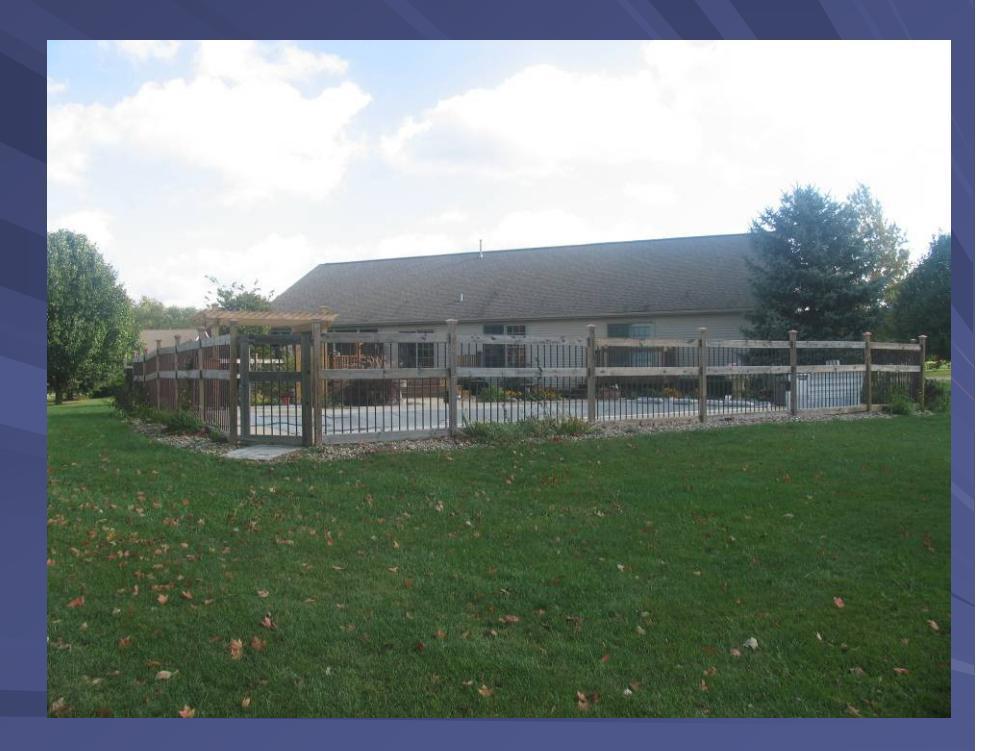
- Newly installed in-ground pool
- Immediately felt 'tingling' when using metal hand rail to exit the pool
- Measured 1.5 2.5 VAC between hand rail and pool water

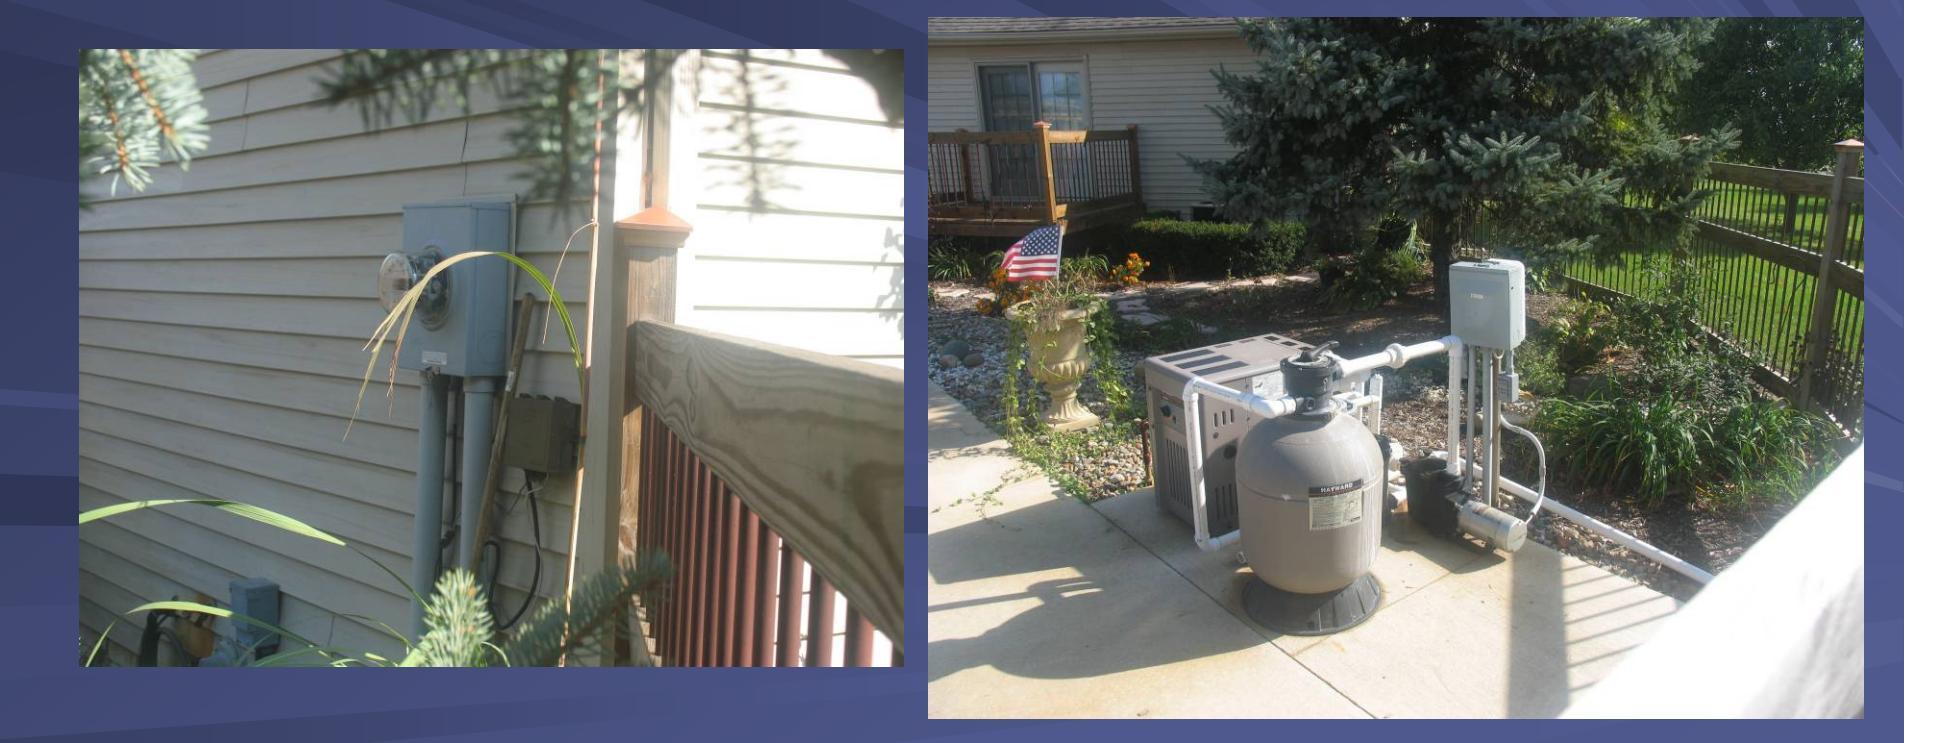
Inspected wiring at main entrance panel and sub-panel at the pool.

- Inspected wiring at main entrance panel and sub-panel at the pool.
 - "Amateur" electrician had bonded the neutral to the case ground at the pool sub-panel, creating a ground-loop. Lifting that illegal jumper fixed the GFI breaker problem

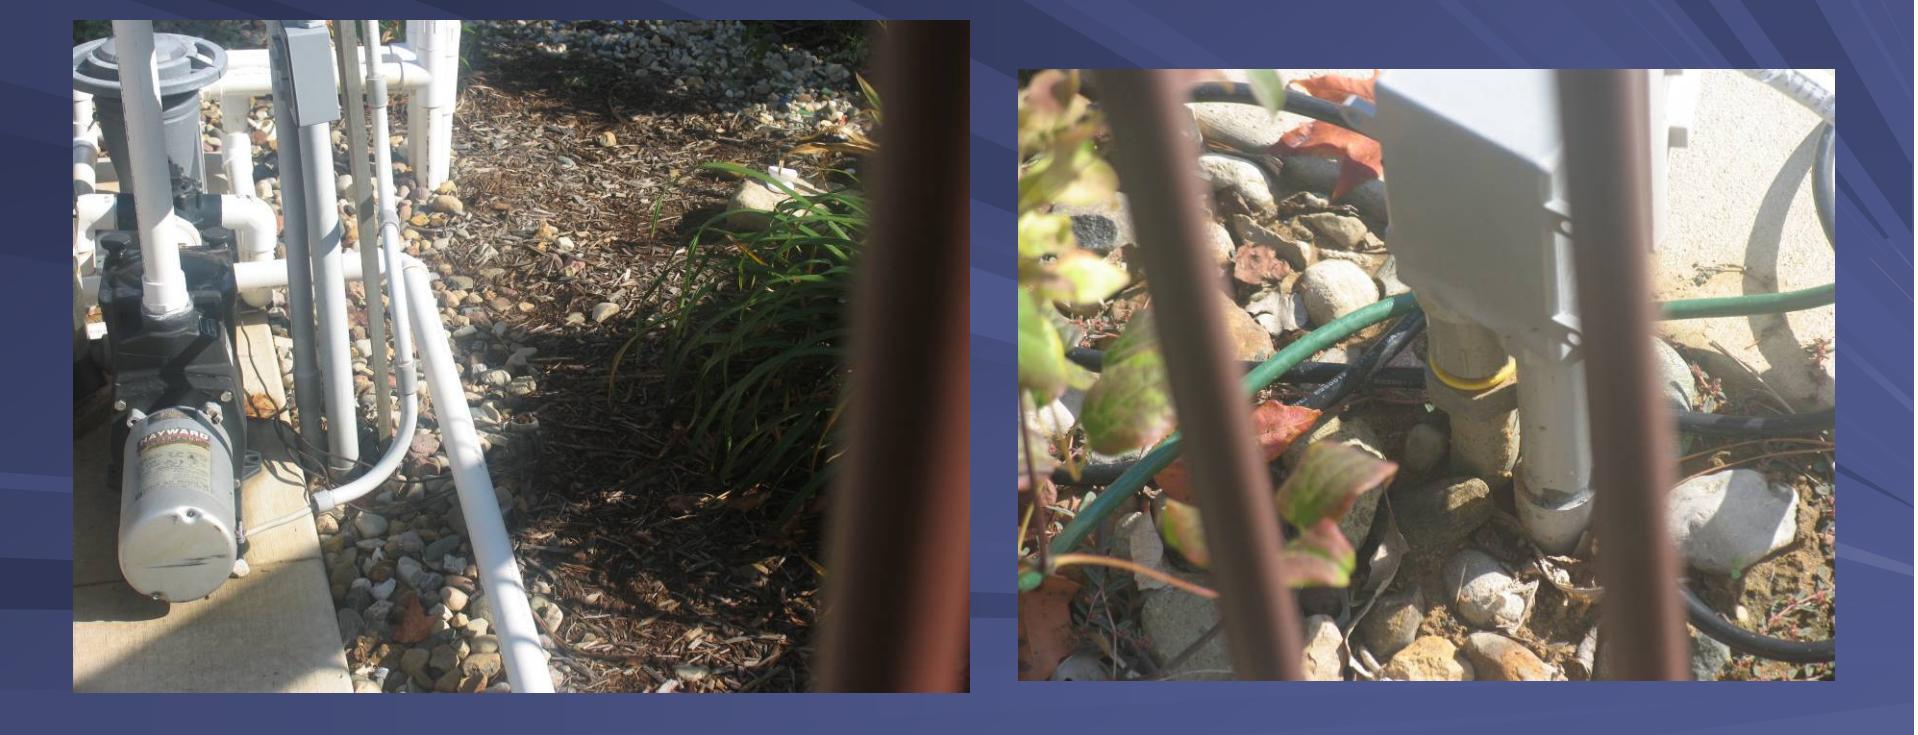
Inspected the grounding and bonding around the pool

- Inspected the grounding and bonding around the pool
 - Observed ground rods at the meter, at the pump sub-panel, and at the far end of the pool.
 - Observed multiple grounding conductors attached to ground-rods around the pool
 - Were told by "electrician" that the pump, pool lights, powered pool cover, and all metal fittings and fixtures were bonded to this ground grid

The "Amateur" electrician and / or pool installer did not understand NEC requirements for pool area grounding and bonding.

There was no equipotential grid around this pool.

Advised customer that it was his responsibility to bring his pool up to NEC Code Compliance.

- Advised customer to hire electrician to correctly bond all metal fixtures in pool area.
- Advised customer to call back if that did not fix the problem

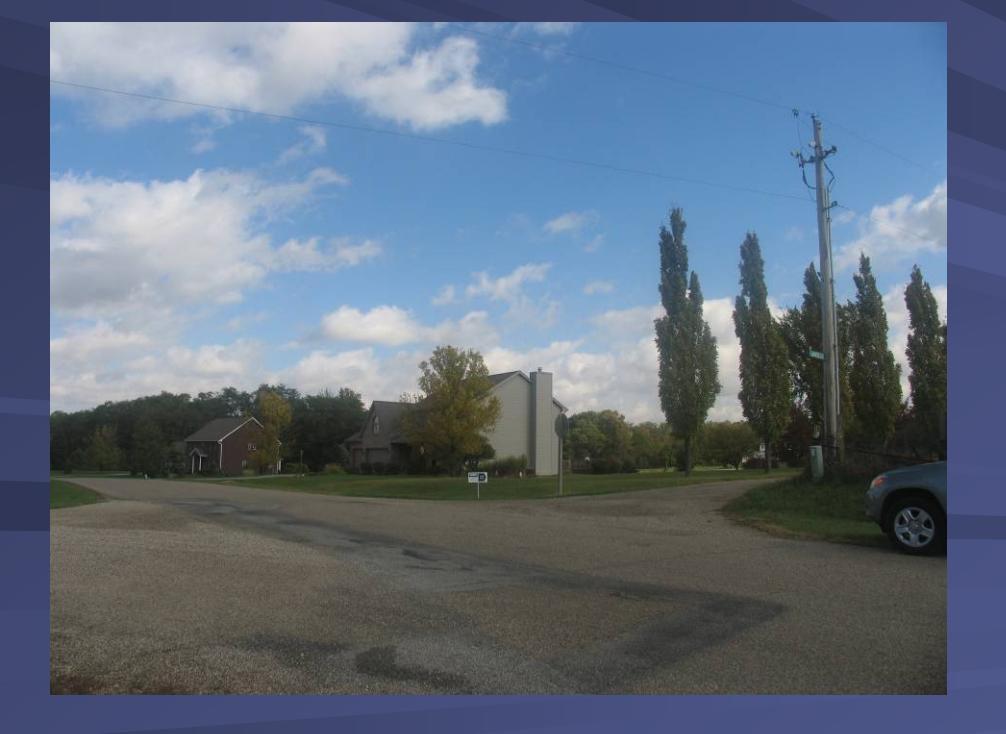
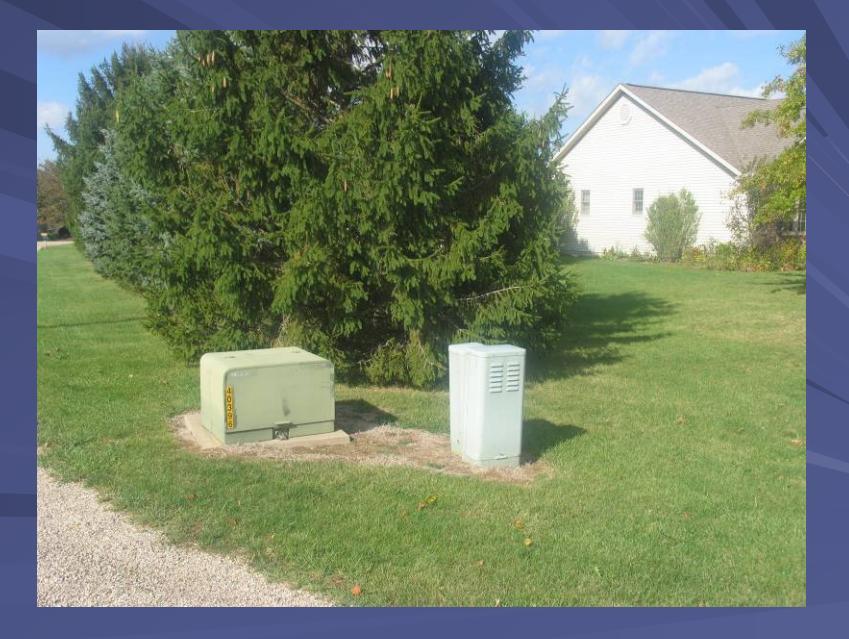
Inspected utility service to the residence

Disconnecting hot-leads had no affect on Stray Voltage

Disconnecting neutral at meter lowered Stray Voltage, but not by enough to call it fixed.

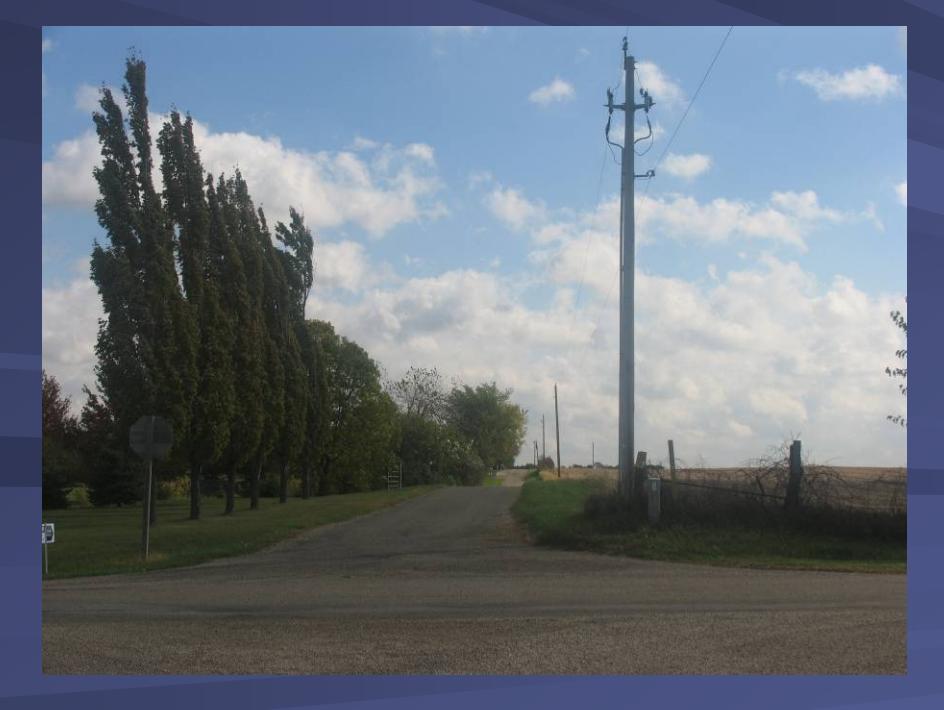
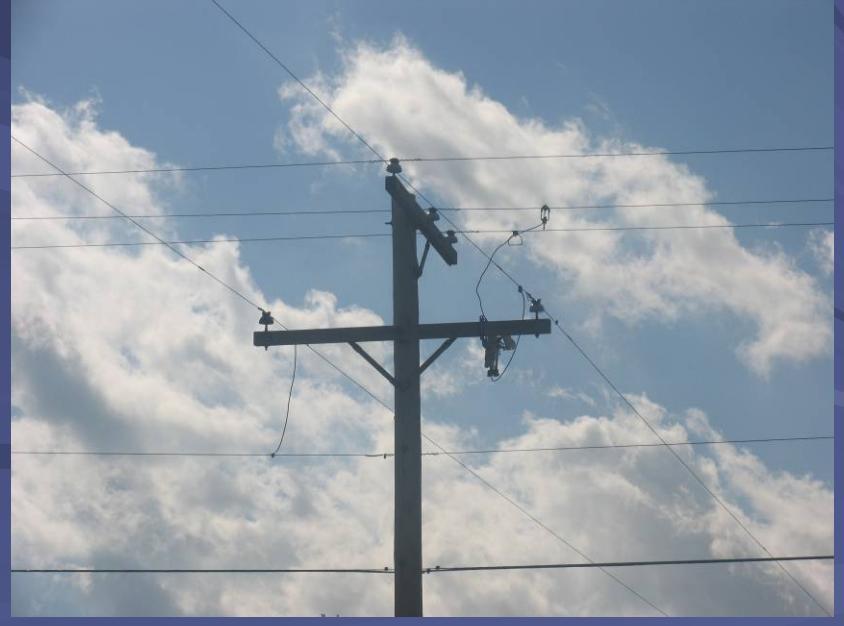
- Tested lines into subdivision (looking for Ground Faults or Bad Neutrals)

- Opened cut-outs one at a time (Each time Stray Voltage went down to about half)
- Checked neutral connections on OH line for 1.5 miles back to 3-ph main line (All connections good)
- Measured phase and neutral currents on OH line
 - 14 amps phase current
 - Only 10 amps neutral return current

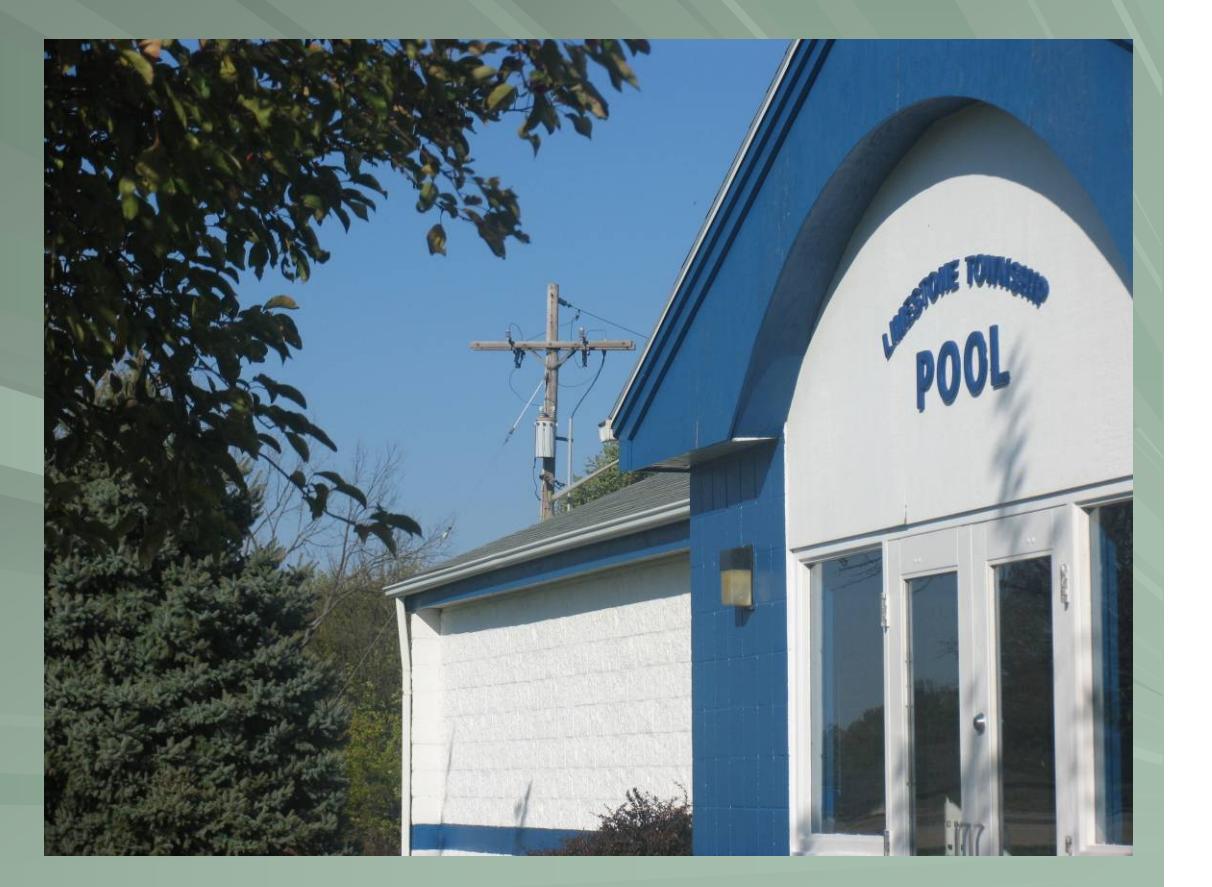
Customer Complaint:
 - "Shocking" voltages felt in the Snack Bar
 - Closed pool for the season (Early)

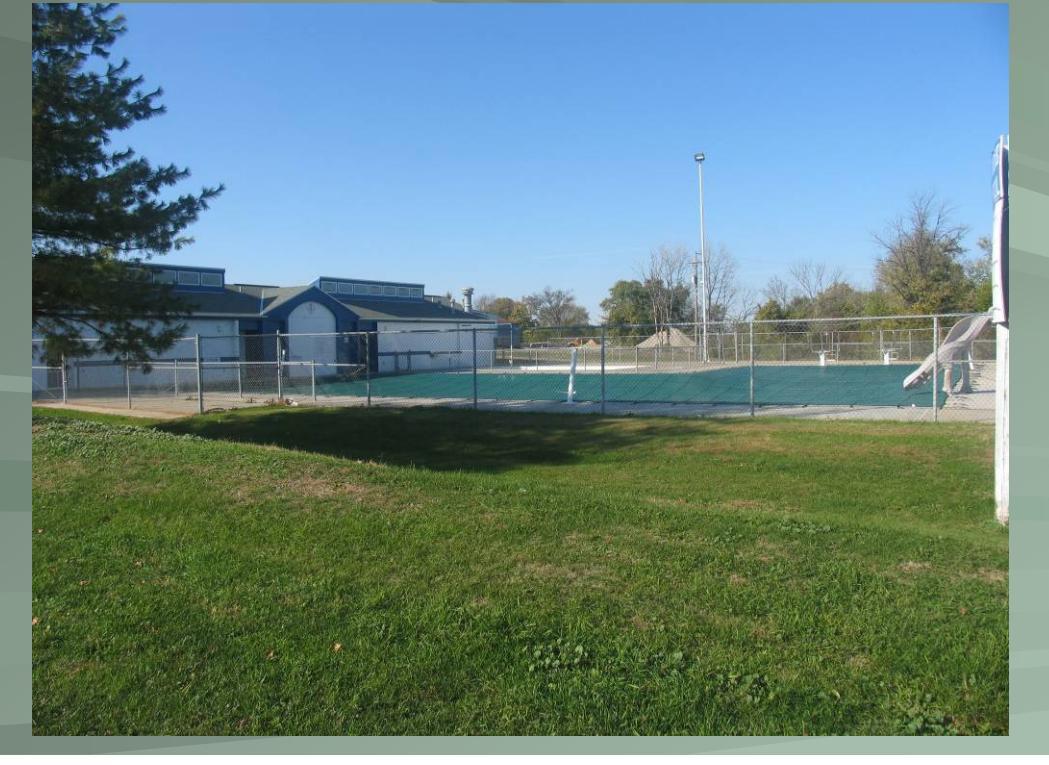
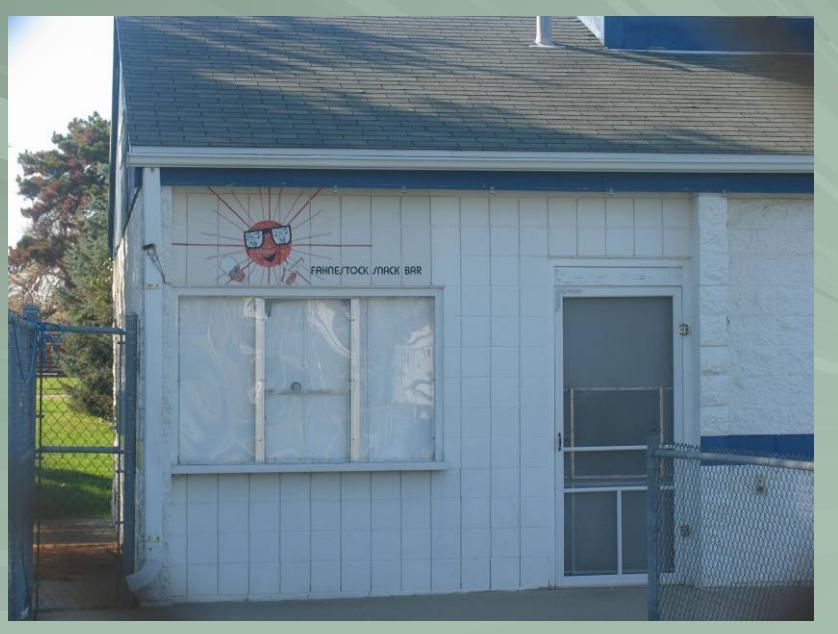
Snack bar kitchen volunteers are getting shocked around the sink

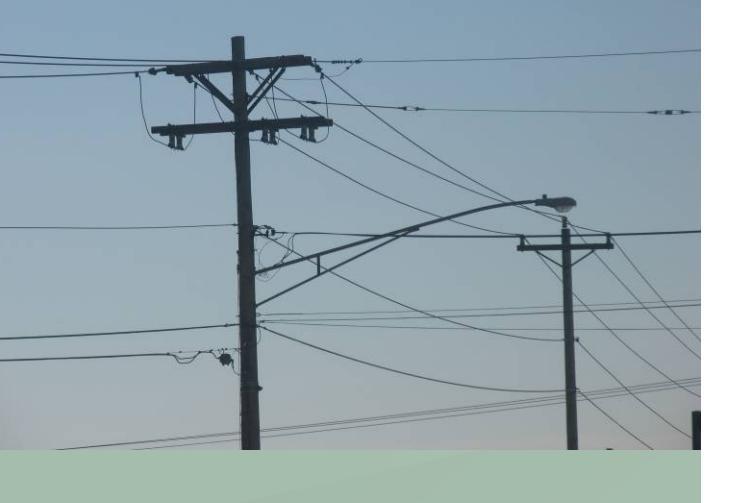
- Initial measurements between plumbing and metal electric conduits in kitchen were in the 8 – 10 VAC range.
- Line crews found and fixed a nearby primary neutral connection, which reduced measurements to 2-3 VAC range.
- Then called for Engineering assistance

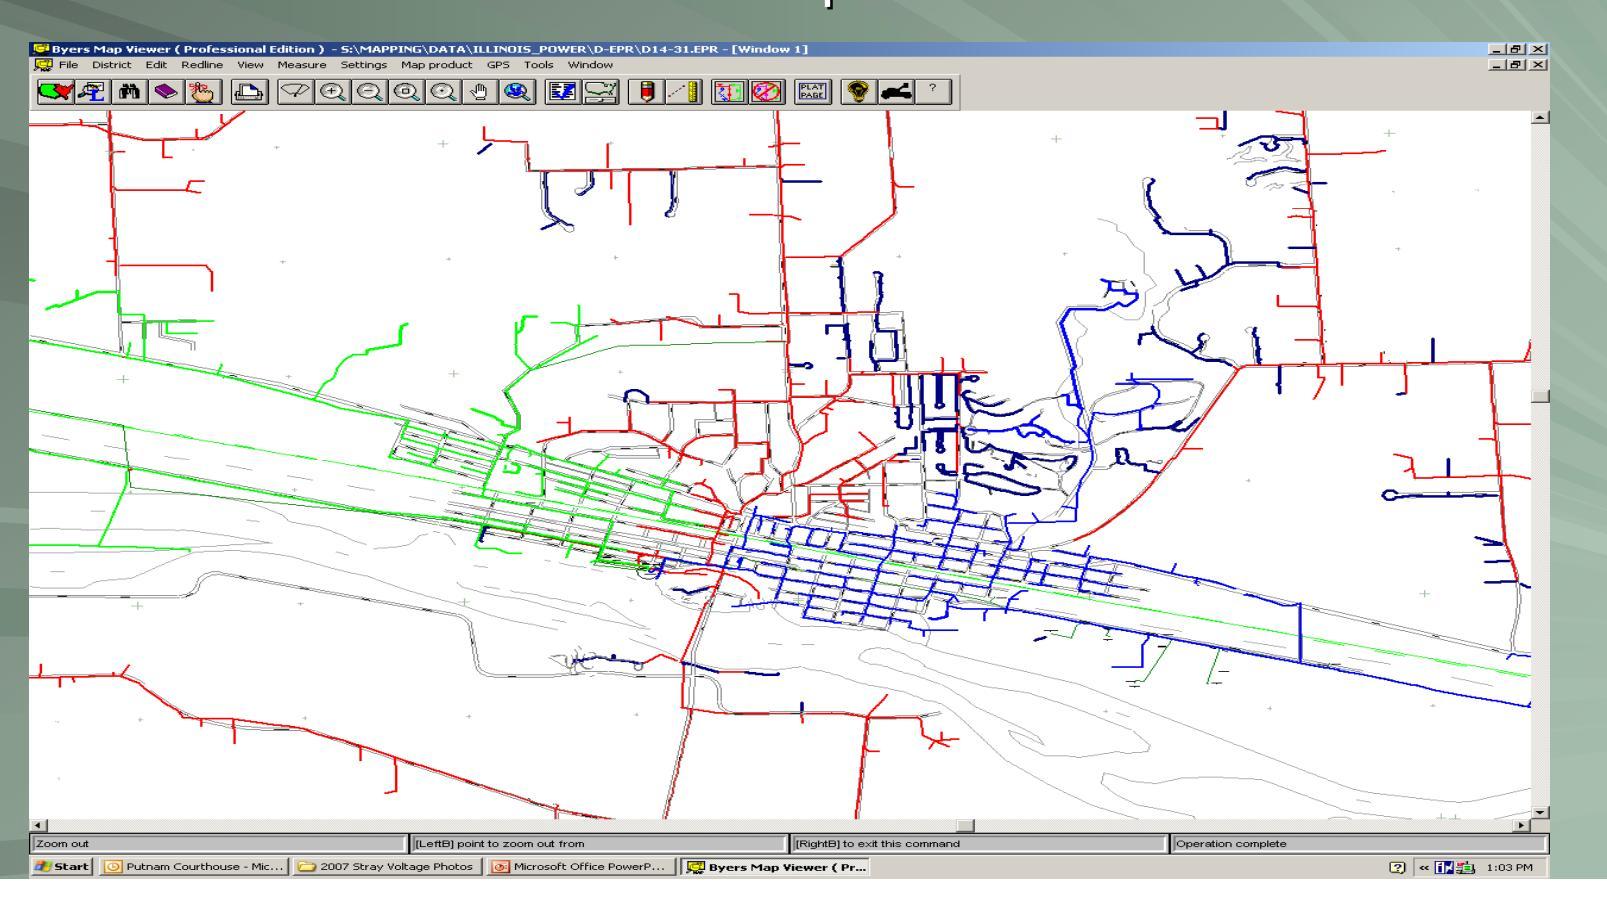
Identified complaint location to be very near Substation with lots of downstream 1-phase loads.
