Investigation of the Electrocution on the Town Street Bridge in Columbus, Ohio on May 22, 2003

City of Columbus 90 West Broad Street Columbus, Ohio 43215

John Loud, MSEE, Principal Engineer Exponent Failure Analysis Associates 149 Commonwealth Drive Menlo Park, California 94025

Date: June 24, 2003

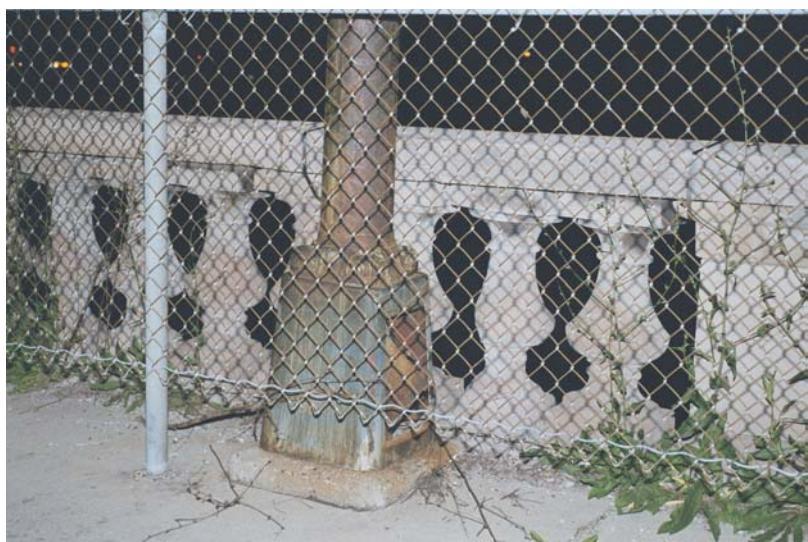
Figure 2. The incident light post shortly after the incident. 03-1011AA015.jpg

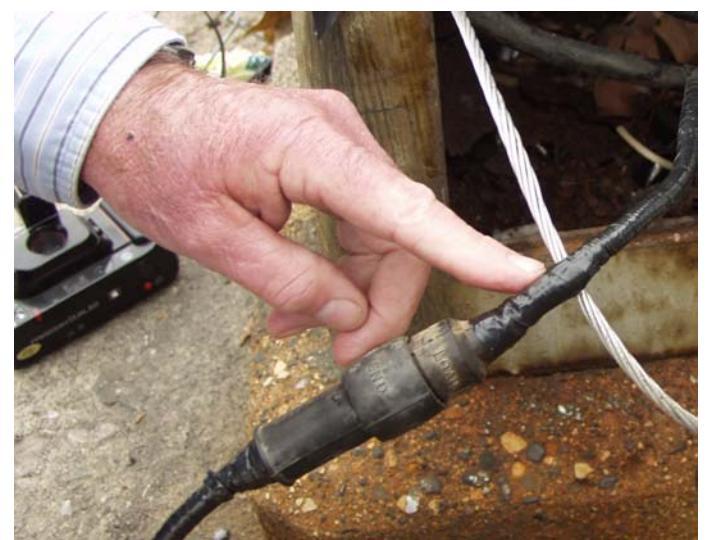
Exponent met with C2 on the bridge to document what was reported, and to evaluate the assertions made that C2 knew what had caused this incident. C2 asserted that the DOE personnel had taped over the region of the 480-volt conductor where C2 had witnessed the burned fault in the insulation where it had contacted the neutral conductor as shown in Figure 7. C2 asserted that the mark on the neutral conductor was still present and pointed it out as shown in Figure 9. Later Exponent wiped away the alleged "burn mark" on the neutral conductor to show that it was not a burn mark, but rather just some of the anti-oxidant compound used in the crimped splice. No other burned mark was found on the neutral conductor in the presence of C2 yet no such fault was found. Exponent also removed the old and brittle tape that was beneath the new tape, and again found no burned insulation, as shown in Figure 8.

Figure 7. C2 pointing at the taped-over burned fault in the 480-volt conductor insulation. P6037878.jpg

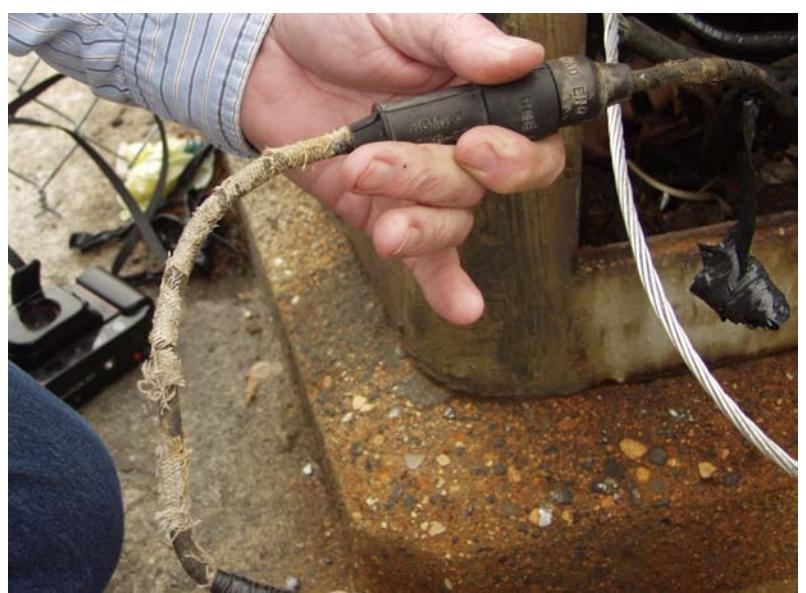
No evidence of the asserted fault between the 480-volt and neutral conductors was found. Exponent testing, performed at a different time, showed that this neutral conductor was a very low impedance path back to the power source and that it was effectively grounded. Therefore, it would not be possible for such a line-to-neutral fault to exist and for the light to operate without blowing its protective fuse. No one was found at the time of this report who had witnessed the alleged 67 to 400+ volt reading that could verify which scale the meter was on and what the actual reading was. Even the Police report of the voltage measured by C2 gave a number that the laws of science show could not be correct. It was also noted that C2's alleged problem was on the south side fence, while the incident happened at the north side fence. Finally, the reading could not be demonstrated by C2 when DOE personnel arrived to investigate C2's claims. Given that the lights were off at the time of C2's observations, John Loud did not find a theory to explore that might explain the asserted measurements and their connection to the incident.

Figure 8. C2 holding the 480-volt conductor but unable to find the reported region of burned insulation. P6037882.jpg

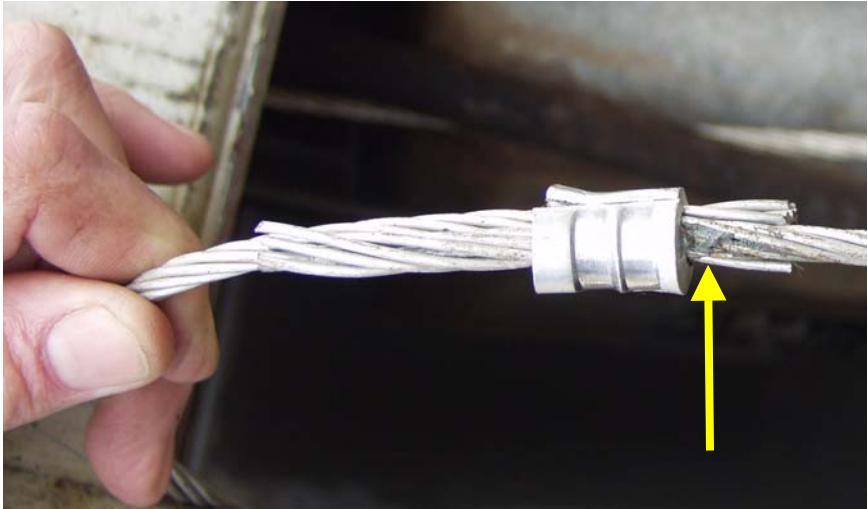
Figure 9. C2 holding the newly spliced neutral conductor indicating where it was "burned" from its contact with the burned insulation on the 480-volt conductor. P6037883.jpg

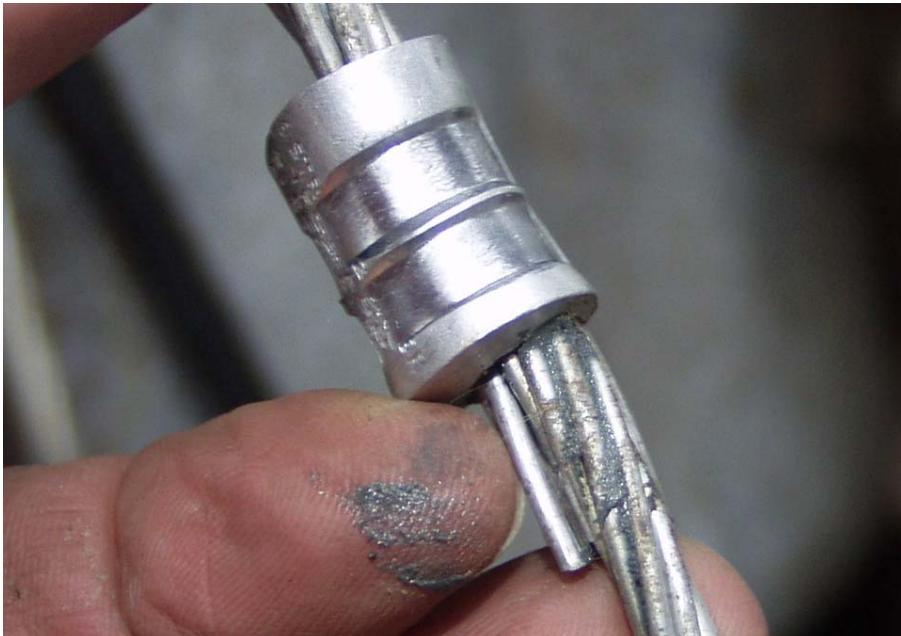
Figure 10. John Loud wiped the anti-oxidant paste from the alleged burned region to show that there was no evidence of the alleged contact as was asserted by C2. P6037940.jpg

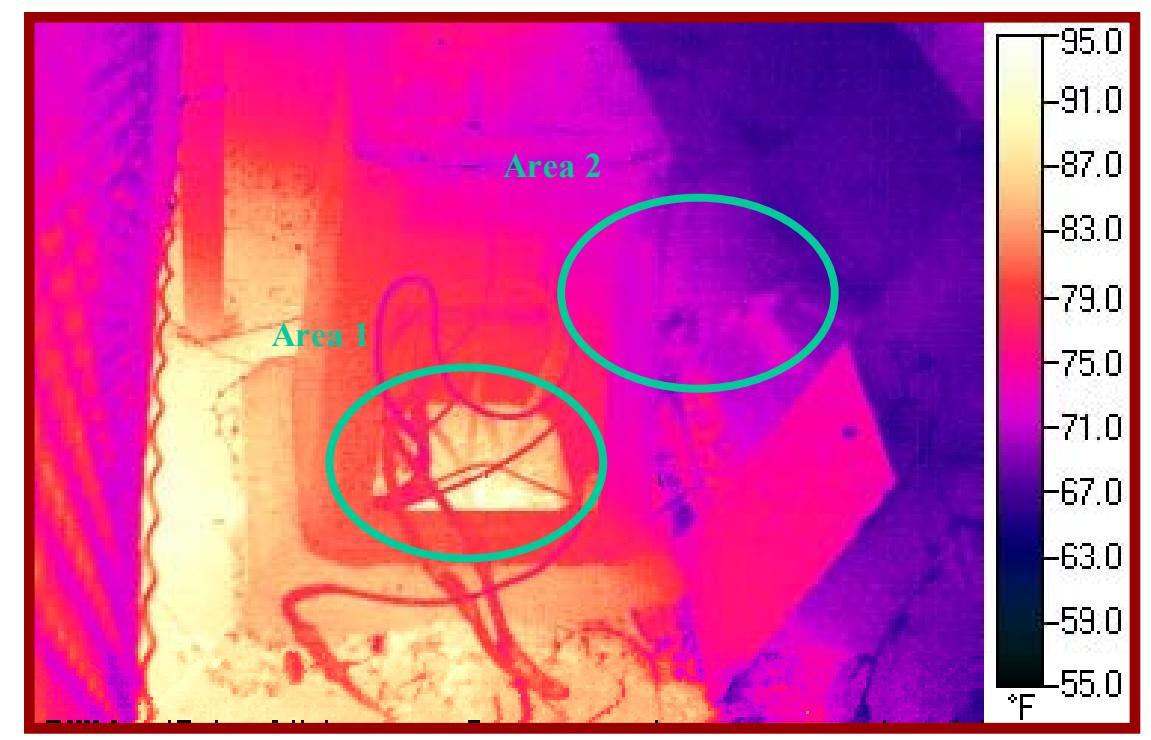
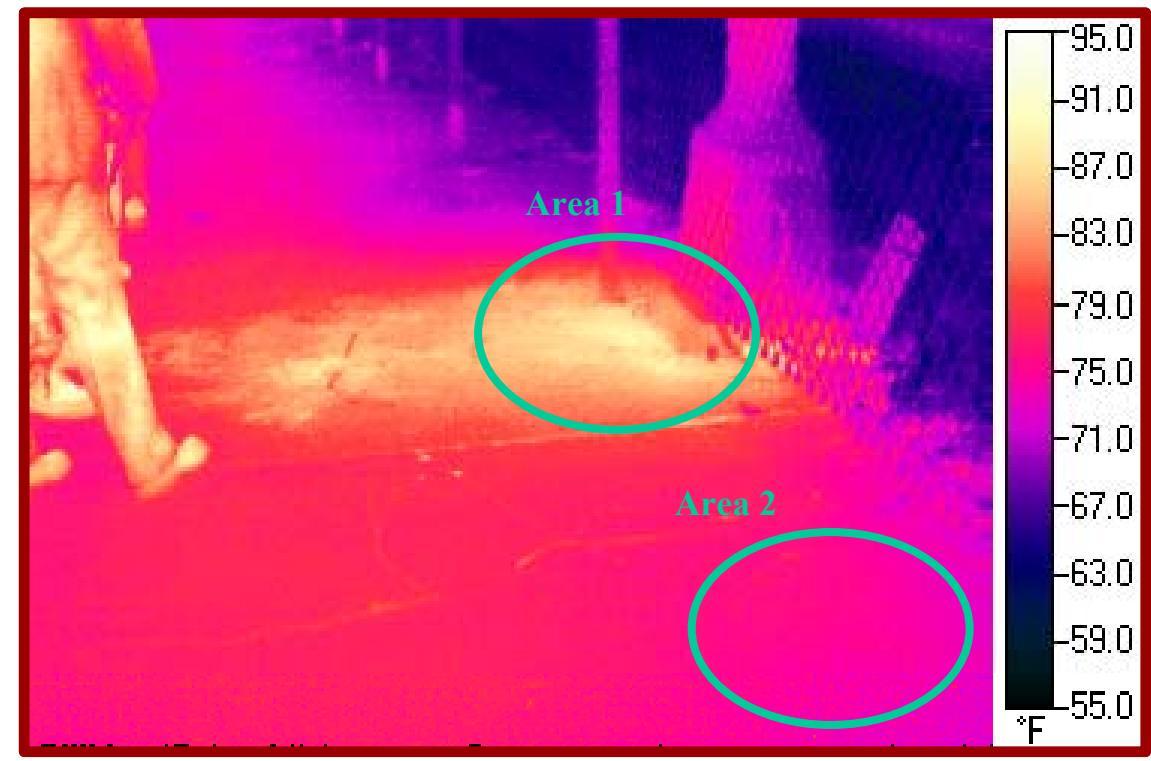
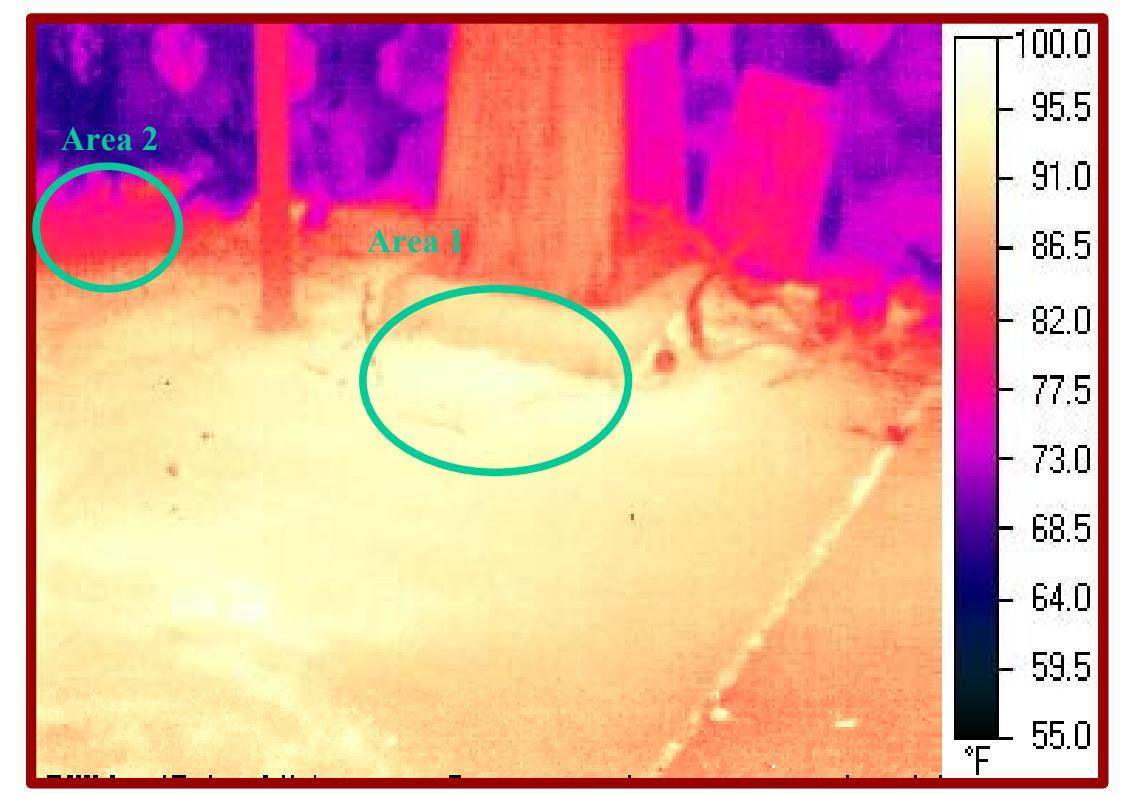
Invision was retained by the City of Columbus to characterize the temperature of the bridge after the accident. Invision showed that the bridge was hotter in the region immediately surrounding the incident light post as compared to the surrounding bridge. Selected images from the Invision report are presented here. These images show the relative temperatures of the bridge surfaces by assigning a color for each temperature following the temperature scale on the right side of each image⁵. There are two circles (Area 1 and Area 2) shown in each image that are averaged. The first image taken by Invision is shown in Figure 11 where it indicates that the concrete below the incident lamp post was hotter than the surrounding bridge concrete.

Figure 11. Image taken at 10:33:54 on May 23, 2003.

Figure 12. Image taken at 10:43:22 on May 23, 2003.

Figure 13. Image taken at 12:15:19 on May 23, 2003.

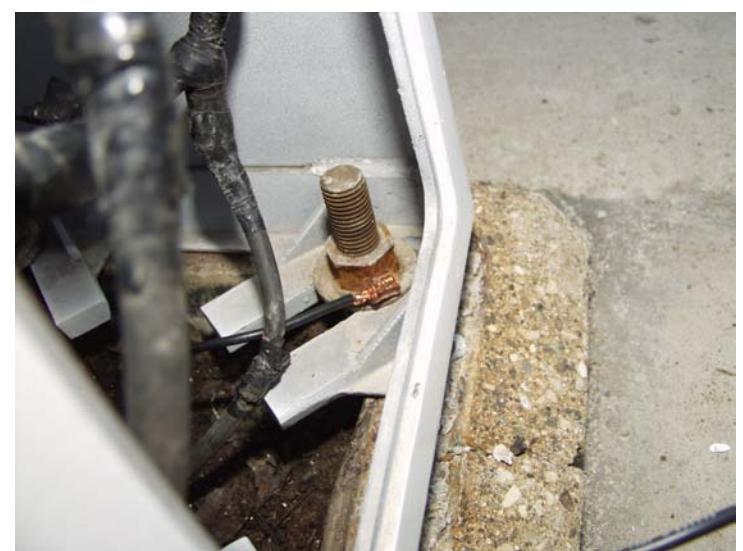
This test was performed by resting a bare crimped copper splice on the 10 AWG 480-volt conductor on one of the mounting nuts for the lamp base as shown in Figure 15. The voltage and current into this fault were monitored using a BMI recording device. The current into the fault started out at 9.2 amperes, and increased slightly to 10.3 amperes during the test. The 10-ampere fuse to the north side of the bridge blew approximately one hour into the test. It was replaced with a 20-ampere fuse and the test was continued. The power into the bridge during this test was approximately 4.8kW. A small amount of discoloration resulted on the rusty steel nut where the current was conducted into it as shown in Figure 16 and Figure 17. The power was applied for approximately 2 $\frac{1}{2}$ hours⁶.

Figure 15. The copper crimp on the 480-volt line lying on the rusty nut. P6047978.jpg

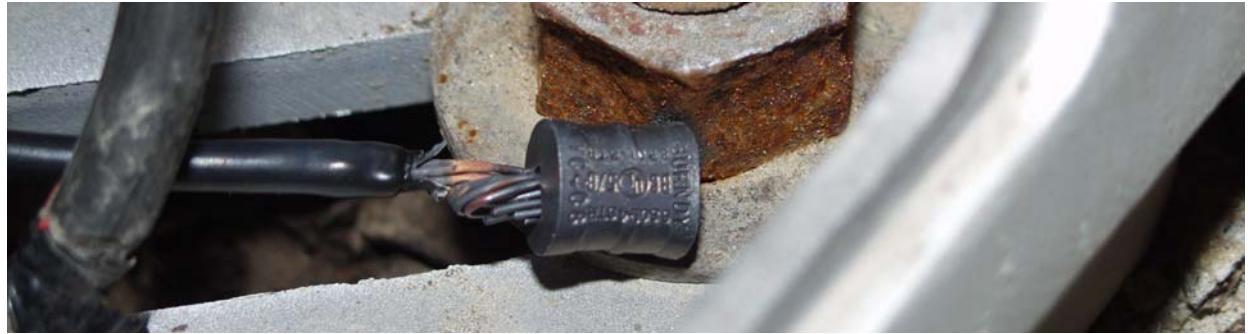
Figure 16. The copper crimp and the conductor were discolored after the test. P6047990.jpg

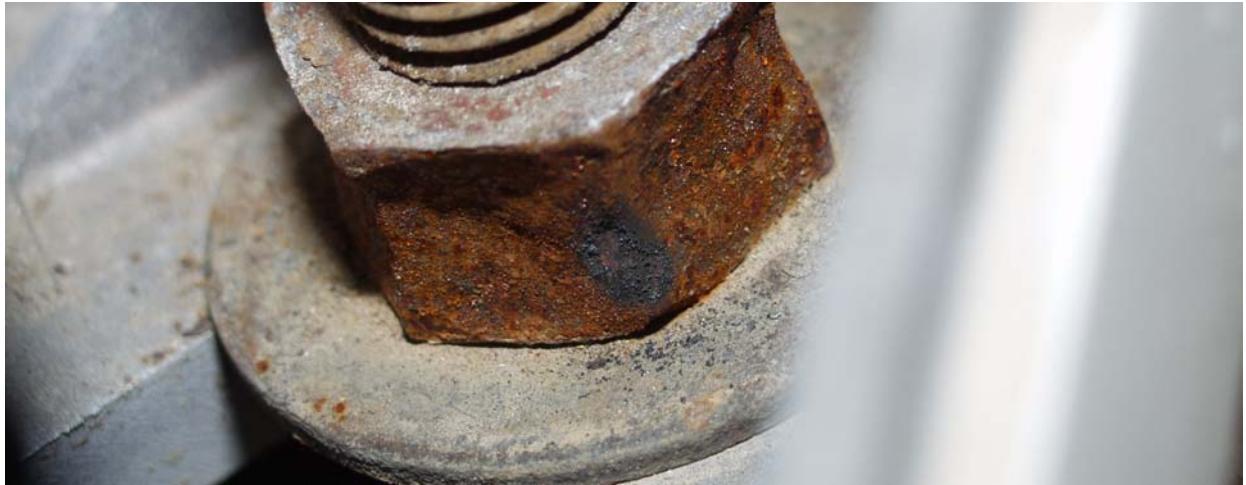
Figure 17. Slight discoloration on the rusted nut at the point of electrical faulting. P6047990.jpg

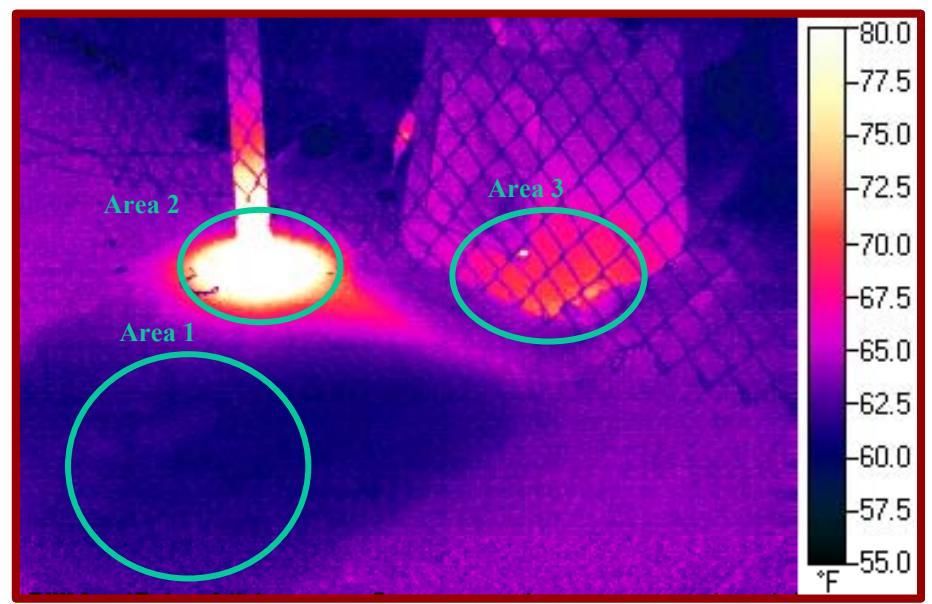
Thermal images made during the testing revealed substantial heating in the new concrete path to the fence post as shown in Figure 19. The voltage on the fence was measured to be 1.3 volts at one point during this test. None of the region surrounding the incident light was heated as was observed approximately 13 ¹/₂ hours after the incident.

Figure 19. Thermal image made at the beginning of the electrical fault test. June 4, 2003 at 22:22:35. Area 1: 60.6°F, Area 2: 121.9°F, and Area 3: 68.1°F.

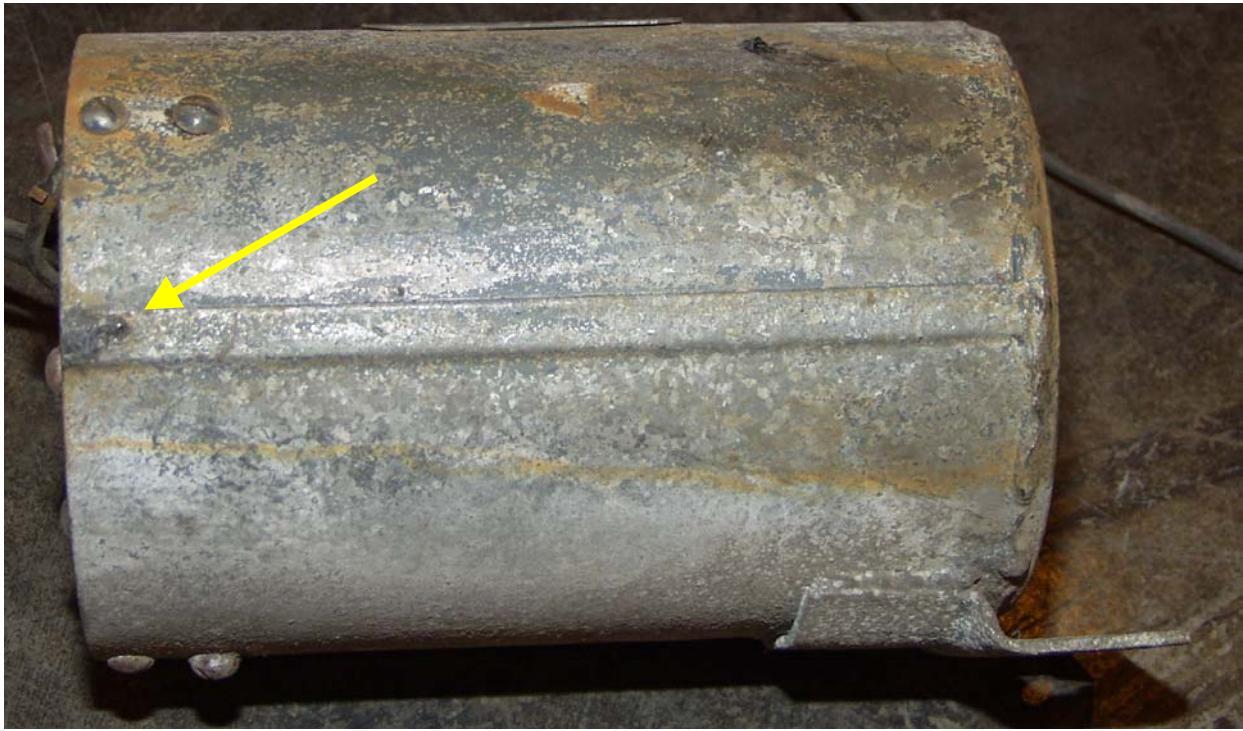
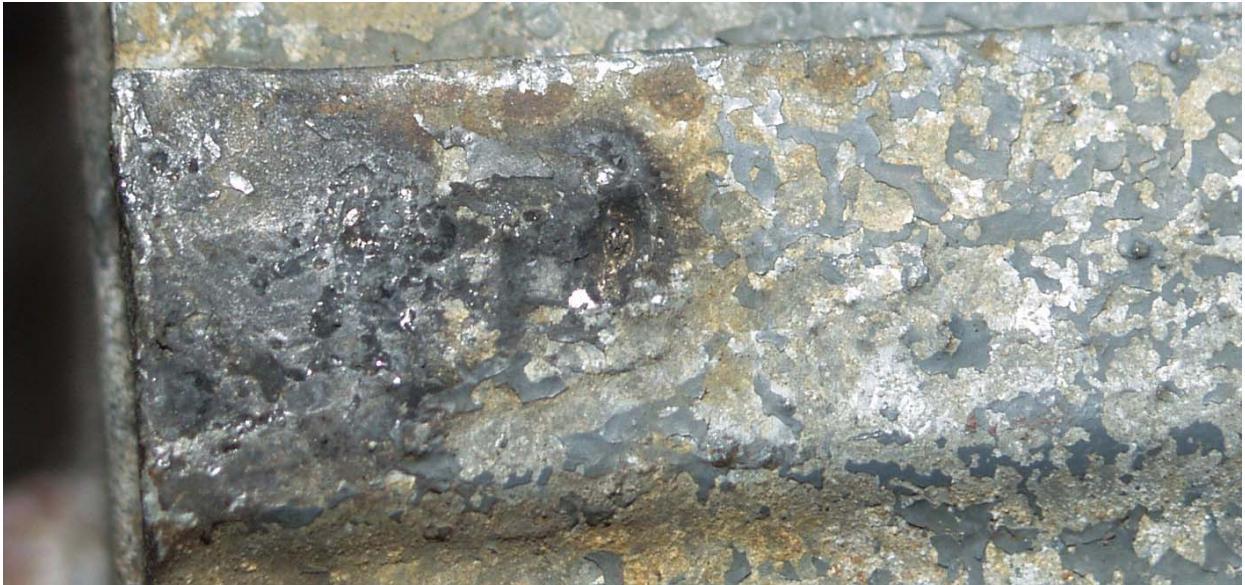
The inspection of the Police evidence revealed that there was a discolored region (Figure 27) on the old unused ballast that was in the base of the incident light at the time of the incident (Figure 36). A closer examination of the discolored region revealed that it may have been caused by low-current electrical faulting. Close-up photographs seemed to support this observation as shown in Figure 28. Microscope images of this region, shown in Figure 29 through Figure 31, confirmed that this evidence is consistent with damage that would be caused by low-current electrical faulting. Specifically, there were numerous small shiny beads and divots on the surface of this metal that are typical and characteristic of electrical faulting.

Figure 27. Discoloration found on the ballast from the base of the light. P6027776.jpg

Figure 28. Close-up photo of the discolored region from Figure 27. P6027810.jpg

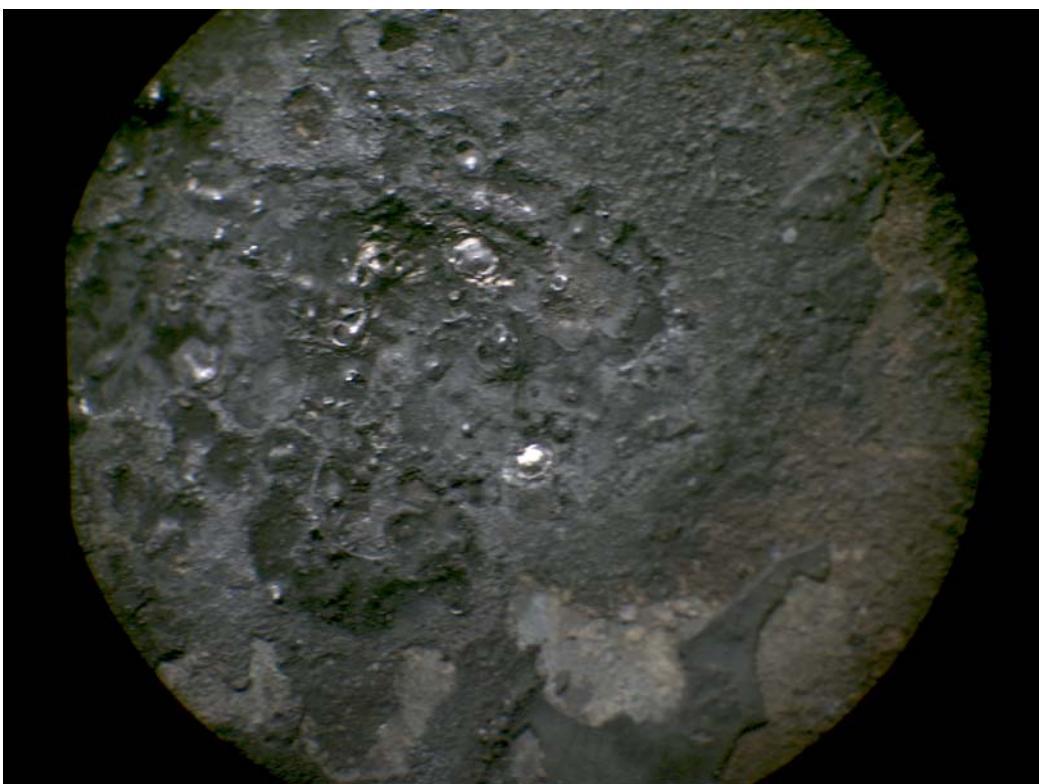
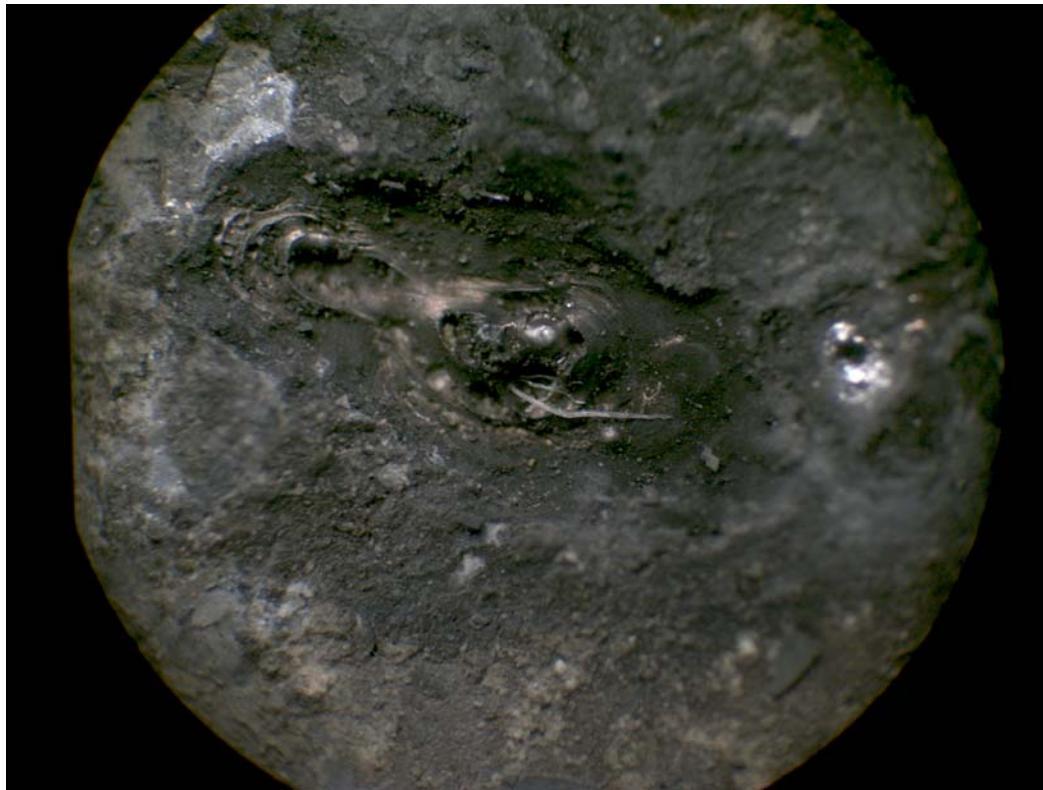
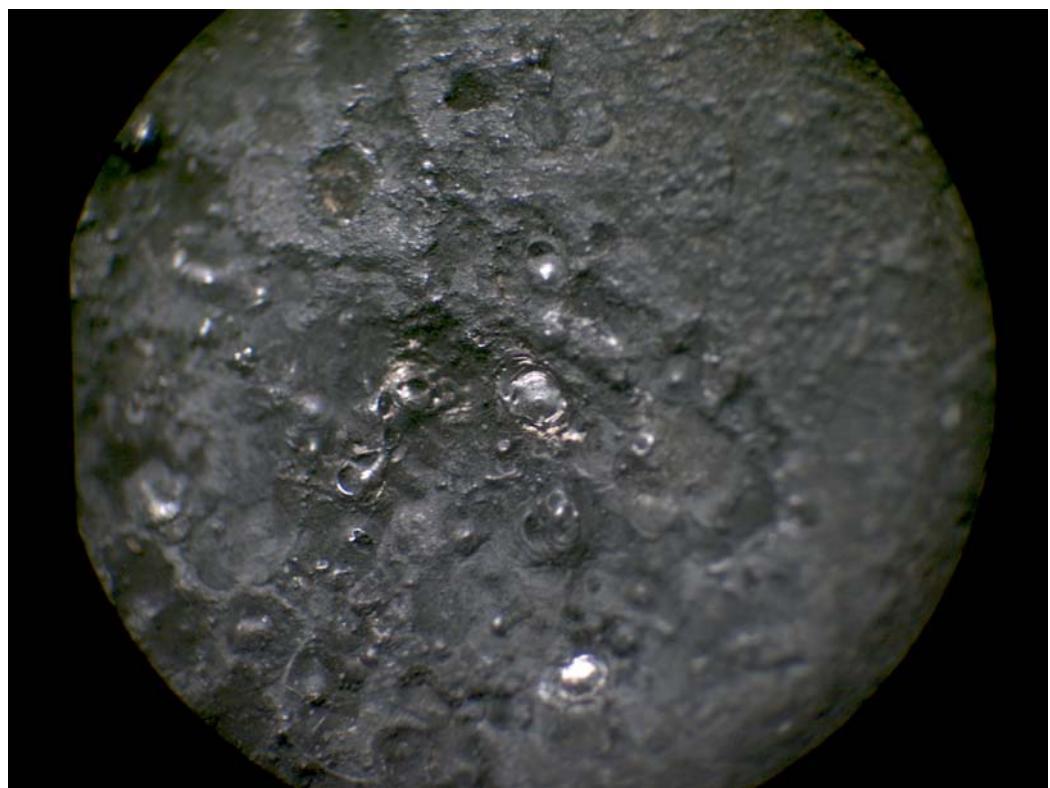
Figure 29. Microscope image of one section of the region shown in Figure 27. Image02.tif

Figure 30. Microscope image of one section of the region shown in Figure 27. Image03.tif

Figure 31. Microscope image of one section of the region shown in Figure 27. Image04.tif

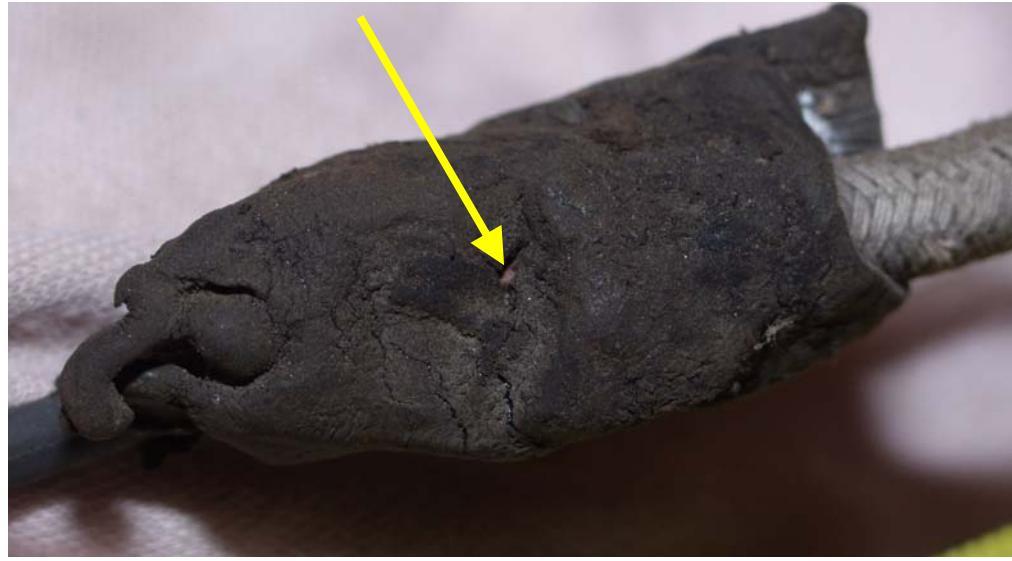
It was also observed that a neoprene splice, in the 480-volt conductor, had a hole in it (Figure 33). It was not initially readily apparent where this splice was at the time of the incident, except that it would have been in the base of the incident light post (Figure 32). An ohmmeter measurement confirmed that the visible material inside the hole was the 480-volt conductor. A laboratory examination and removal of this neoprene insulation revealed no evidence of electrical arcing or faulting on the internal crimp splice as shown in Figure 34.

Figure 33. Neoprene splice with a hole in the insulation on the 480-volt line. P2067773.jpg

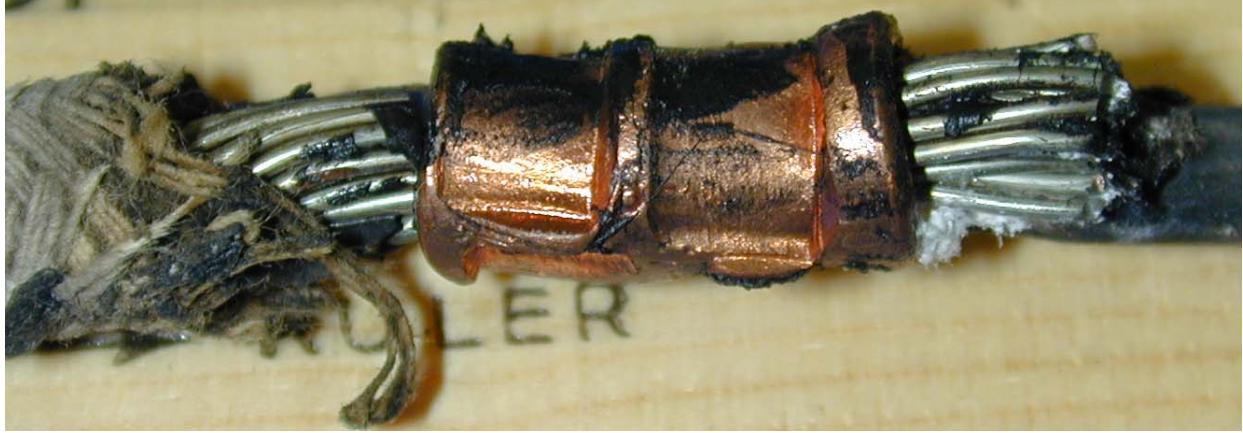
Figure 34. There was no evidence of arcing on the crimped splice inside the hole in the splice insulation. DSCN0201.jpg

This analysis revealed that while there was a breach in the insulation covering this splice, there was no obvious evidence of electrical arcing on the internal conductors or the crimped splice itself. This splice was therefore ruled out as a possible cause of this incident.

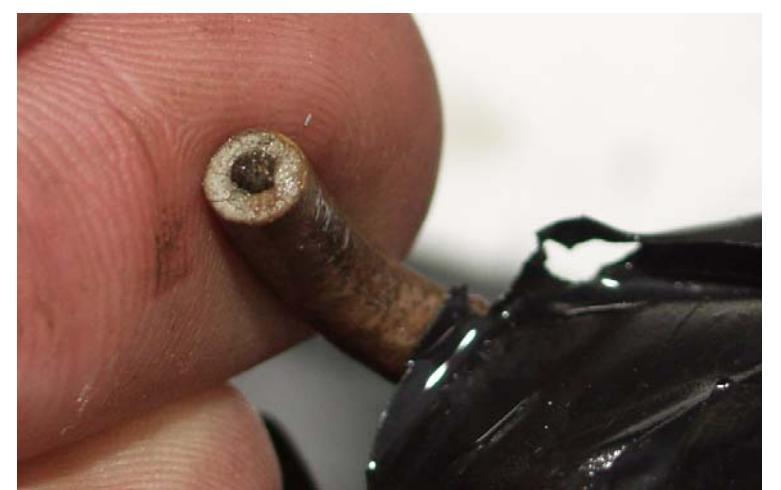
An examination of the remaining wires from the bridge revealed a short stub of 480-volt wire that was not insulated. While the exposed end could have faulted to any internal metal surface, its appearance indicated that no electrical faulting had occurred as shown in Figure 35.

Figure 35. Exposed 480-volt stub found in the base of the incident light. P6037933.jpg

Exponent agrees with the DOE personnel conclusion that this stub can be ruled out as a possible cause of this incident.

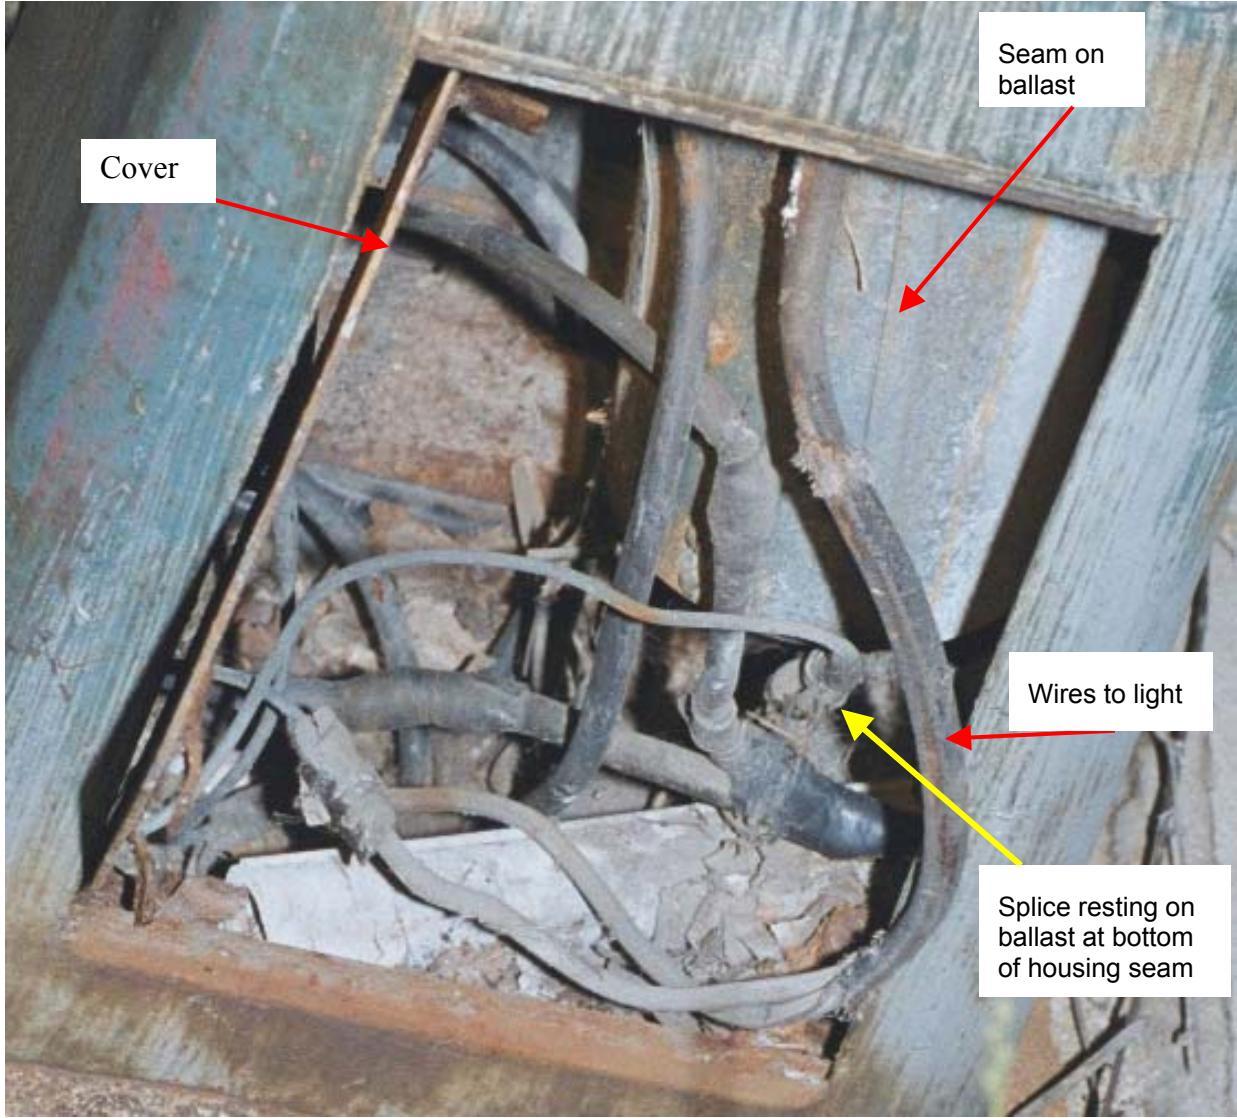
Figure 36. Police photo of incident base. 03-1011AA020.jpg

The police photograph in Figure 36 and Figure 37 shows a conductor and what appears to be a splice lying against the ballast in the region where the ballast exhibited evidence of electrical arcing. The identity of this conductor was established to be the conductor shown in the adjacent photo in Figure 37 because:

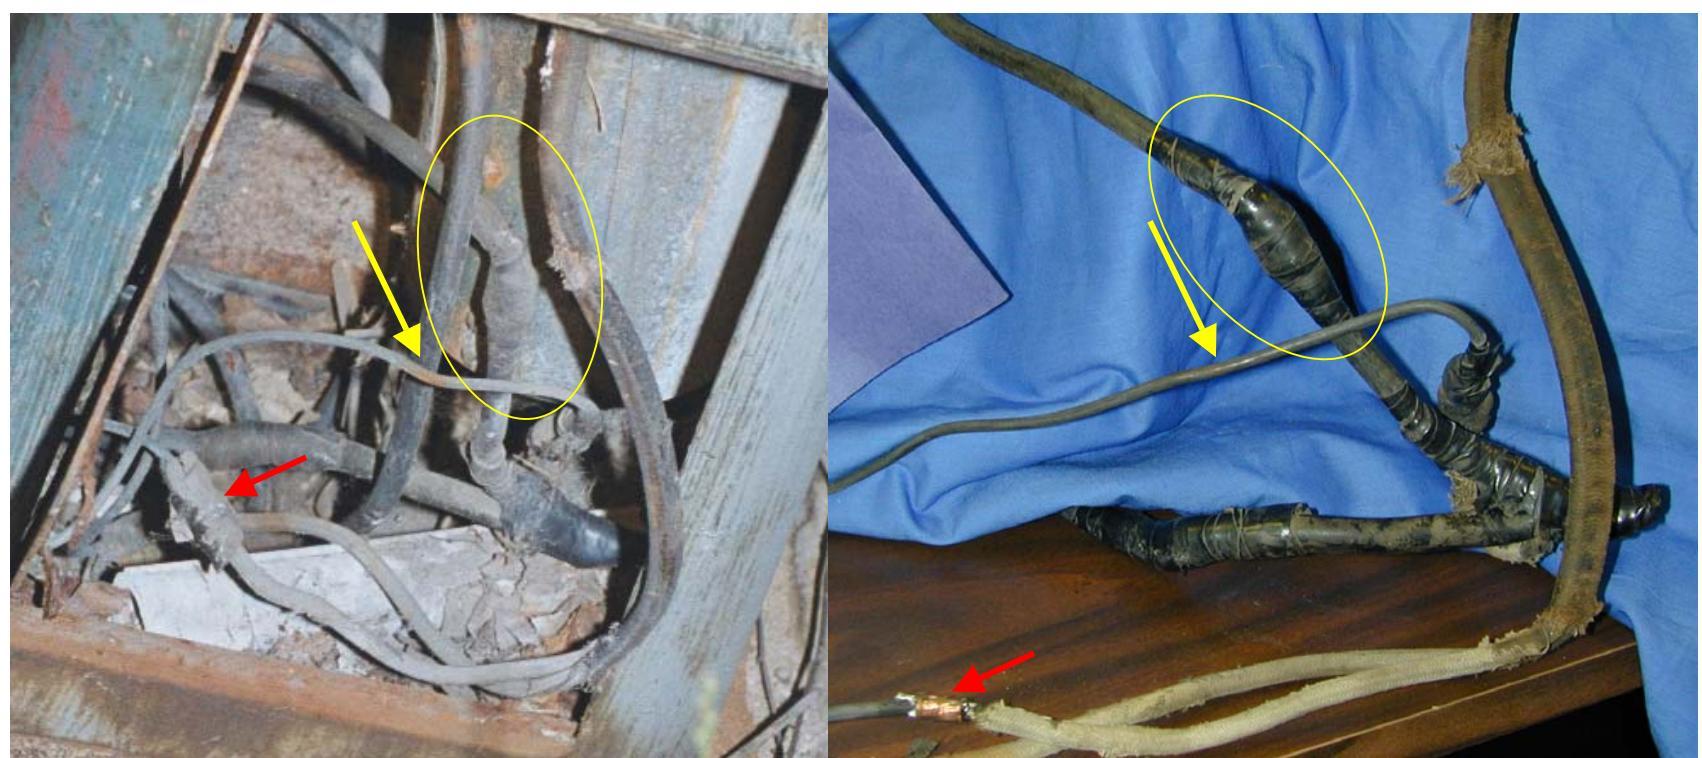
Figure 37. Police photo (03-1011AA0020.jpg) and Exponent photo of removed wires (DSCN0049.jpg). The red arrow indicates the neoprene splice, the yellow arrow the rust-colored region, and the yellow circle, the 480-volt conductor splice with a bend in it.

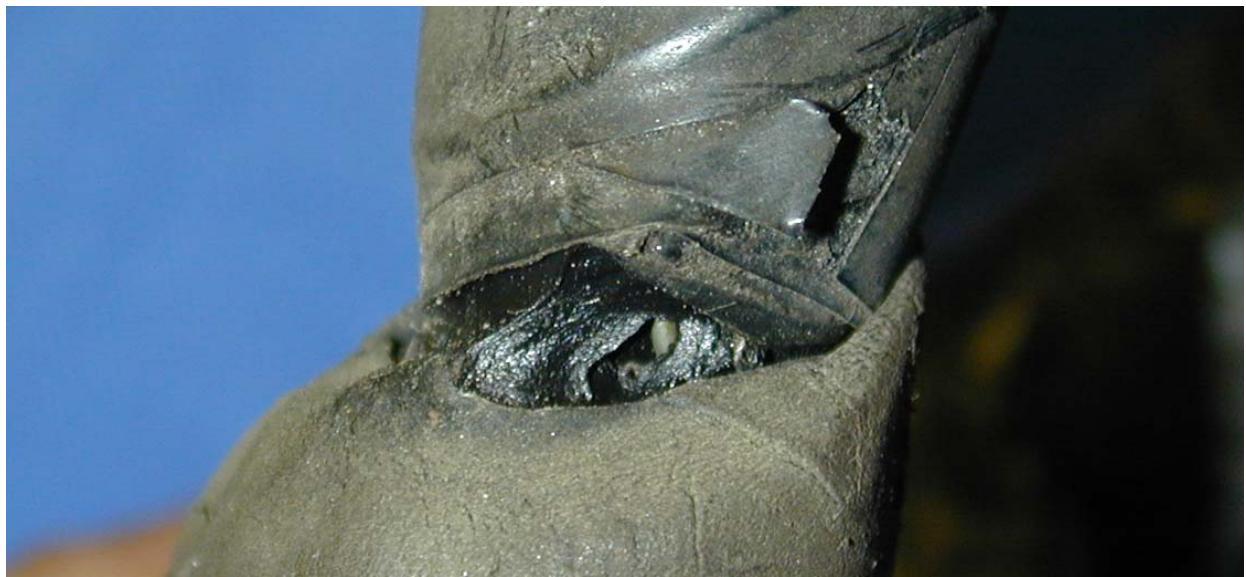
The splice, identified as resting against the ballast in the police photos, was inspected. It was found to have two regions where the insulation no longer covered the internal wiring and where the neoprene insulation was no longer intact (Figure 38). An ohmmeter was used to show that metal could easily be contacted through the breaches in the neoprene insulation. The insulation was cut away from this splice to allow examination of the internal conductors. It was observed that some of the conductors were not crimped in this splice as shown in Figure 39⁸. A region of erosion and discoloration was found on the conductors beneath the holes that were found in the insulation as shown in Figure 40. The conductors in this region were cleaned using a flux remover to allow an inspection of the characteristics of the individual strands. A microscope image of the strands shows melting and beading that is consistent with damage that would be expected to occur due to a low-current type electrical fault as

Figure 38. Breach in the ballast splice neoprene insulation. DSCN0061.jpg

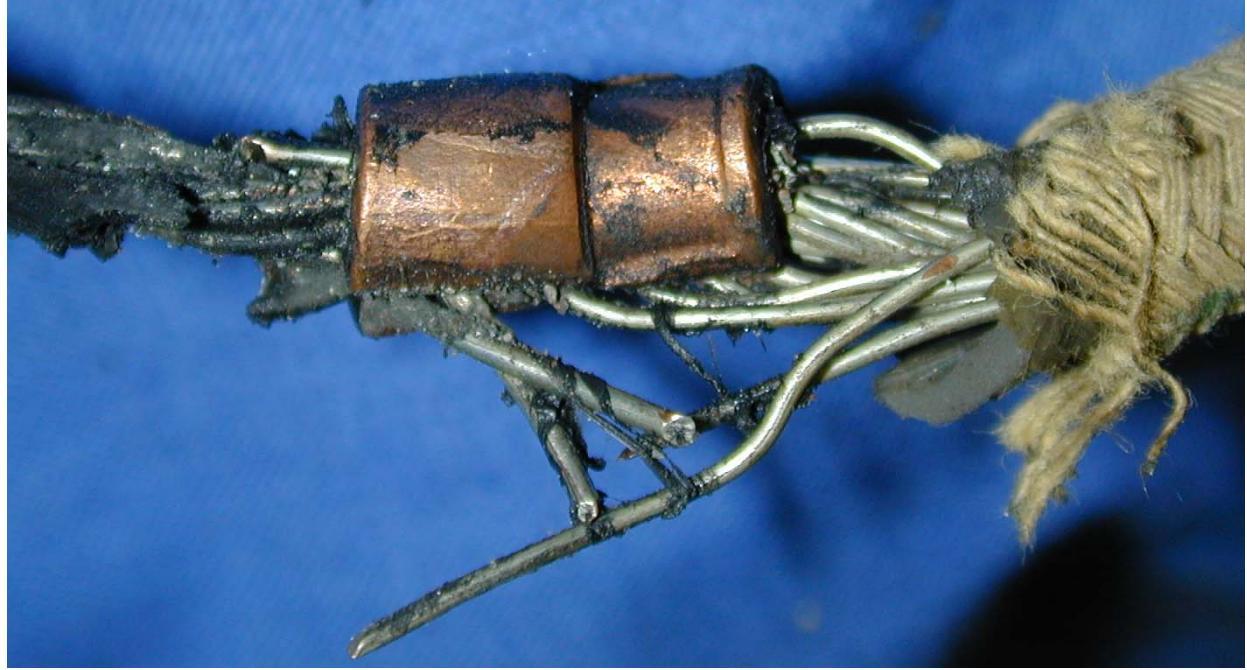
⁸ While not crimping all of the strands in a splice can lead to a failure due to heating, no significant heating occurred due to this poor crimp in this instance.

Figure 39. There were a number of strands that were not crimped in this splice. DSCN0074.jpg

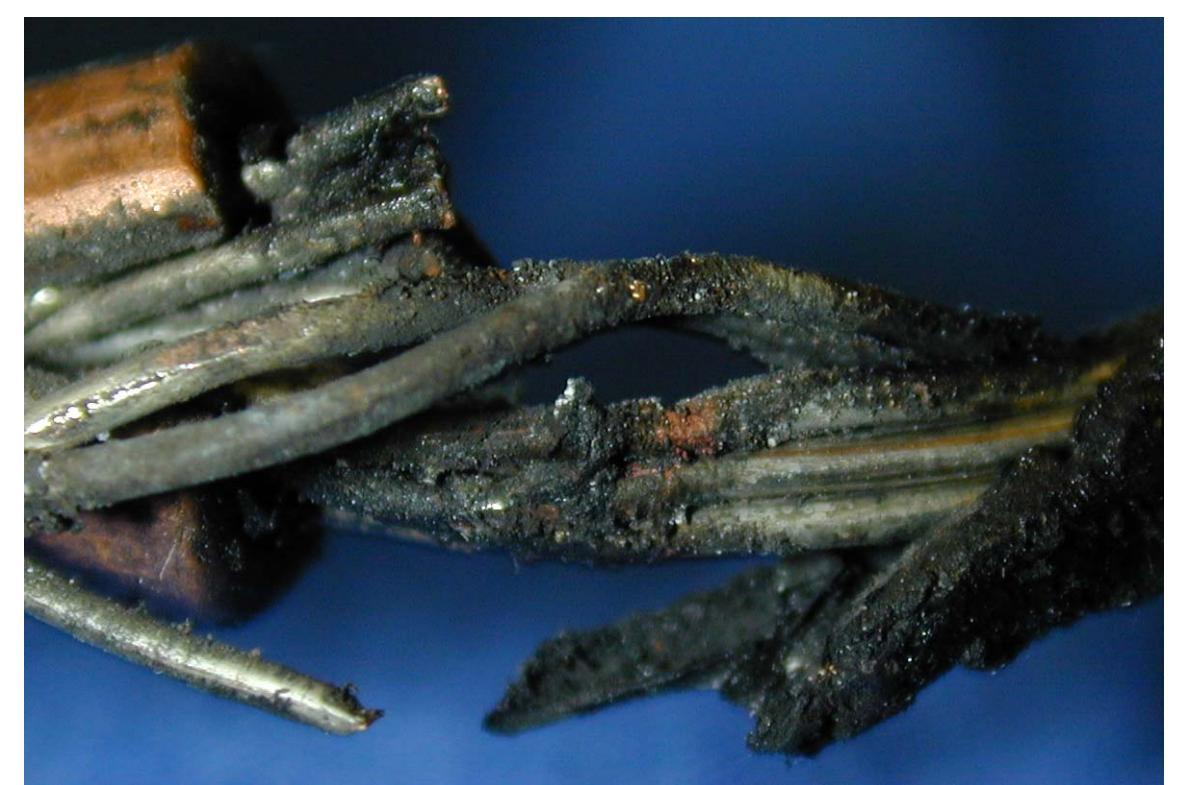
Figure 40. There was evidence of electrical faulting on some of the conductor strands where the hole was found in the neoprene insulation. DSCN0080.jpg

This analysis shows that there is evidence consistent with low-current electrical faulting on the strands of the 480-volt conductor. This conductor, which was discovered to have been resting on the ballast in the region where there is evidence of low current electrical faulting, was also found to have failed insulation.

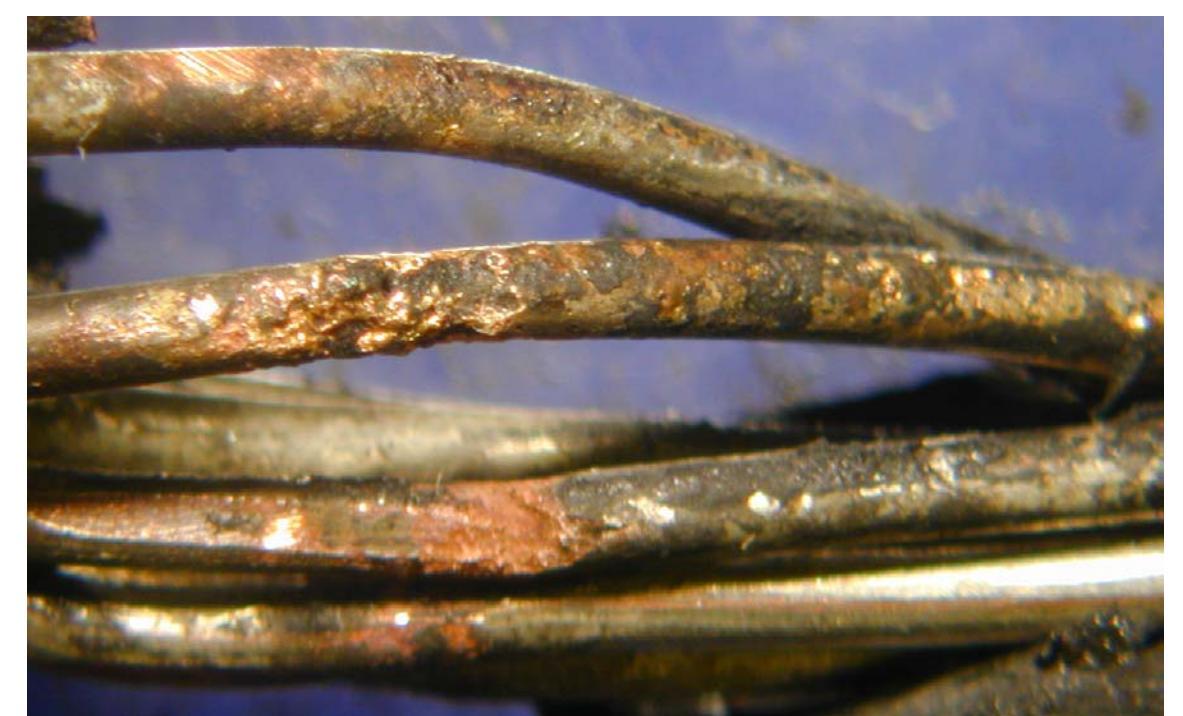
shown in Figure 41. Specifically, electrically induced beading or melting can be recognized due to the sharp line of demarcation between the melted and non-melted regions on a conductor. This characteristic occurs since heating due to electrical faulting is usually localized and only present in a very small region.

Figure 41. Microscope image of strands. The conductors were cleaned to reveal melting and beading that is consistent with damage that is expected due to low-current electrical faulting. DSCN0084.jpg
