EQUIPOTENTIAL PLANES, A FIGMENT OF THE IMAGINATION

Copyright Material IEEE
Paper No. ICPS-06

Donald W. Zipse, P.E.
Life Fellow, IEEE
Electrical Forensics, LLC
PO Box 7052
Wilmington DE 19803-0052
USA
don.zip@ieee.org

Abstract – This paper challenges conventional established practice and presently accepted standards concerning equipotential planes. The concepts, ideas and recommendations contained within this paper are the opinions of the author.

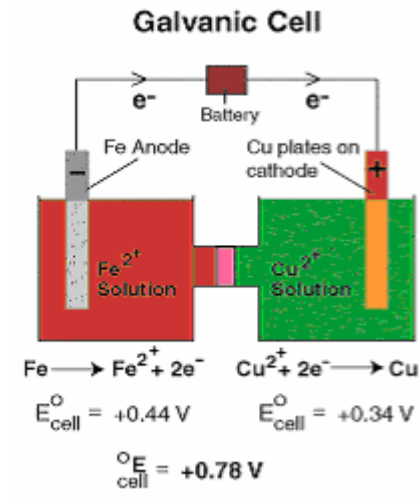
Figure 1. Galvanic or Voltaic Cell [12]

The maximum voltage that can be produced by a half-cell is comprised of Lithium at -3.04 volts and Iron at + 2.87 volts for a total of a constant output of 6.93 volts. This combination is not available in a normal dairy or swimming pool setting. What is available in a dairy would be using a copper

conductor and the iron in the concrete, which will produce a constant +0.34 volts for the copper and the iron at -0.44, or a paltry sum of 0.78 constant dc volts maximum.

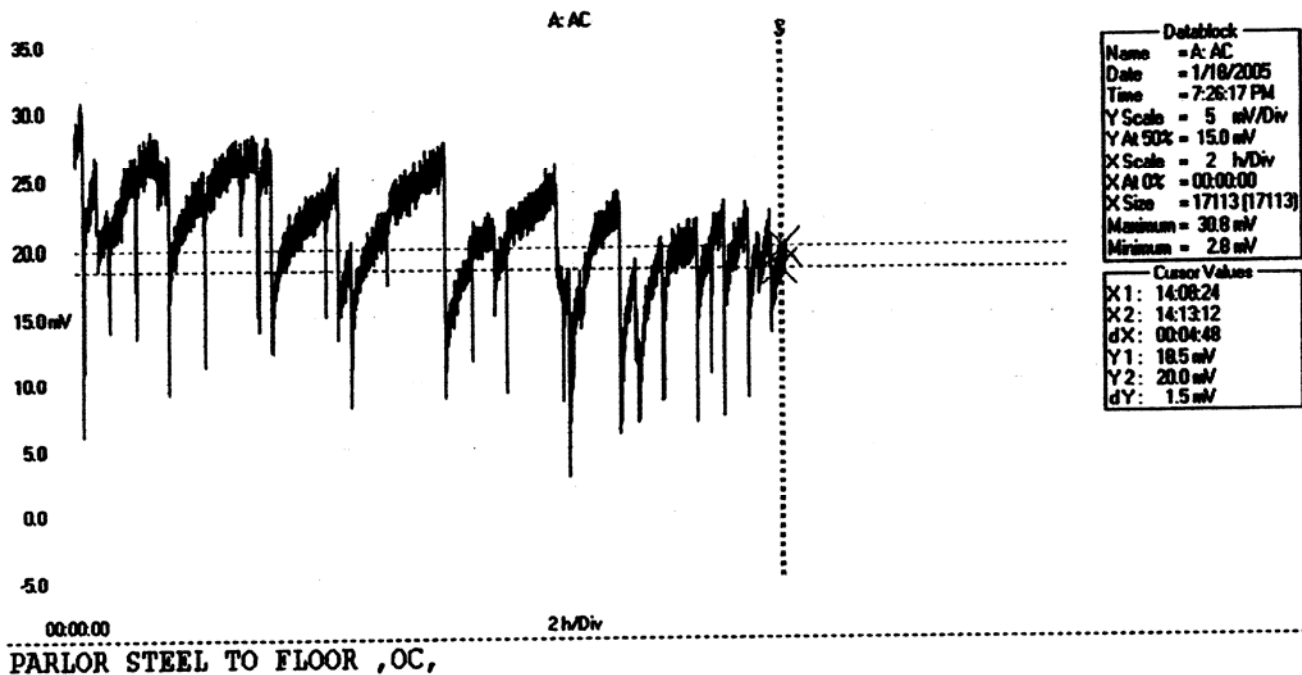
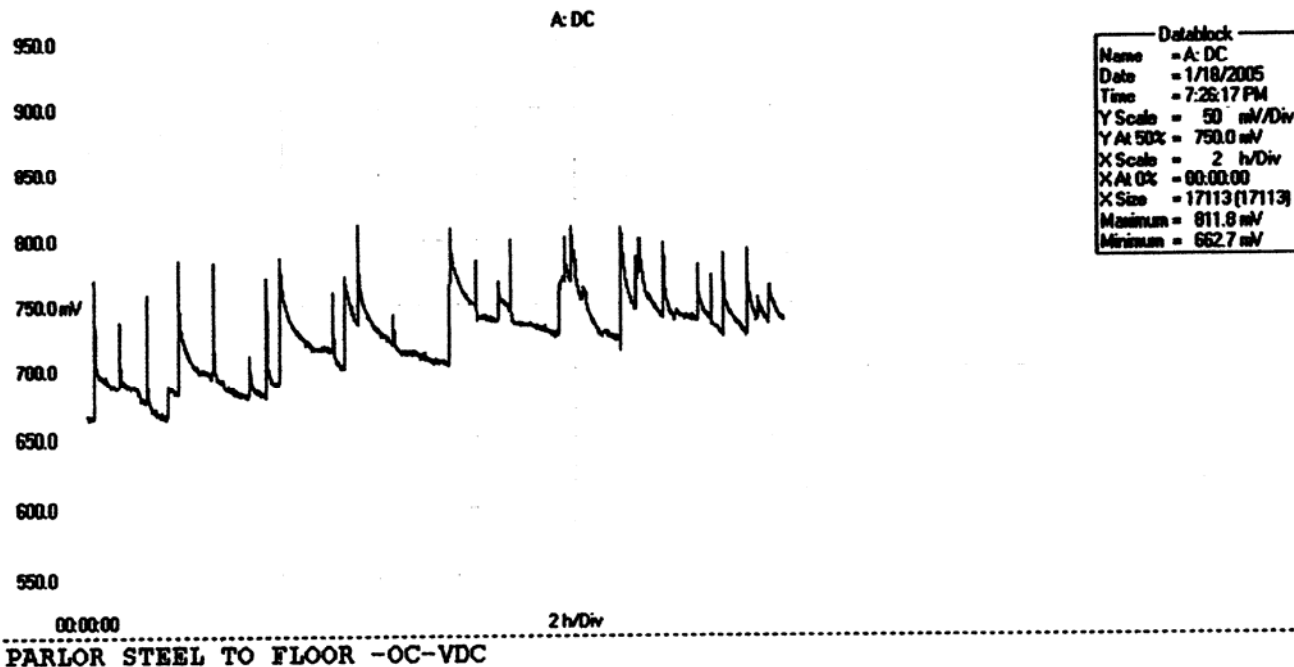
Chart 1. The above plots are preliminary and greater study is required. However, it is believed the following is occurring. Both plots are voltage measurements, open circuit measurements. The measurements are being taken in the milking parlor from the metal to the floor. The upper plot is ac voltage while the lower plot is dc voltage. The cow is drinking. The dc is galvanic action from copper and steel and the rectified dc. The maximum galvanic voltage is approximately 0.79 volts dc. Note that as the ac voltage decreases the dc voltage increases. It is opined that the rectified voltage is in opposite polarity to the galvanic cell in this case.

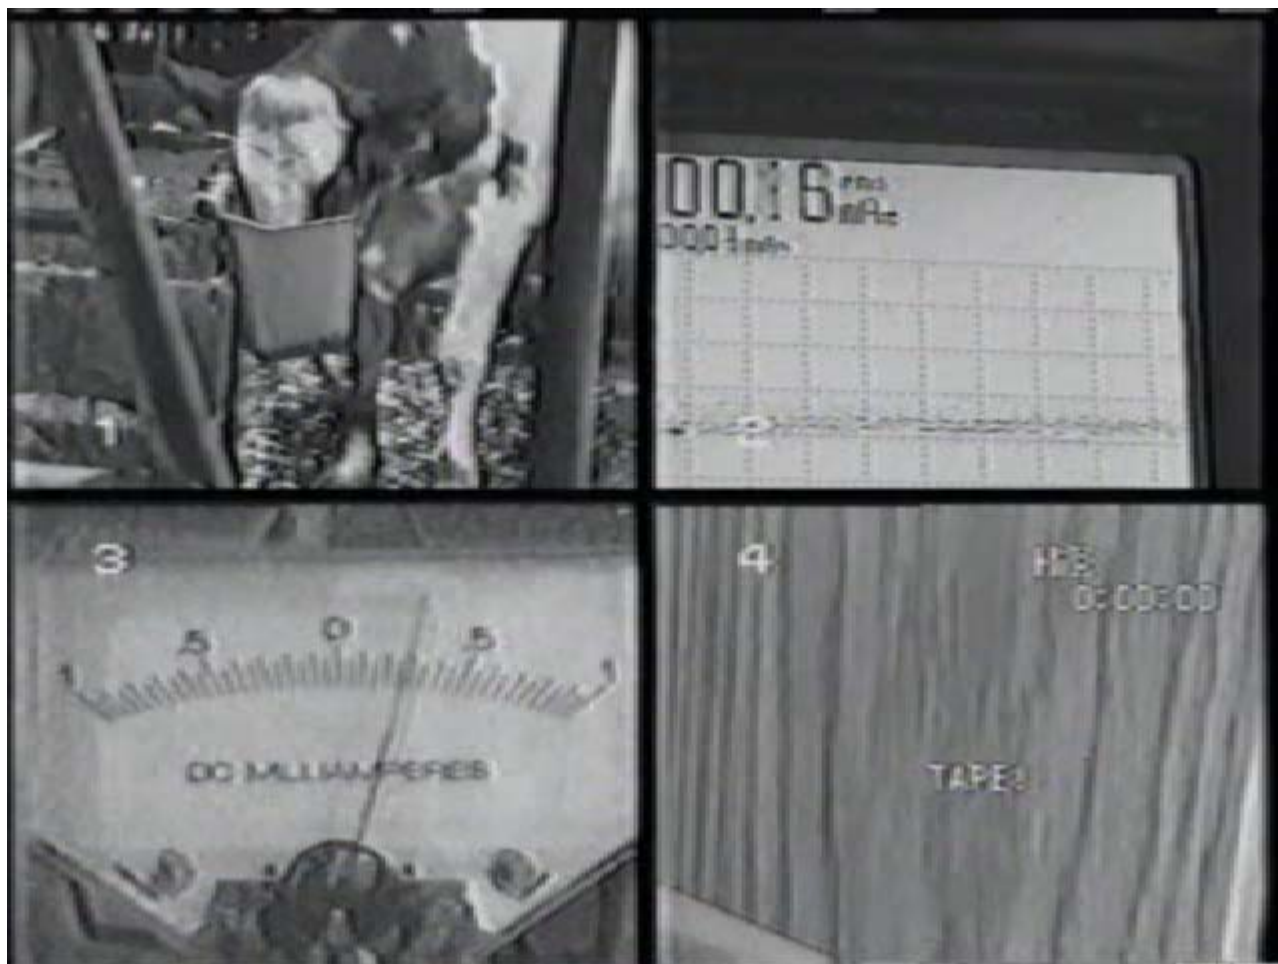
Video Capture 1. The above image has been captured from videotape made during testing of a dairy. There are inputs from four cameras. The upper left quadrant shows the cow eating from a plastic bucket. The bucket is filled with grain, which is wetted in order to make it conductive. The measuring circuit is from one end of a copper conductor connection to the metal stanchion. The other end of the conductor is connected to the measuring equipment, such as ammeters and/or voltmeters. From the other side of the measuring equipment a copper conductor is placed in the bottom of the plastic feed bucket. About 305 mm (12 inches) of the insulated copper conductor is stripped, coiled and placed in the bottom of the plastic bucket.

This test is referred to as cow contact, cc. Cow contact is defined as any two places that a cow can come into contact with and receive an electric shock. Before Mr. Neubauer's water bucket and plastic feed container tests, just a voltmeter was used between the two cow contact points and a resistor of 470 ohms placed across the voltmeter. The 470 ohm resistor was the most readily available value and closest to the supposedly internal resistance of a cow, 500 ohms. These tests use the actual cow to determine the actual electrical current flowing through the cow.

The upper right quadrant can capture an ac ammeter or voltmeter. The lower left quadrant shows the milliamper meter. The lower right quadrant is available for another camera input.

The four-quadrant video is captured on tape and or feed into one of seven computers in the data collection trailer. Each measuring device can and usually is captured by its self in one of the seven computers. Data can be transferred to CD.

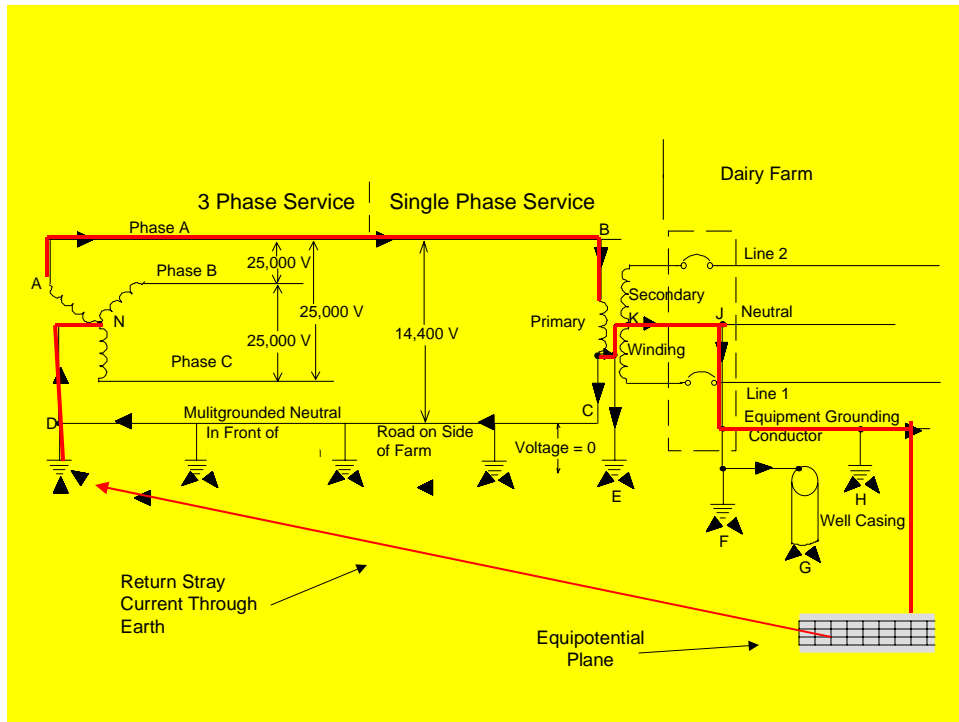
Figure 4. Stray Current Flow Directly Connected To Equipotential Plane

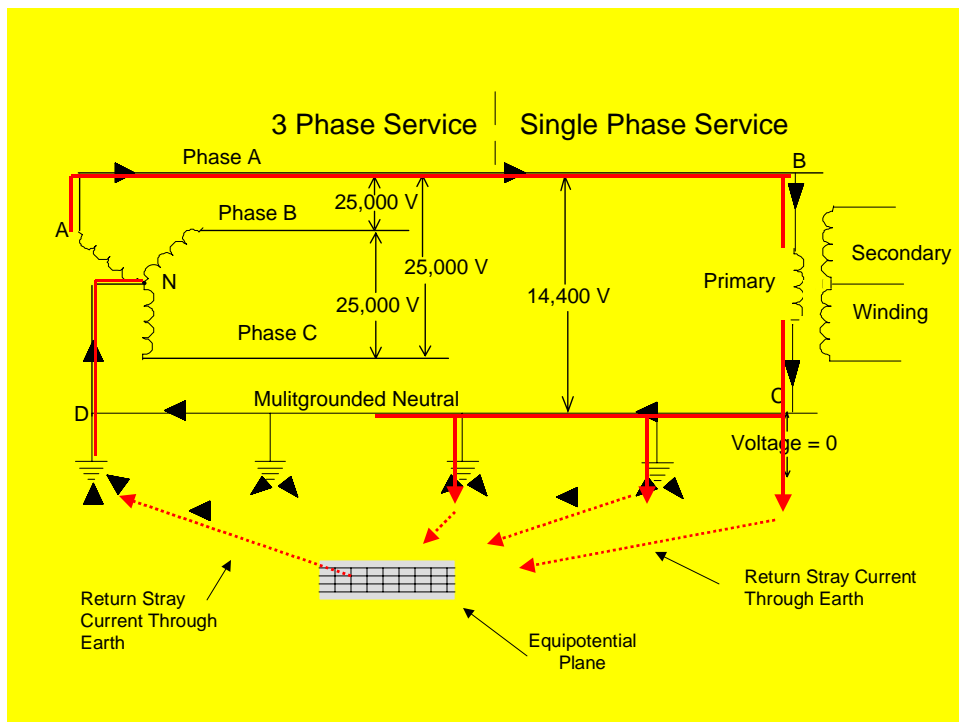
Figure 5. Stray Current Flowing through the Earth and Through the Equipotential Plane.
