Preface – Prelude – Prologue
(Take your pick)
to the Institute of Electrical and Electronic Engineers' (IEEE) paper
EQUIPOTENTIAL PLANES, A FIGMENT OF THE IMAGINATION

Donald W. Zipse, P.E.
Life Fellow, IEEE
Electrical Forensics, LLC
PO Box 7052
Wilmington DE 19803-0052
USA
don.zip@ieee.org

EQUIPOTENTIAL PLANES, A FIGMENT OF THE IMAGINATION

Copyright Material IEEE
Paper No. ICPS-06

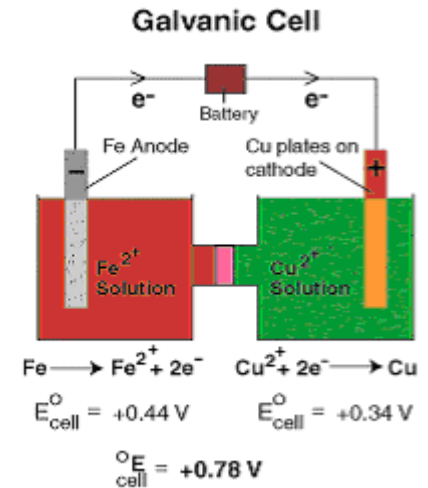
Figure 1. Galvanic or Voltaic Cell [12]

conductor and the iron in the concrete, which will produce a constant +0.34 volts for the copper and the iron at -0.44, or a paltry sum of 0.78 constant dc volts maximum.

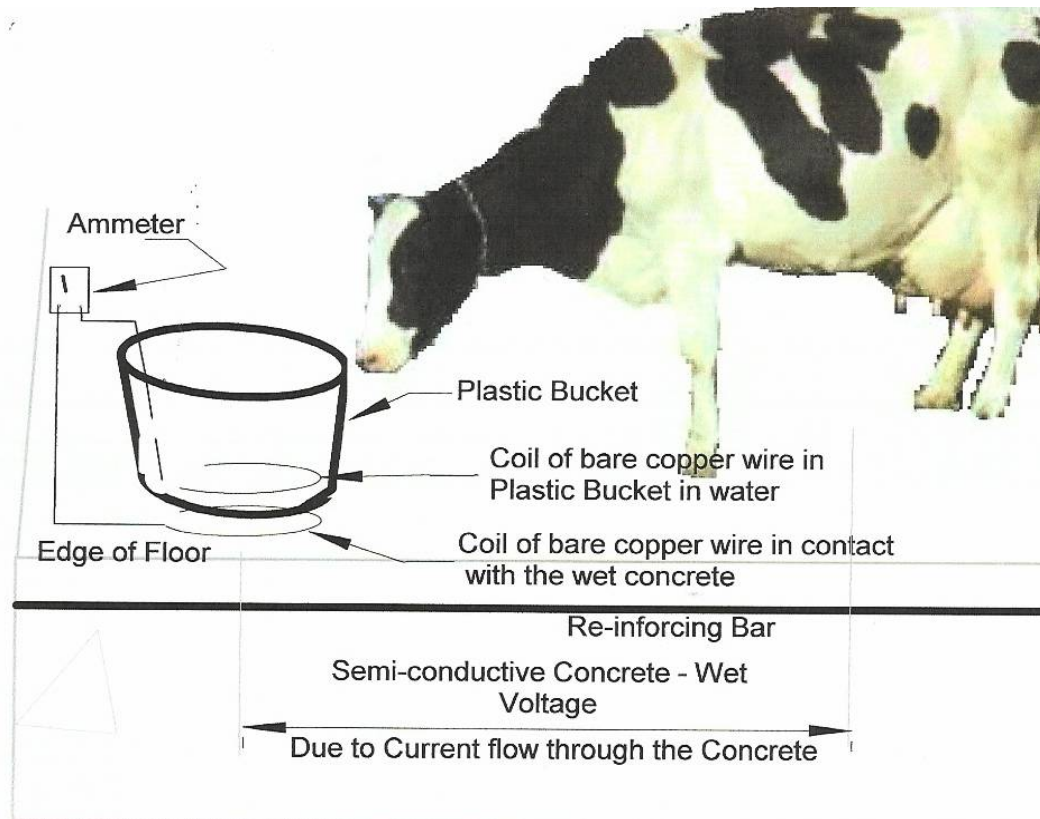
Figure 2. Test Setup Number 1

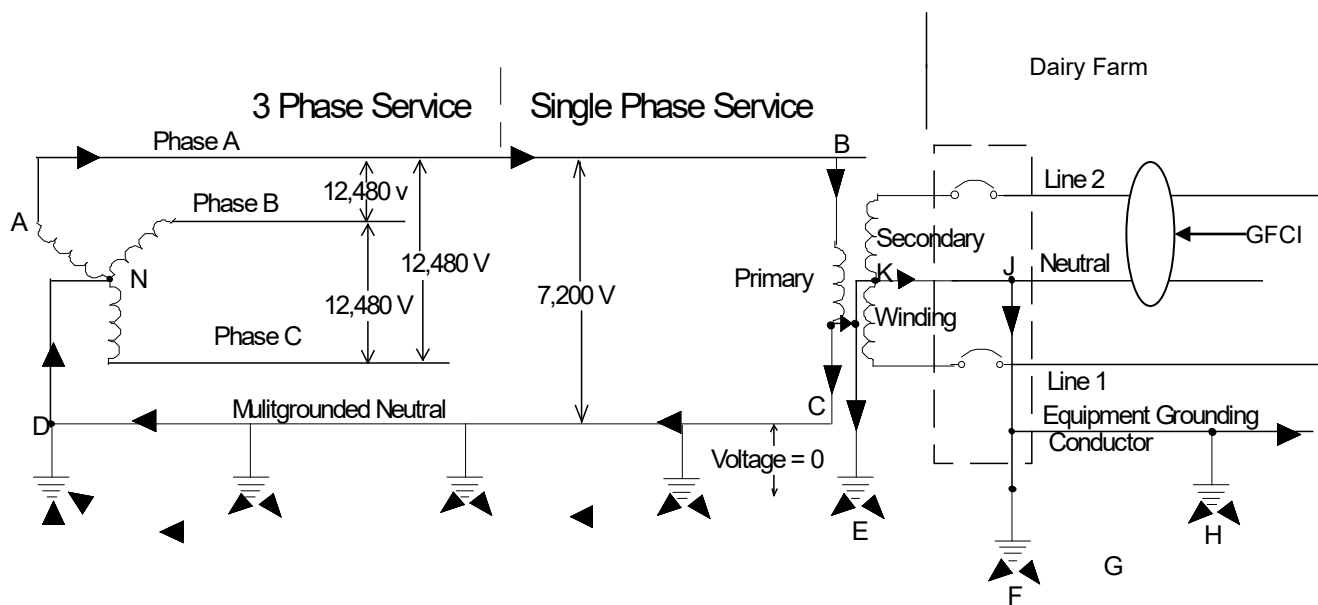
Figure 3. Wye Connected Electrical System Multigrounded Neutral with Primary Neutral to Secondary Neutral Electrical Service Connection Showing the Hazardous Stray Uncontrolled Primary Current Flow over Dairy's Facility

Each of the black triangles at the lower portion of the figure indicate stray current entering and flowing over the earth and returning to the substation's earth connection ground rod and up to point labeled "D", and on to the substation's Xo, neutral terminal, labeled "N".

The complete circuit is described in the Petroleum and Chemical Industry Committee's technical paper titled, "The Hazardous Multigrounded Neutral Distribution System and the Dangerous Stray Currents" [10][2]. Briefly, the circuit begins at the substation supplying the distribution circuit. The current leaves the substation flowing on the phase conductor to the transformers on the line. The stray current enters the earth by two paths. (See figure 3)

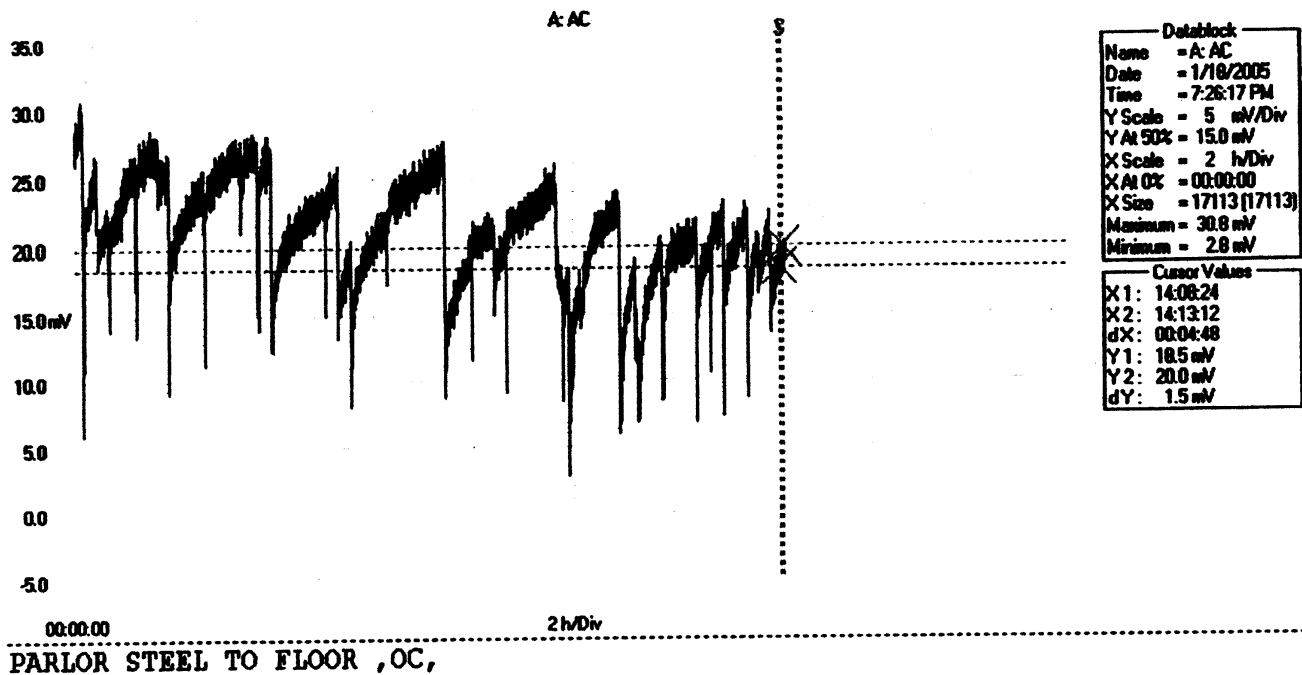
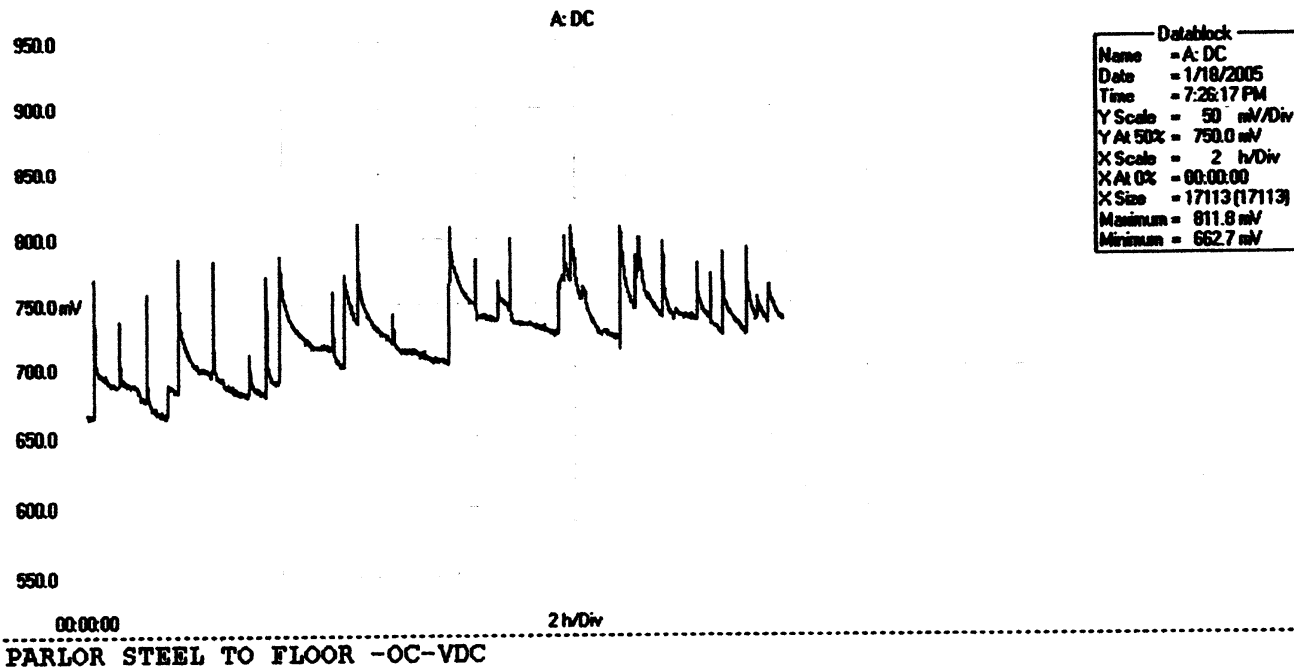
Chart 1. The above plots are preliminary and greater study is required. However, it is believed the following is occurring. Both plots are voltage measurements, open circuit measurements. The measurements are being taken in the milking parlor from the metal to the floor. The upper plot is ac voltage while the lower plot is dc voltage. The cow is drinking. The dc is galvanic action from copper and steel and the rectified dc. The maximum galvanic voltage is approximately 0.79 volts dc. Note that as the ac voltage decreases the dc voltage increases. It is opined that the rectified voltage is in opposite polarity to the galvanic cell in this case.

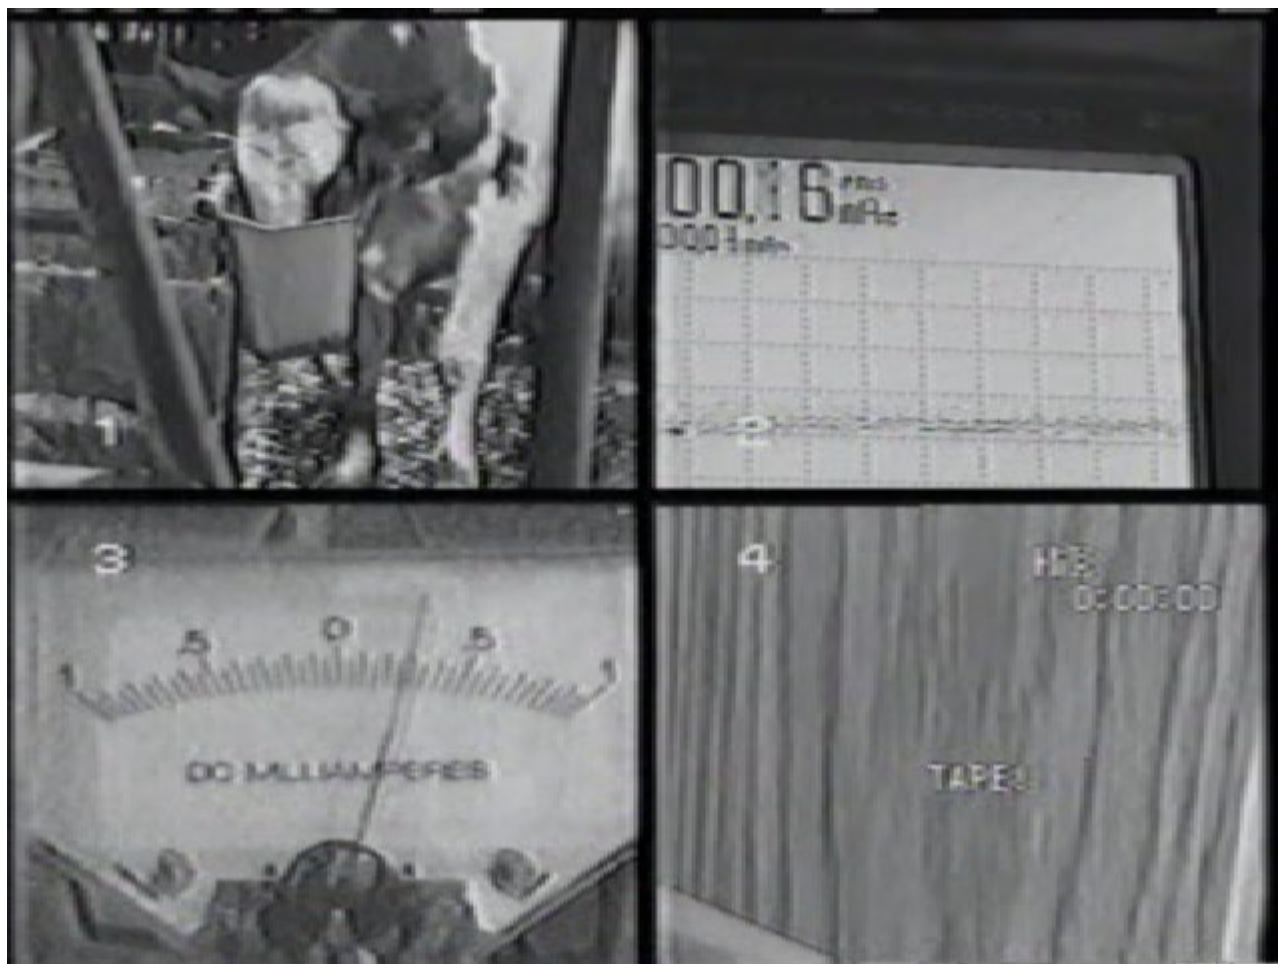
Video Capture 1. The above image has been captured from videotape made during testing of a dairy. There are inputs from four cameras. The upper left quadrant shows the cow eating from a plastic bucket. The bucket is filled with grain, which is wetted in order to make it conductive. The measuring circuit is from one end of a copper conductor connection to the metal stanchion. The other end of the conductor is connected to the measuring equipment, such as ammeters and/or voltmeters. From the other side of the measuring equipment a copper conductor is placed in the bottom of the plastic feed bucket. About 305 mm (12 inches) of the insulated copper conductor is stripped, coiled and placed in the bottom of the plastic bucket.

This test is referred to as cow contact, cc. Cow contact is defined as any two places that a cow can come into contact with and receive an electric shock. Before Mr. Neubauer's water bucket and plastic feed container tests, just a voltmeter was used between the two cow contact points and a resistor of 470 ohms placed across the voltmeter. The 470 ohm resistor was the most readily available value and closest to the supposedly internal resistance of a cow, 500 ohms. These tests use the actual cow to determine the actual electrical current flowing through the cow.

The upper right quadrant can capture an ac ammeter or voltmeter. The lower left quadrant shows the milliamper meter. The lower right quadrant is available for another camera input.

The four-quadrant video is captured on tape and or feed into one of seven computers in the data collection trailer. Each measuring device can and usually is captured by its self in one of the seven computers. Data can be transferred to CD.

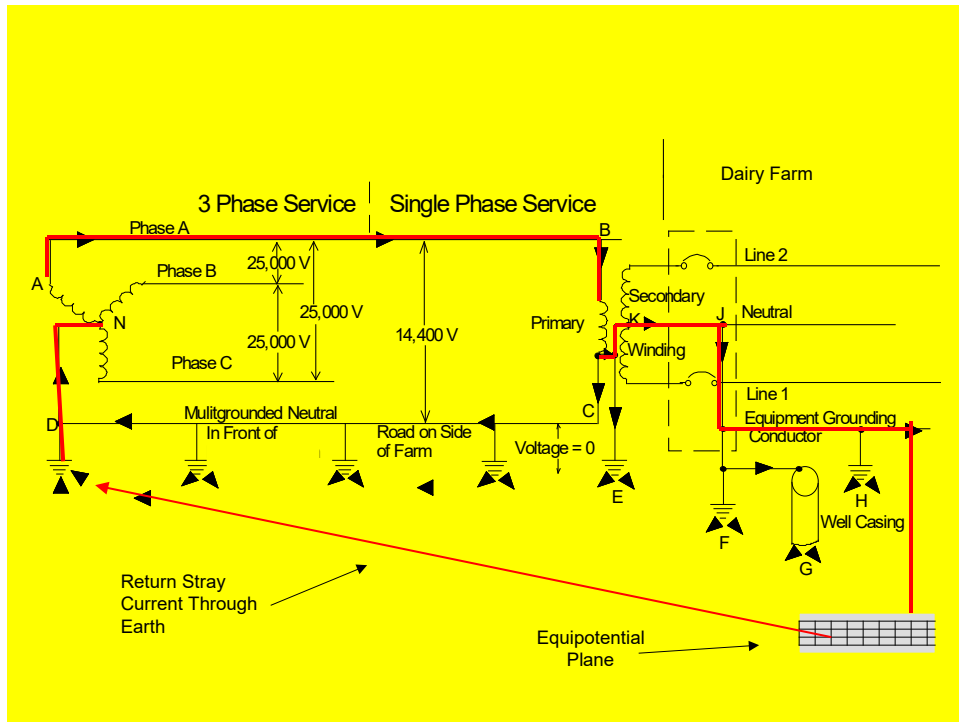
Figure 4. Stray Current Flow Directly Connected To Equipotential Plane

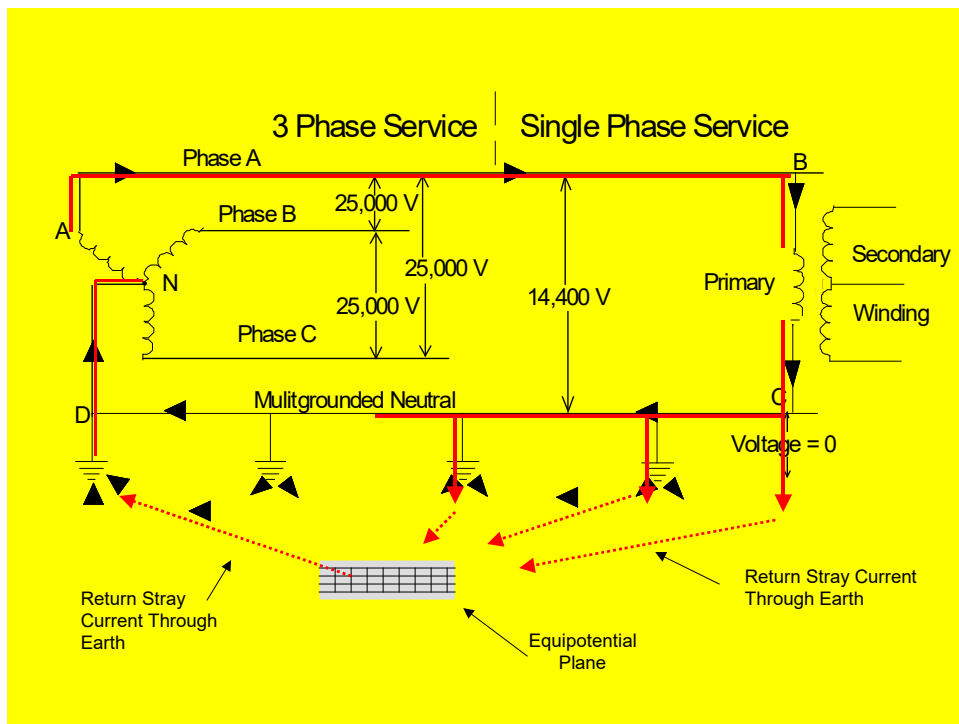
Figure 5. Stray Current Flowing through the Earth and Through the Equipotential Plane.
