WHERE IS THE GROUND?

With each code cycle, the code evolves in response to events, practices, and developing technologies. In the discussion herein, I present a case study where past and current code editions are in conflict with each other. Supporting the case study are discussions of code and history that help to shine a light on the potential problems between code editions.

James A. Montross, PE, CEM, LEED AP BD+C jmontross@thorntontomasetti.com

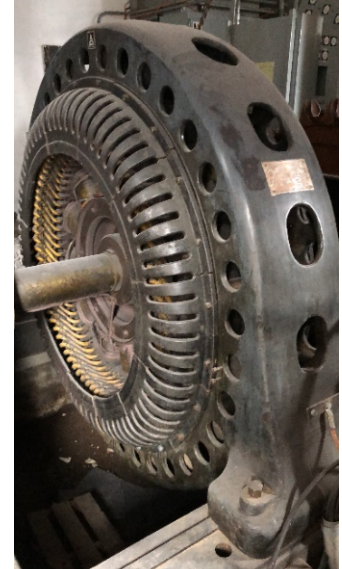
Photo Courtesy of G. Tuley
Tesla AC Machine

On June 21st, 1891, L.L. Nunn, a Colorado lawyer and manager of the Gold King Mine, signed a contract with Westinghouse to install the Tesla A.C. power system. The plan was to harness a river below the mine and replace the costly coal powered steam generators. This facility became known as the Ames Power Station and was the first power station in the world to transmit alternating current at high voltage for a long distance for power use purposes. The Electric Age had arrived. Not far away, aware of the success of the Ames power station, Smuggler-Union Hydroelectric plant was constructed in 1907, also using a Tesla designed Westinghouse AC generator (pictured at right). The power was used in the Smuggler-Union mine, adjacent residence and cook house. It is believed Tesla stayed at this residence to assist in the installation of the generator and electrical equipment. They diverted a nearby stream that fed a water fall through the basement of the house with the intent of using the falling water to generate electricity. The house was perched precariously on a 400 foot cliff. The flowing water turned an electric generator that produced the electric power. Right from the start it was clear electric power was a marvelous albeit little understood utility capable of making life more convenient for the user. The Ames Power Station is still in operation today with the original generator making it one of the oldest generators still in operation. It currently provides power to approximately one-fourth of the neighboring town of Telluride, or about 2000 average American homes. The birth of the electric code was essential to the safe development of electric power use.

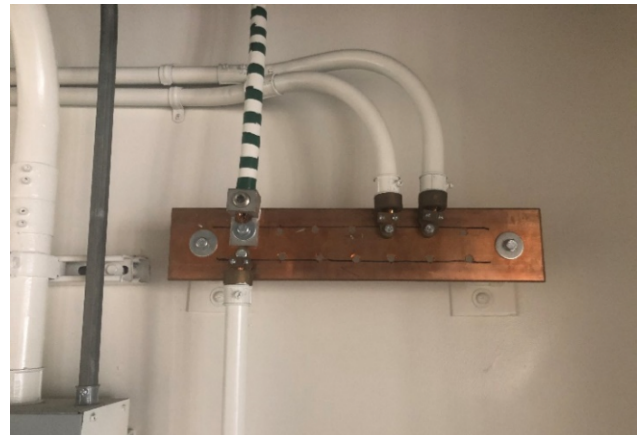
*Photo courtesy of J. Montross
Ground Bus with grounding connections*

At this one point at the service, all ground connections are made and are connected to ground by the grounding electrode conductor. The grounding electrode can be comprised of (if available) buried metal water pipe, metal in-ground support structures like building steel in direct contact with earth or that is an extension of a ground connection in the building footing, rebar in the concrete footing, ground rods, and buried copper conductors. Anything making a connection to earth is an electrode, but the code permits only these and a few other items.
