Stray & Contact Voltage Case Studies

IEEE Working Group January 2008, San Antonio

Craig D. Frommelt PE, CPQ, CEM AmerenCILCO

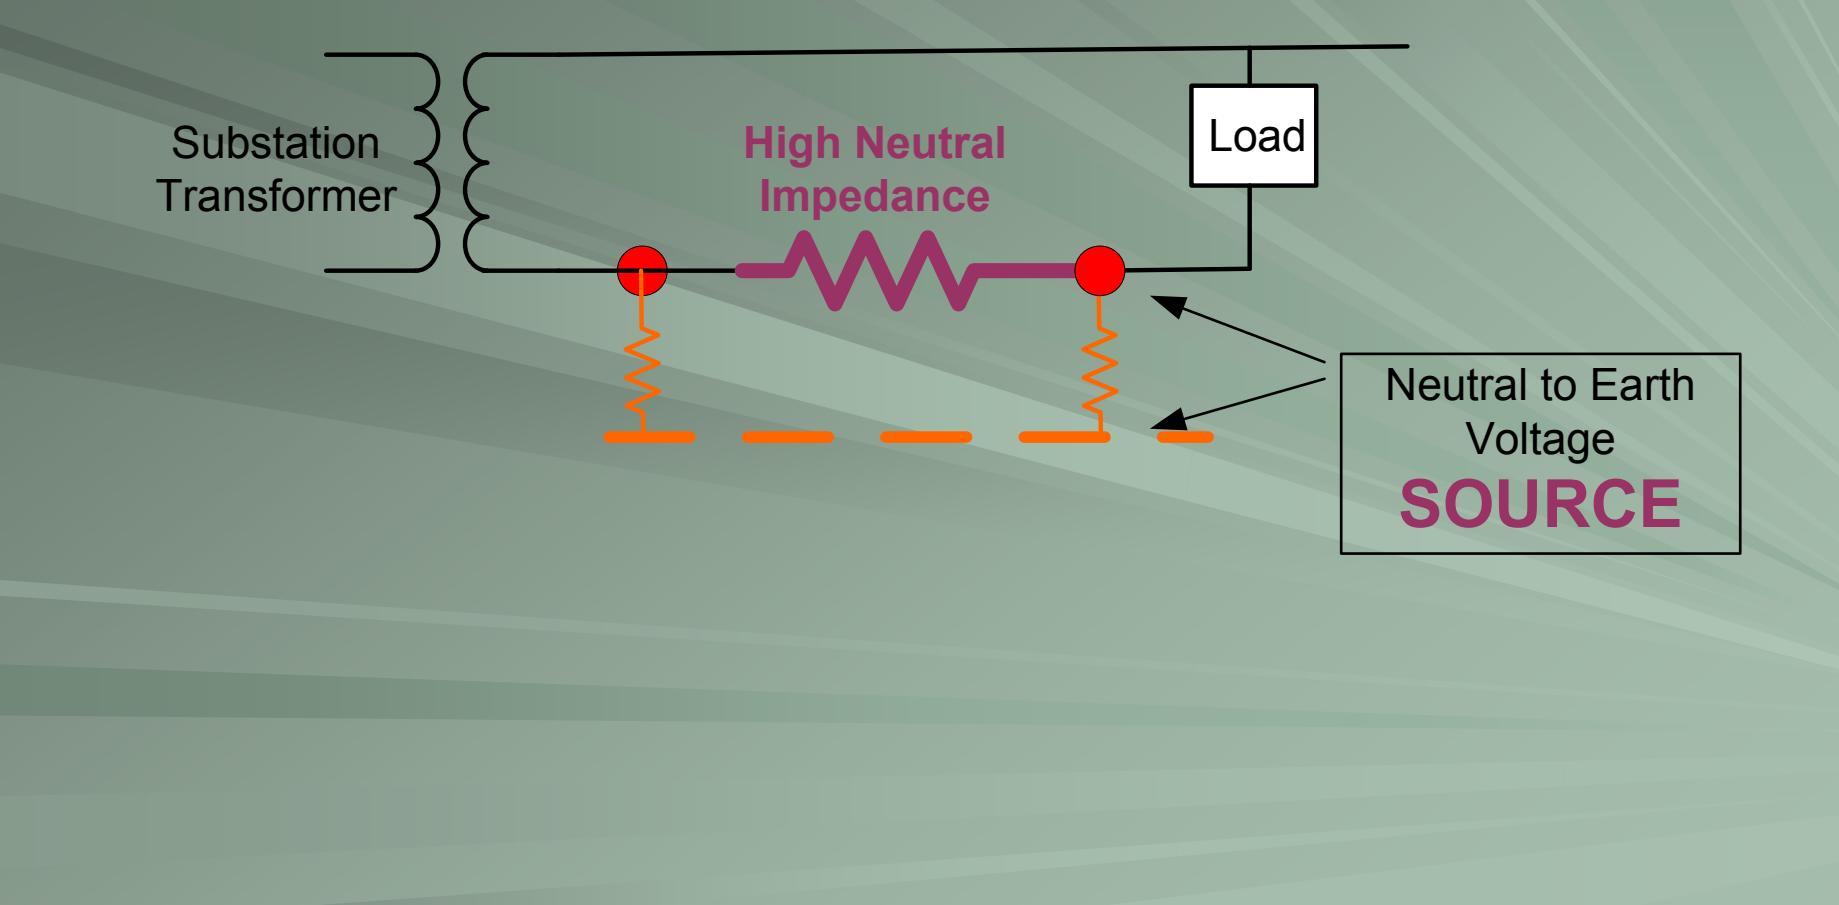
Problem Cause (Classification)

- Location is near end of 1-ph Tap, distant from Substation.
- Significant 1-ph loads downstream of this customer.
- Stray voltage measurable at neighbors, but no complaints from them.
- Previous reports from Construction of URD cable neutral corrosion in this area.
- Impractical to replace all of this URD Cable, as not failing yet. (We do not replace due to neutral corrosion)
- Verified that lifting the Service Neutral fixed the problem.

Case #1 - Outdoor Faucet Remedial Actions Taken: - Installed 2nd ground rod near Customer Meter (Impedance went down, Current went up, No Voltage Change) - Installed 2nd ground rod at Pad Transformer (No significant affect)

Case #1 - Outdoor Faucet Remedial Actions Taken: – Installed 2nd ground rod near Customer Meter (Impedance went down, Current went up, No Voltage Change) – Installed 2nd ground rod at Pad Transformer (No significant affect) Learning what DOESN'T WORK

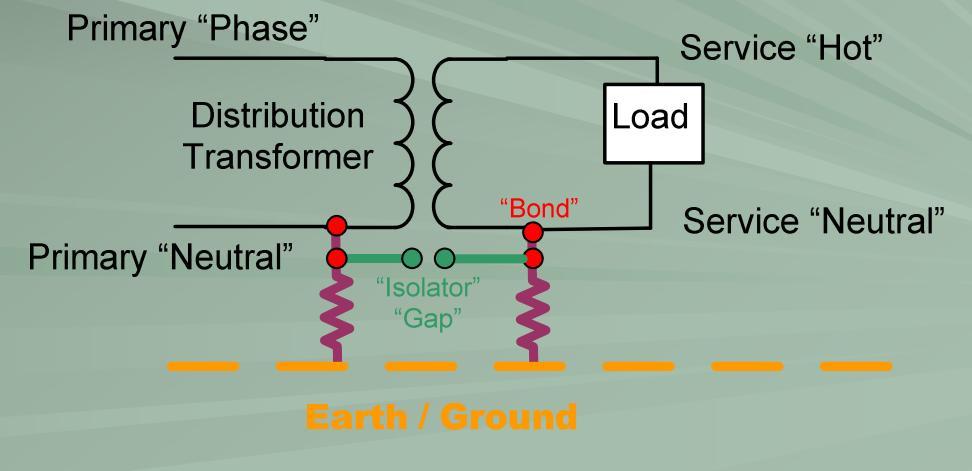
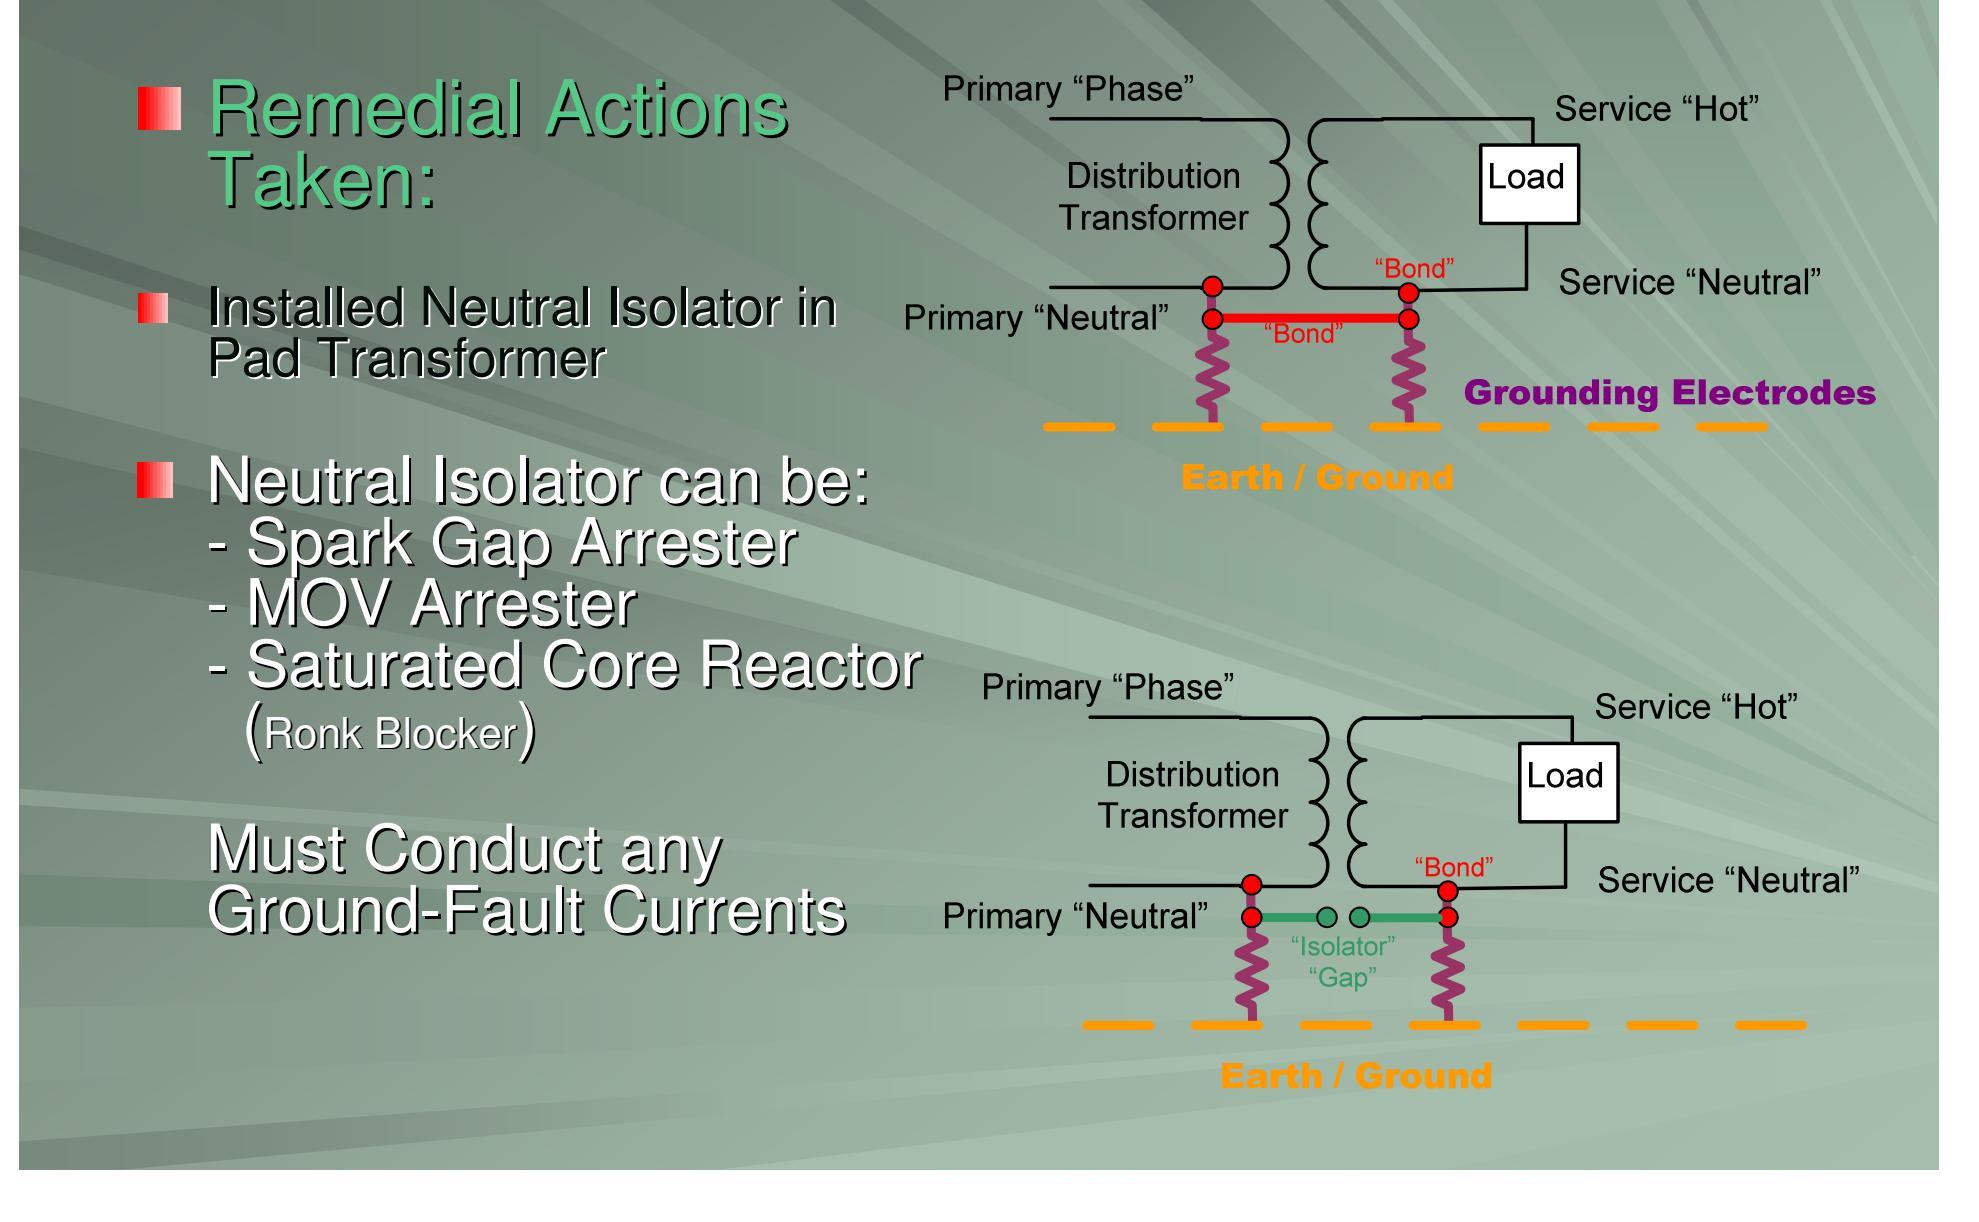
- Voltage reduced to less than 1.0 VAC.

Installed Neutral Isolator in Pad Transformer

– 120/240 Volt
 MOV Arrester

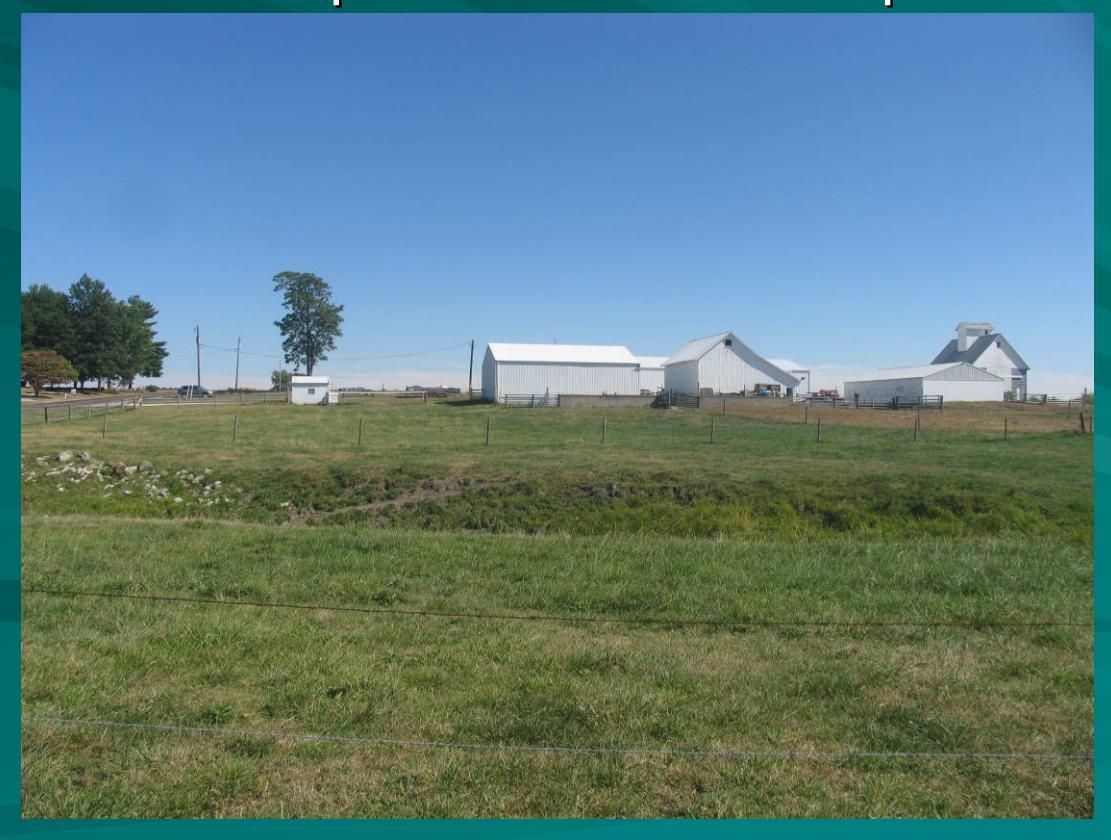
Case #2 - Basement Shower Engineering Diagnostic Actions & Findings – Inspected neighbor's farm operation, no farm house – Farmer showed-up and offered to help

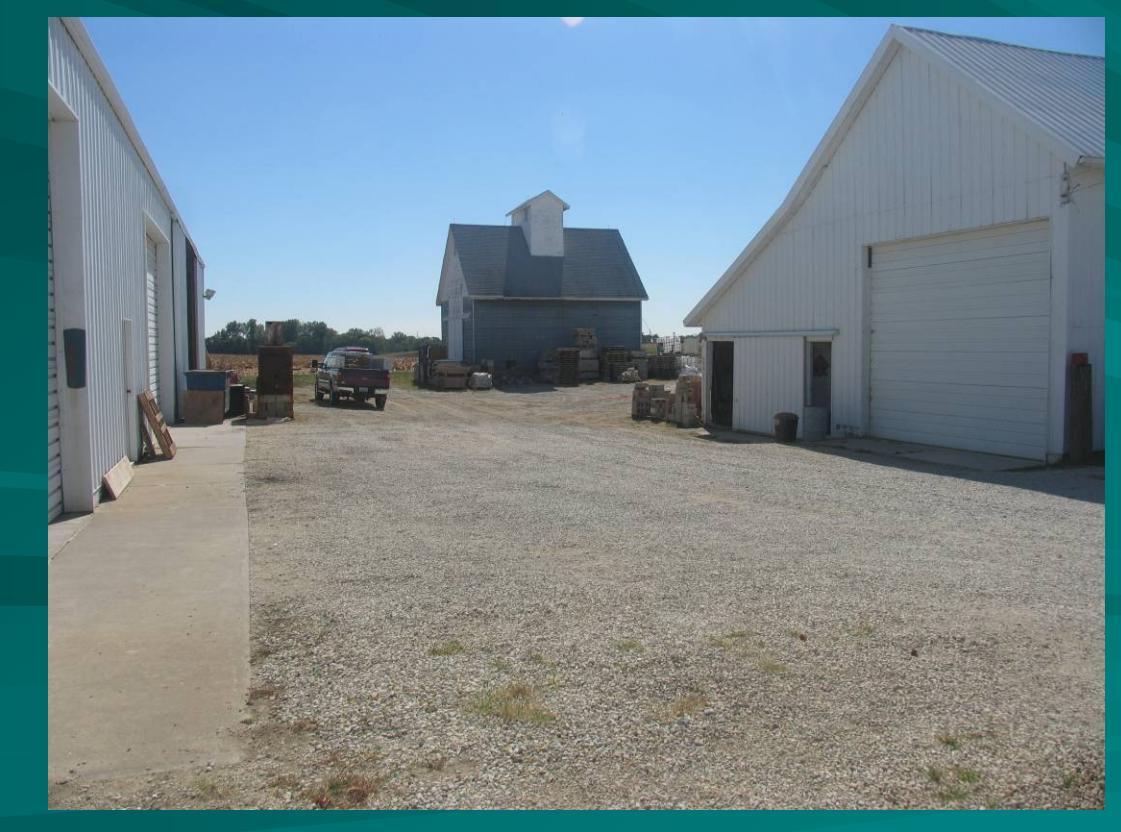
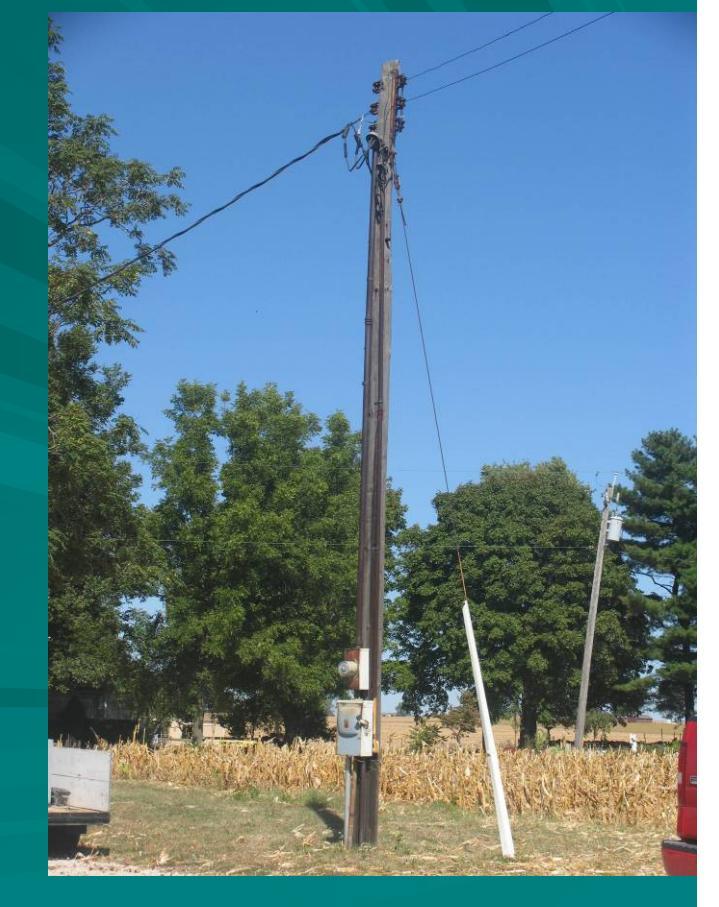
4 branch circuits from meter pole

Engineering Diagnostic Actions & Findings – Customer suggested overhead circuit, which had been torn down by a combine, and reattached by the farmer.

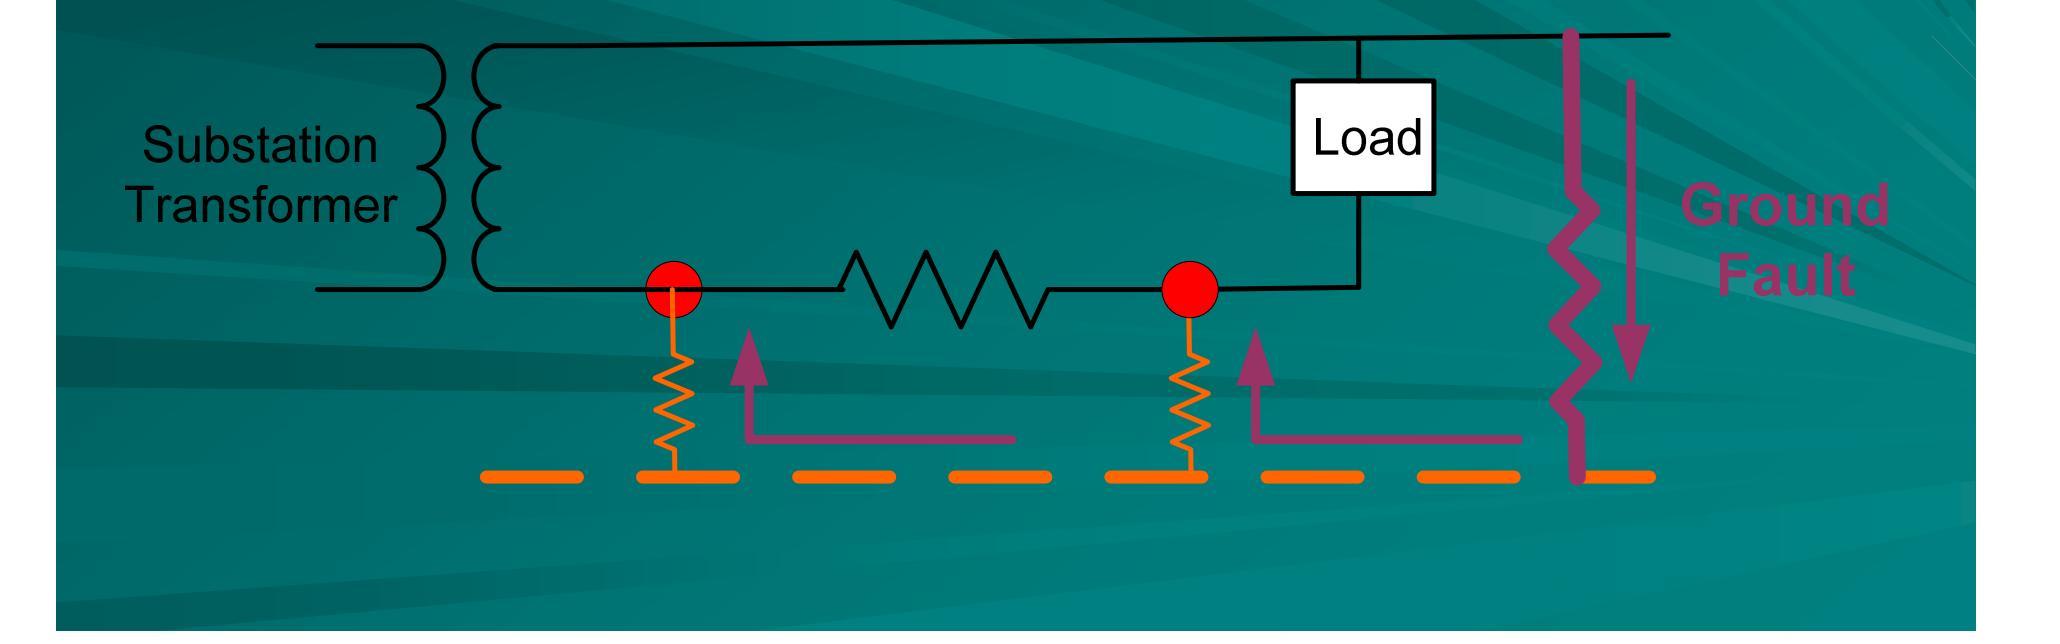
Problem Cause (Classification) Ground Fault

Initially investigated as a "Stray Voltage" type complaint
 Due to underlying cause, this would be classified as a "Contact Voltage" issue.
 The miswiring constitutes an ABNORMAL system condition.

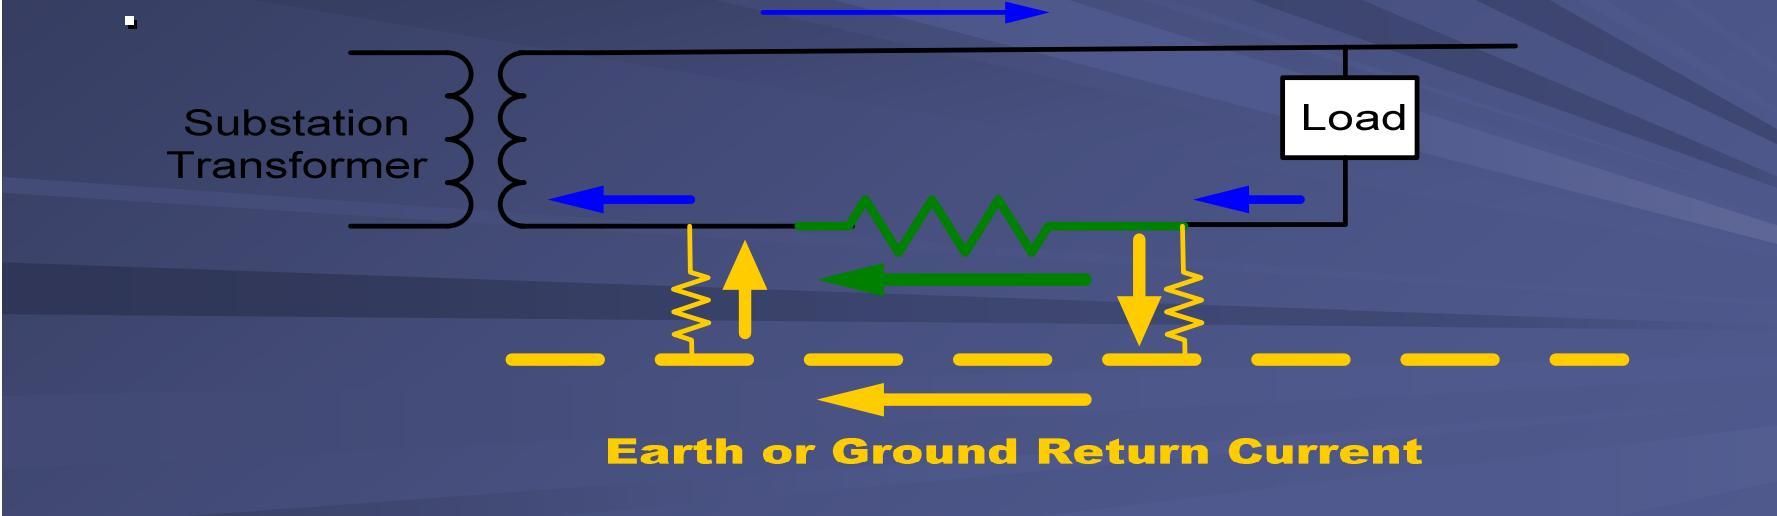
Problem Cause (Classification)

- This was not a Utility problem

- It represented NORMAL electric operation
- Nothing for us to fix.
 This is a Customer Problem.

Nothing for utility to fix.
 Neutral isolation would not fix problem.
 Not practical to run 3-ph for 1.5 miles to balance and thus cancel earth return currents
 Left our 'temporary' bonding conductor in place, so customer could verify our findings

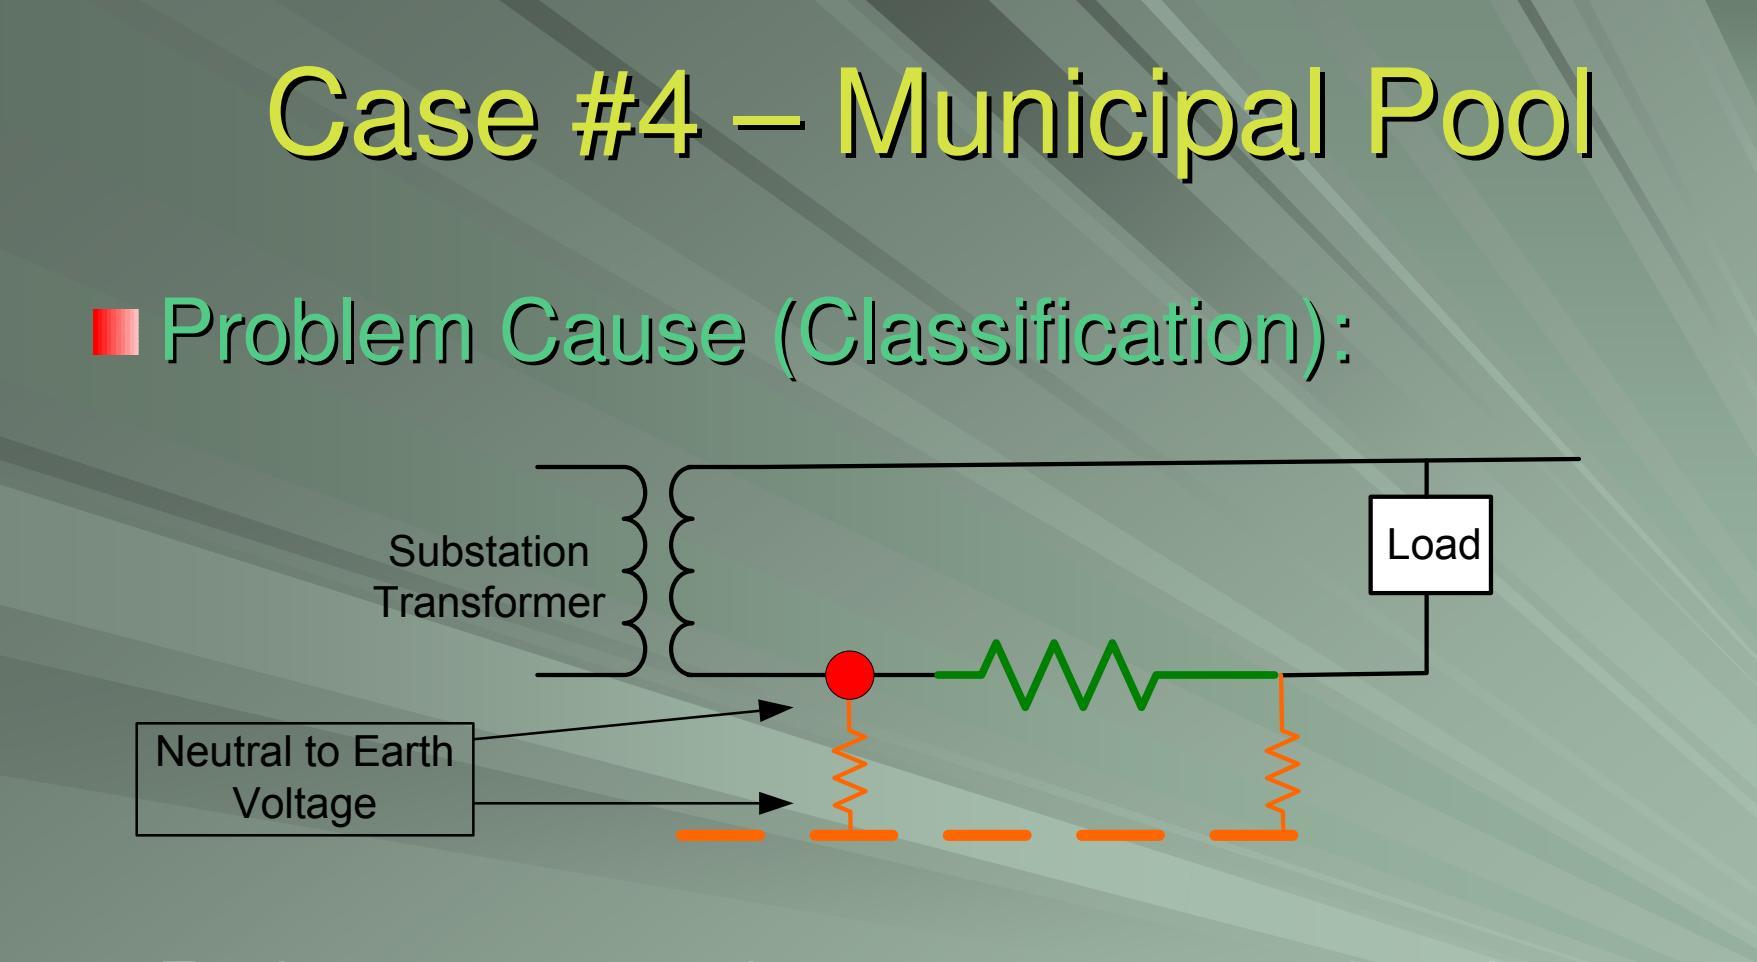
Remaining voltage was measurable, but not a safety hazard and likely not noticeable in 'dryer' locations

Earth currents returning to neutral near substation

Good candidate for "Fix the Symptom"
 Recommended installing a Neutral Isolator
