# **Residential Electrical System Aging Research Project**

## **Technical Report**

July 1, 2008

Prepared by:  
David A. Dini, P.E.  
Underwriters Laboratories Inc.

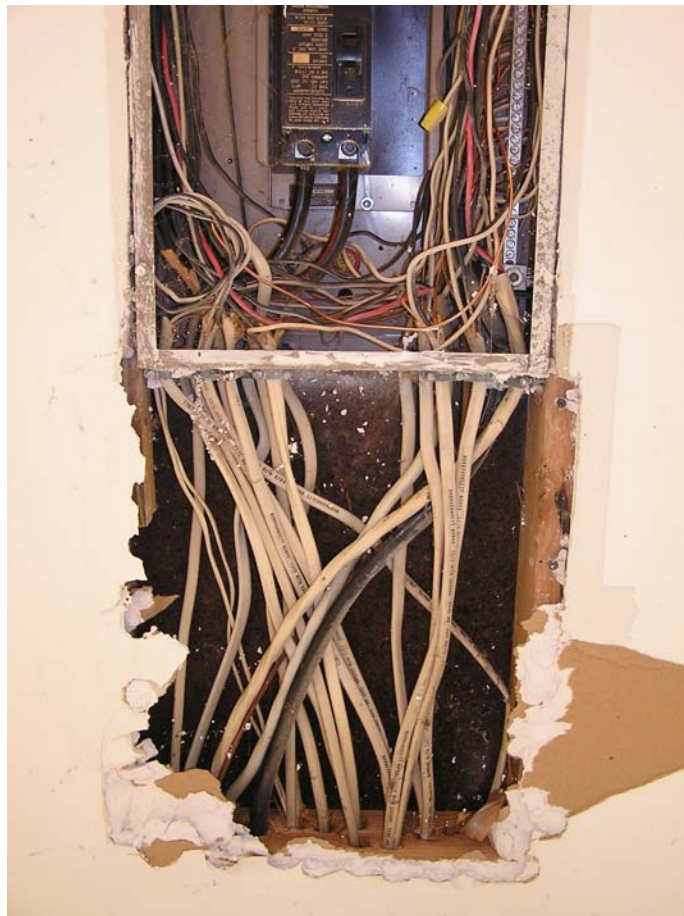
Fig. 6 – NM Cables From House VA-3

To determine the dielectric properties of the recovered nonmetallic cable, two approximate two-foot lengths of the cable were used for test purposes. With one sample, the dielectric potential was applied between each conductor (line-to-line). With the other sample, the dielectric potential was applied between the conductors and a one-foot piece of aluminum foil that was tightly wrapped around the approximate center of the cable jacket. For nonmetallic cables with a grounding conductor, the foil and the grounding conductor were connected. For each sample, the dielectric potential was raised from 0 to 5000 Volts at a rate of 500 Volts per second, and then maintained at 5000 Volts for one minute. All of the NM cable samples that were tested from all of the houses passed the dielectric test line-to-line and line-to-ground without breakdown at 5000 Volts or less.

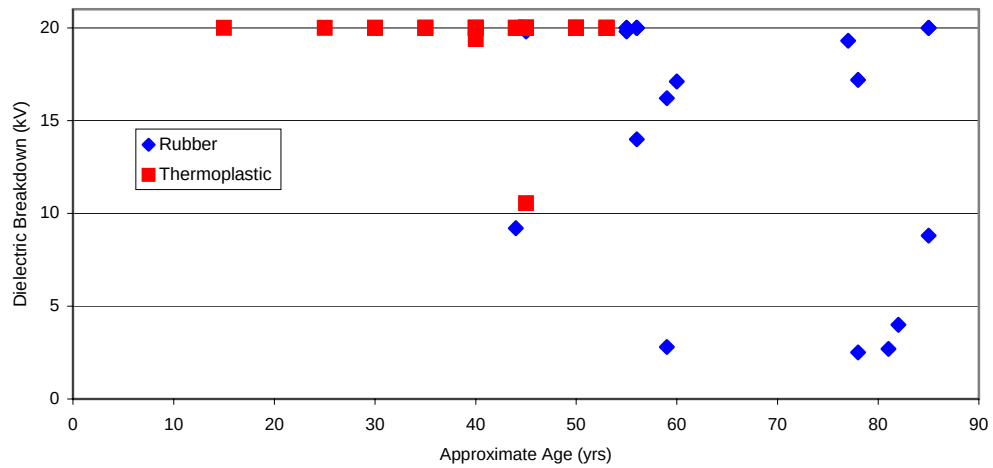
Fig. 1 - Dielectric Test Results vs Age

The trends clearly showed a reduction in dielectric strength and bend strength with age; however, this may have been largely due to the inherent property characteristic differences between older rubber insulations and newer thermoplastic insulations. In general, thermoplastic insulations performed very well with age. Figures 1 and 2 from that study are shown here for reference.

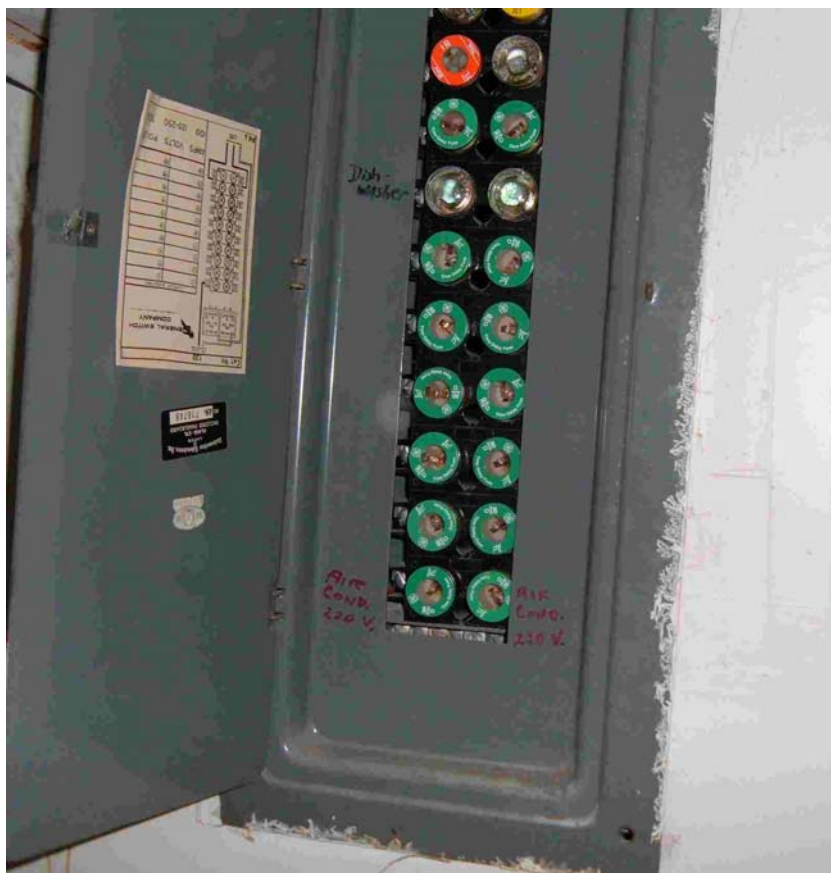
Fig. 12 – 30 Amp Fuses From House AL-8

All of the recovered fuses calibrated properly within the allowable time at the required test current.
