Investigation of the Electrocution on the Town Street Bridge in Columbus, Ohio on May 22, 2003

City of Columbus 90 West Broad Street Columbus, Ohio 43215

John Loud, MSEE, Principal Engineer Exponent Failure Analysis Associates 149 Commonwealth Drive Menlo Park, California 94025

Date: June 24, 2003

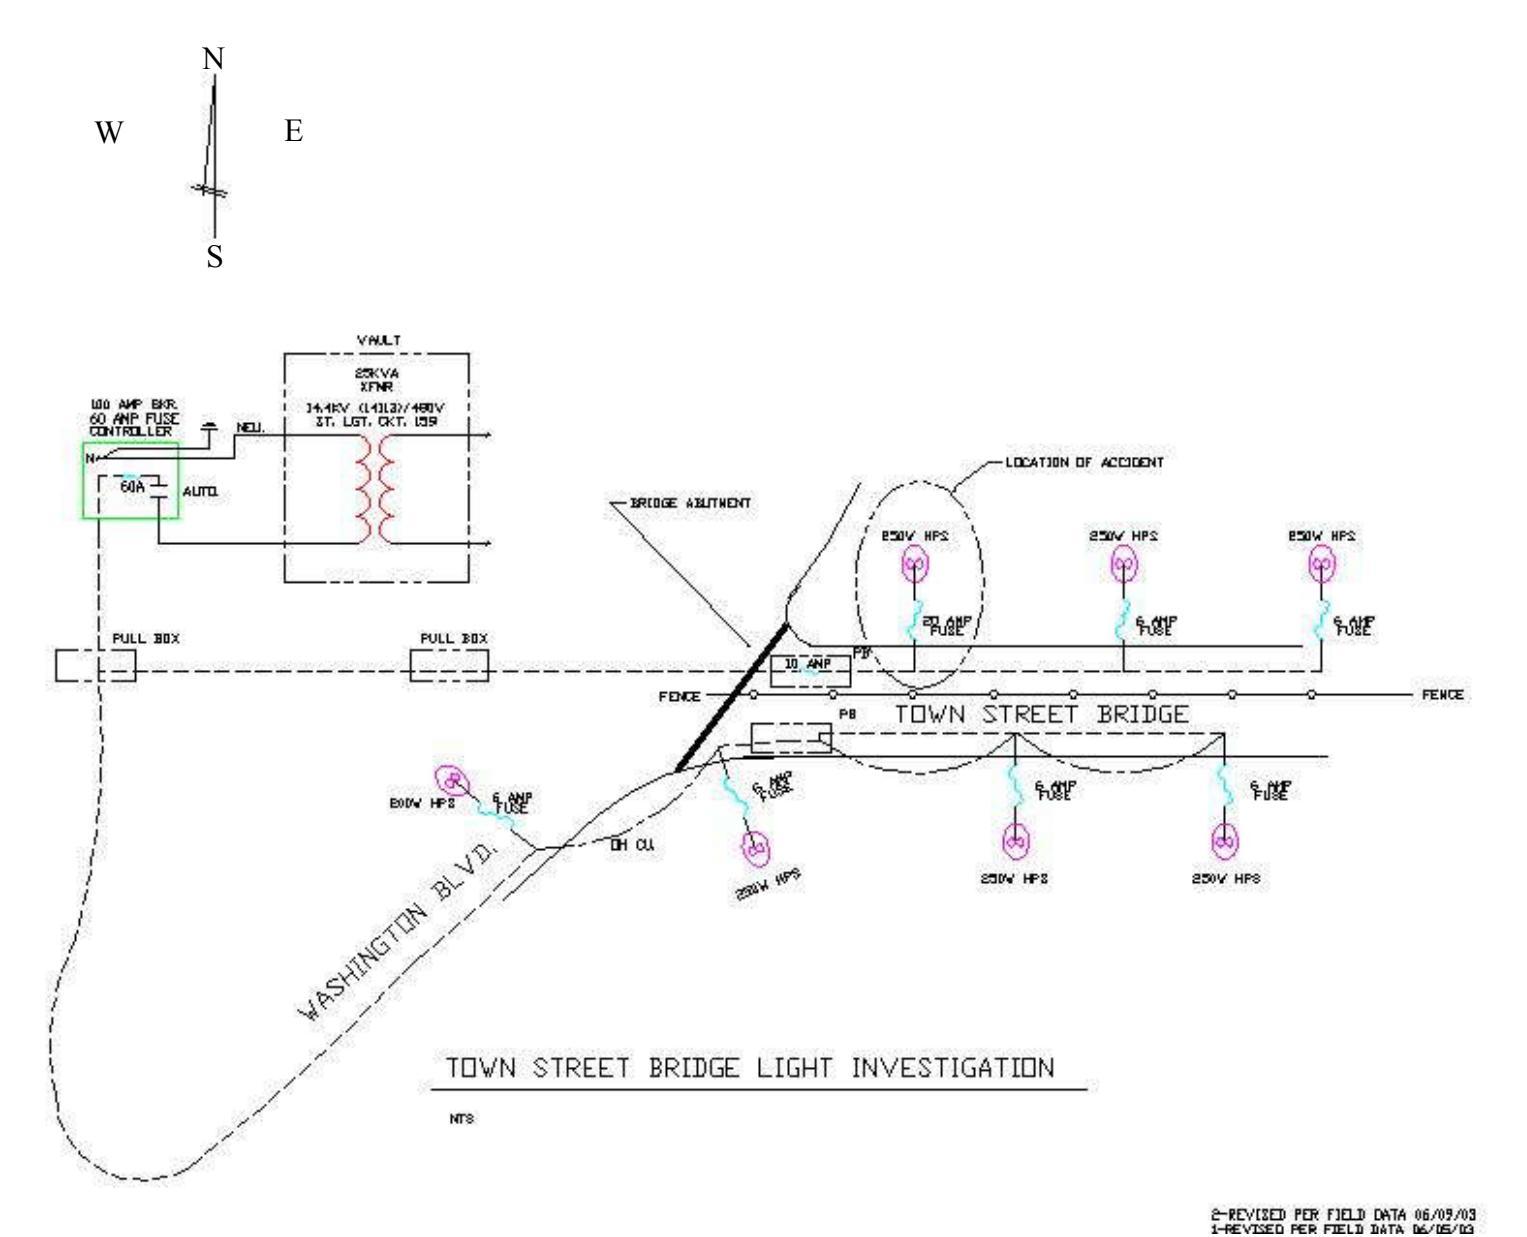
A physical wiring diagram, showing the approximate routing and relative locations of the 480-volt bridge lighting circuit, was received from DOE personnel and is presented in Figure 3 below. A survey of the fuses on this lighting circuit was conducted and the results are included in this drawing. The incident light was the only light that was found to have an incorrect fuse – it was fitted with a 20-ampere fuse instead of the specified 6-ampere fuse. While this value exceeds the specified fuse rating for this application, the 10AWG-sized conductors are permitted to be fused up to 30 amperes. The routing of the neutral conductor is not shown on the drawing.

Figure 3. Electrical drawing showing the 480-volt power to the Town Street Bridge.

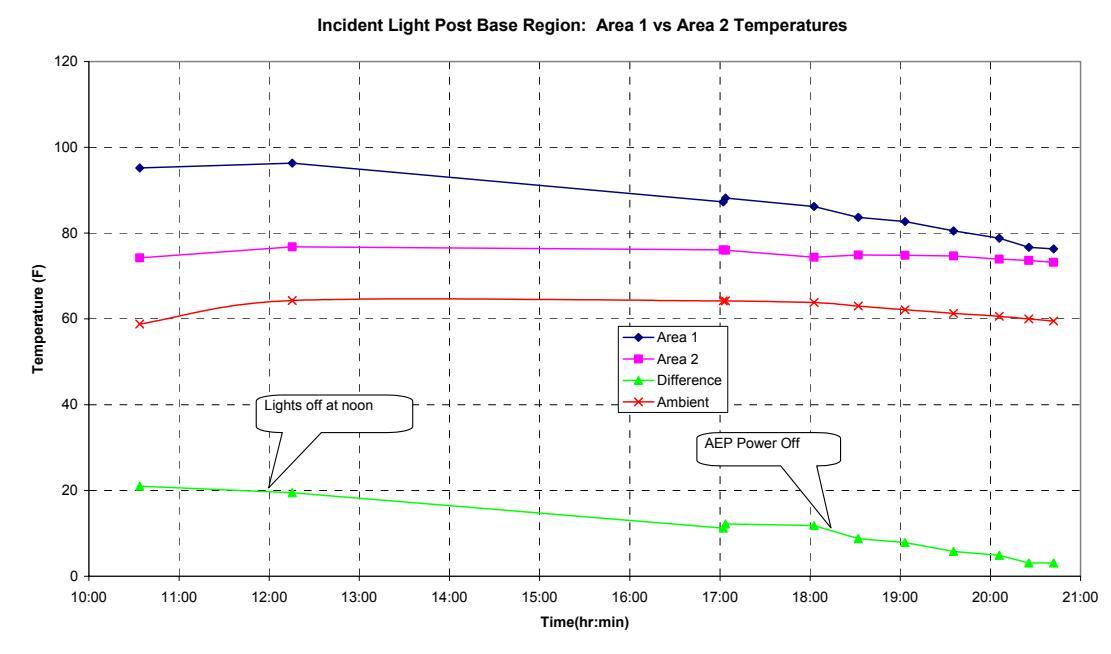
Figure 14. Area 1 and Area 2 average temperatures as well as ambient temperature with respect to time, starting the morning after the incident.

It is observed that the ambient temperature increased between the first readings at approximately 10:30 and the reading at 12:15. A slight increase was observed in the Area 2 temperature in this interval, but no increase in the Area 1 (already elevated) temperature. The temperature difference was calculated and plotted to show the trend between the heated region surrounding the incident light pole and the surrounding bridge. A temperature difference of 20°F at about 10:30 had dropped to only a few degrees just over 10 hours later at 20:40.

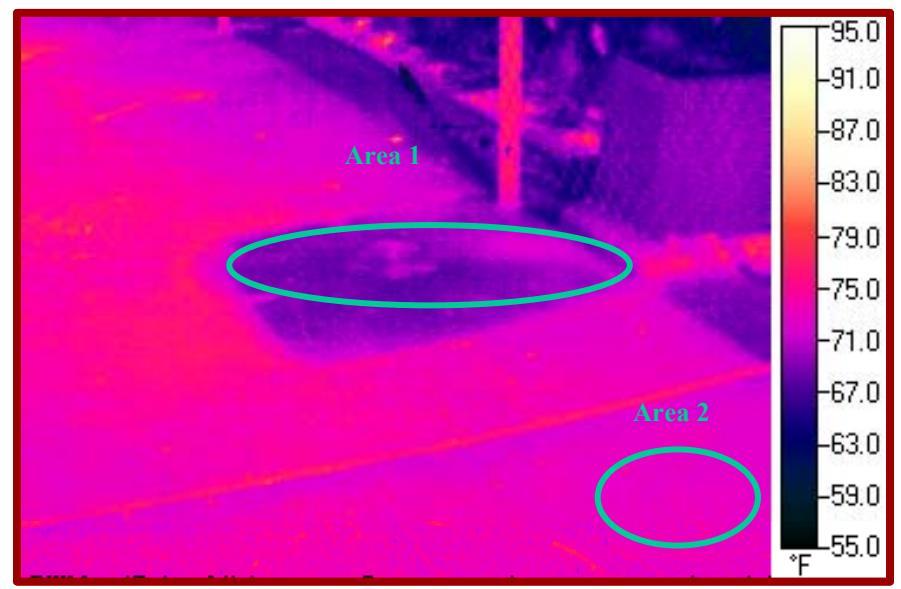
The new concrete patch substantially altered the thermal and electrical properties of the bridge in the incident region. A thermal image of the patch just after it was applied is shown in Figure 18.

Figure 18. May 28, 2003 at 09:46 just after the concrete patch was applied.

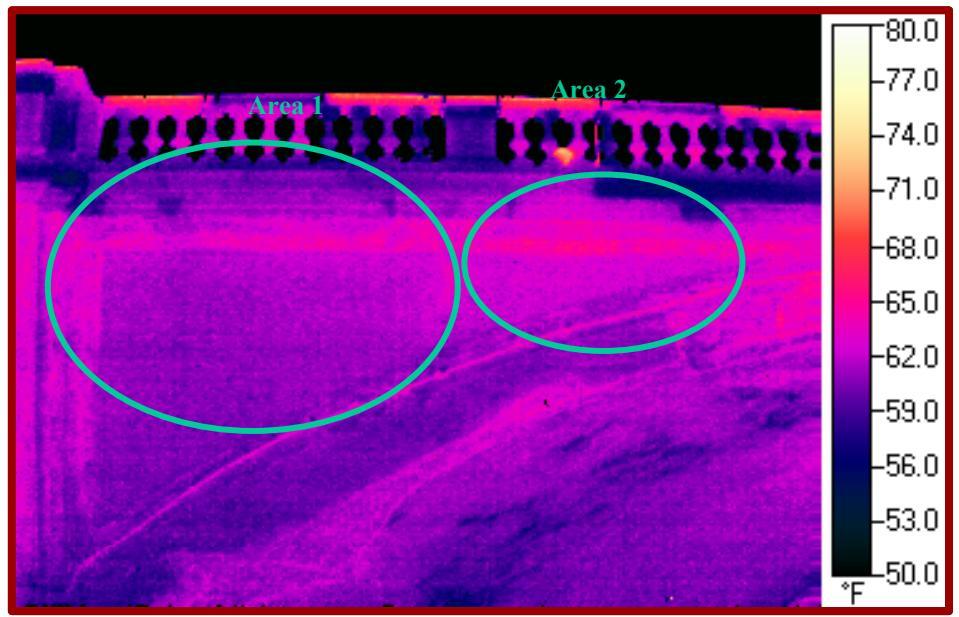
Thermal image of bridge taken on June 5, 2003 at 00:03:43 just after the power was turned off in this 2 $\frac{1}{2}$ -hour heating test. Note that there was no noticeable heating to the bridge supporting structure as had been observed long after the incident.

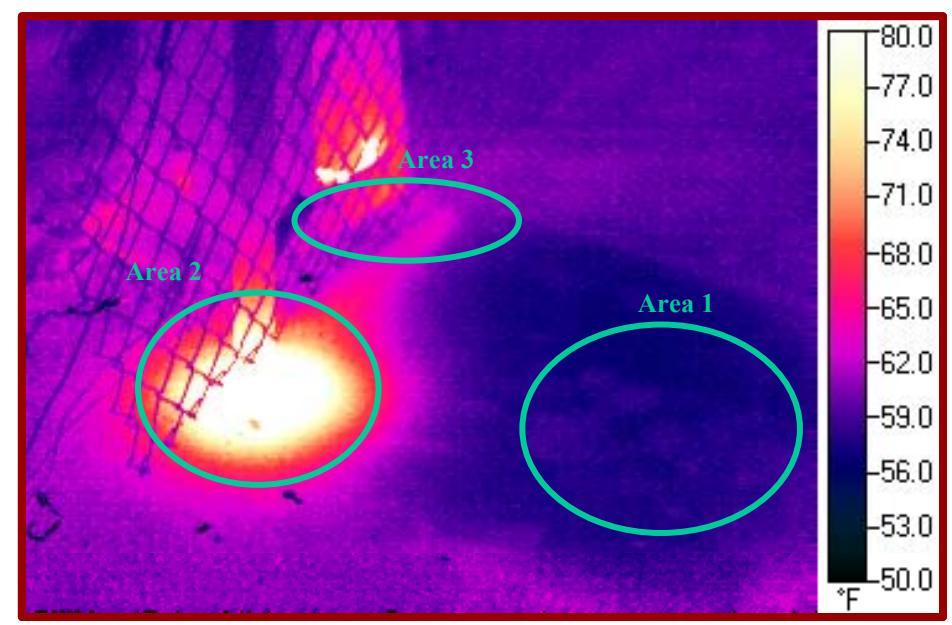
Figure 21. Thermal image made on June 5, 2003 at 00:01:24. Area 1: 56.6°F, Area 2: 113.3°F, and Area 3: 68.1°F.

The resistance of the fault path through the bridge was substantially lowered due to the addition of the new concrete patch. A lower resistance fault path resulted in increased current being conducted into the bridge and a correspondingly higher power being dissipated in the bridge during this test as compared to the expected values prior to and at the time of the incident. The heating on the wire and nut would also have been higher reflecting this increased current. Despite this increased power being dissipated in the bridge during this test, no heating was observed to be present in the region surrounding the fault region as was clearly evident the morning after the incident. Note also that no heating was observed below the bridge as shown in Figure 20.

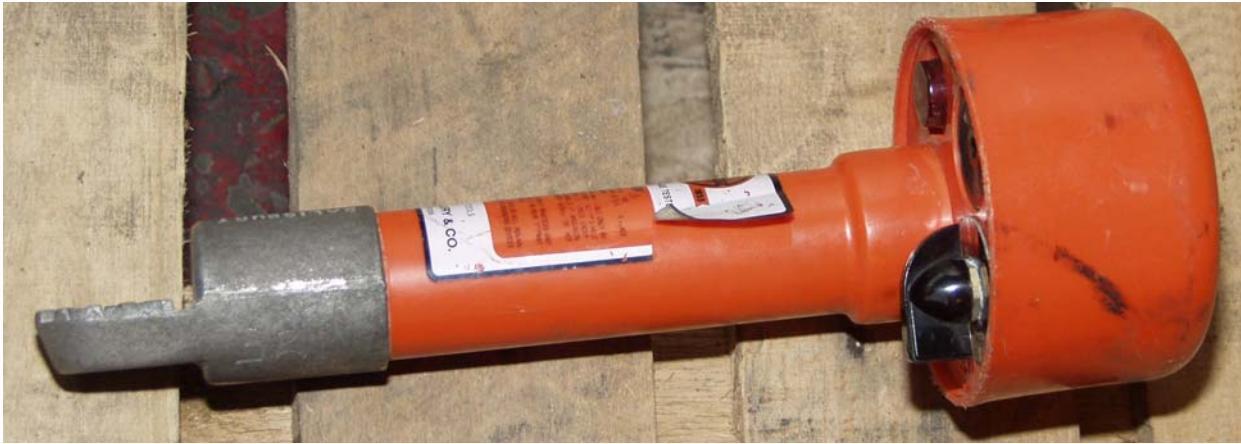
Testing was performed to determine whether the AEP measurement could be used to conclusively show that there was a voltage present on the incident light post after the incident. The tester used by AEP personnel is shown in Figure 22. It was tested and found to correctly indicate voltage on a 480-volt conductor some distance from the conductor as shown in Figure 23. A similar light post was connected to ground through a 100 Ω resistor to approximate the path to ground of the incident light post when it was measured by Exponent. A 480-volt wire inside the exemplar light post was not detected by the Salisbury tester when no light was being powered by the conductor. The hot and neutral conductors were run through the similar light post and then the light was powered. The Salisbury tester was found to indicate in excess of 250

Figure 22. The AEP Salisbury non-contact voltage sensor. P6047953.jpg

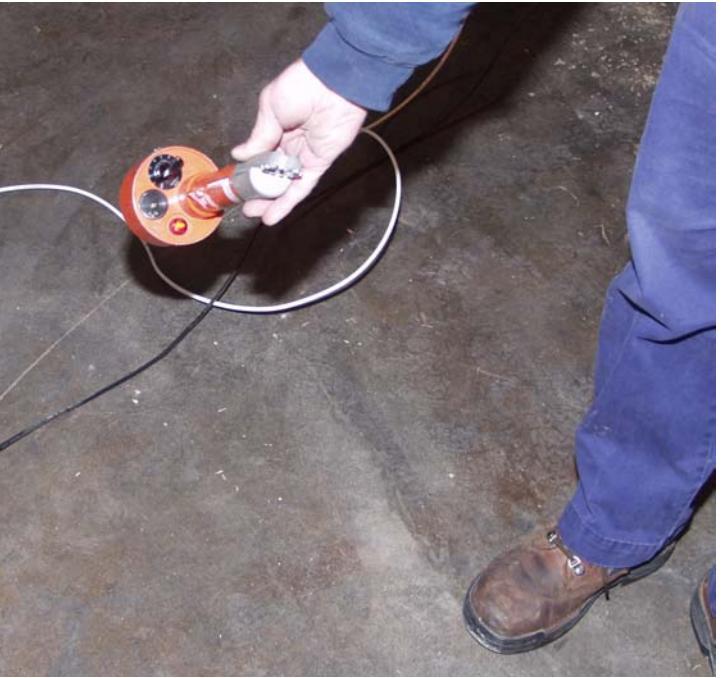
Figure 23. The AEP Salisbury tester sensed greater than 250 volts about 18 inches from the live 480-volt conductor. P6047961.jpg

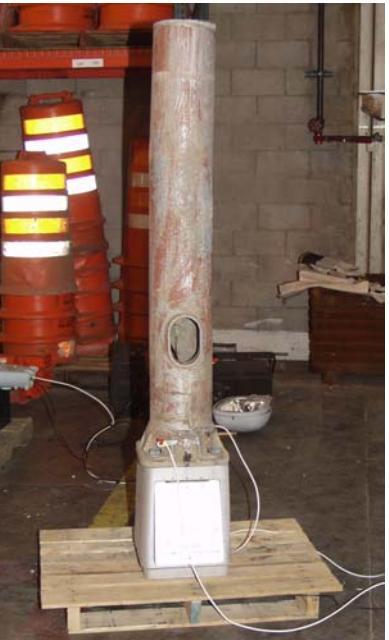
Figure 24. Salisbury tester experiment performed with an exemplar light post. P6047958.jpg

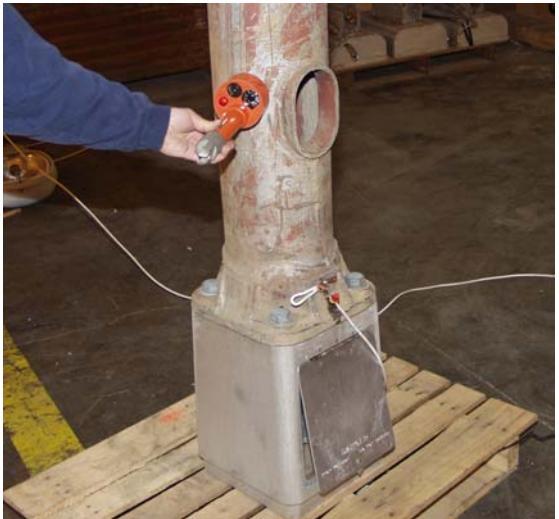
Figure 25. Salisbury tester measured voltage inside the similar light post when a light was powered from the line and neutral conductors that were routed through it with the light pole tied to ground through a 100Ω resistor. P6047962.jpg

This testing shows that no absolute conclusion can be drawn from the reported AEP observation that their Salisbury tester indicated that more than 250 volts were present on the incident light post immediately after the incident since testing has shown that it may have been sensing the power on the internal wires. Subsequent clarifying questions posed to AEP failed to result in

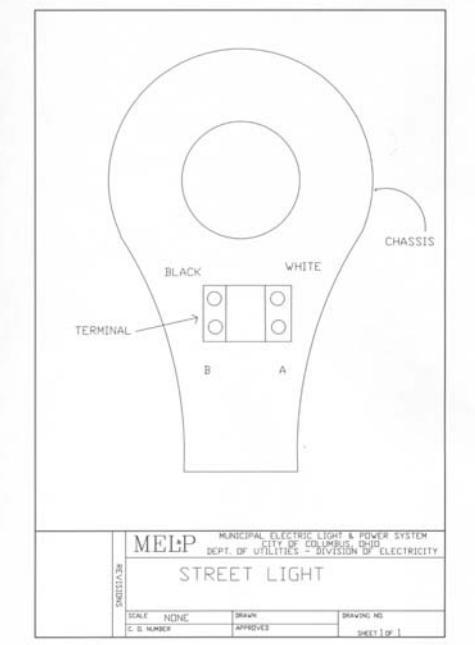
The incident light fixture was tested using a megger on June 13, 2003 by DOE personnel. It was tested at both 500 and 1000 volts DC. The measurements between the line and neutral conductors with respect to the lamp metal housing are summarized in Table 1 below. The points tested are shown in Figure 26.

Figure 26. Street light fixture drawing.

This testing shows that the light fixture in the incident light post was not likely a source of power to the incident light post housing.

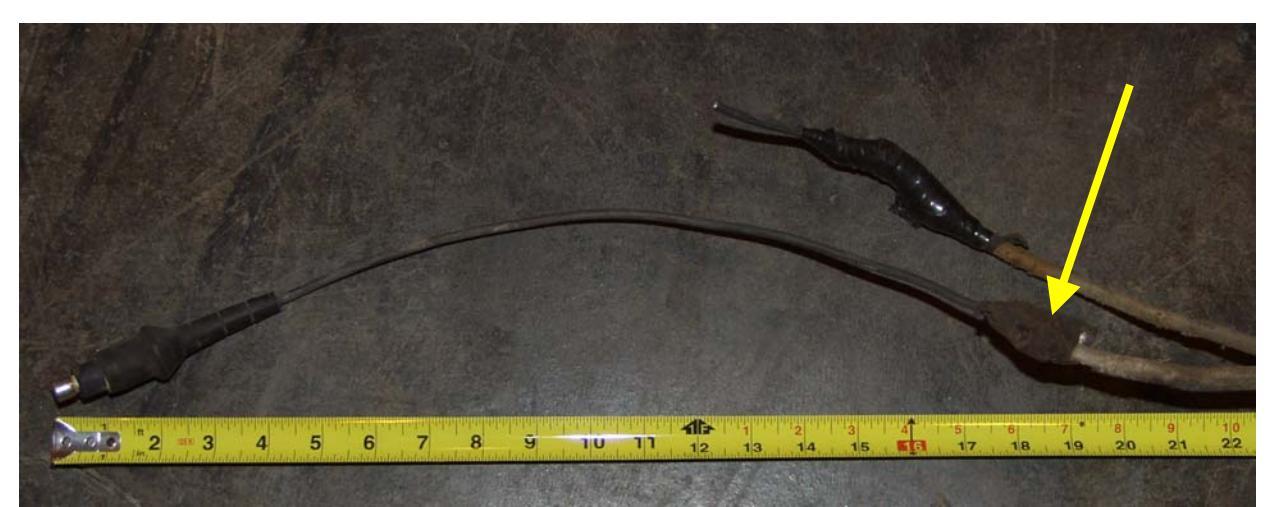
It was also observed that a neoprene splice, in the 480-volt conductor, had a hole in it (Figure 33). It was not initially readily apparent where this splice was at the time of the incident, except that it would have been in the base of the incident light post (Figure 32). An ohmmeter measurement confirmed that the visible material inside the hole was the 480-volt conductor. A laboratory examination and removal of this neoprene insulation revealed no evidence of electrical arcing or faulting on the internal crimp splice as shown in Figure 34.

Figure 32. The location of the neoprene splice. P6027770.jpg
