DC Voltage Induced Pinhole Piping Leaks

Gary R. Gabriel PE

Johnson Controls

The point of this paper is to offer design strategy to reduce the risk of pinhole piping leaks. In practice, once the pinhole leaks show up, it is too late for design changes to do any good. By then, the only answer is to replace the entire piping system. Often a failed copper or steel piping system is replaced with plastic pipe.

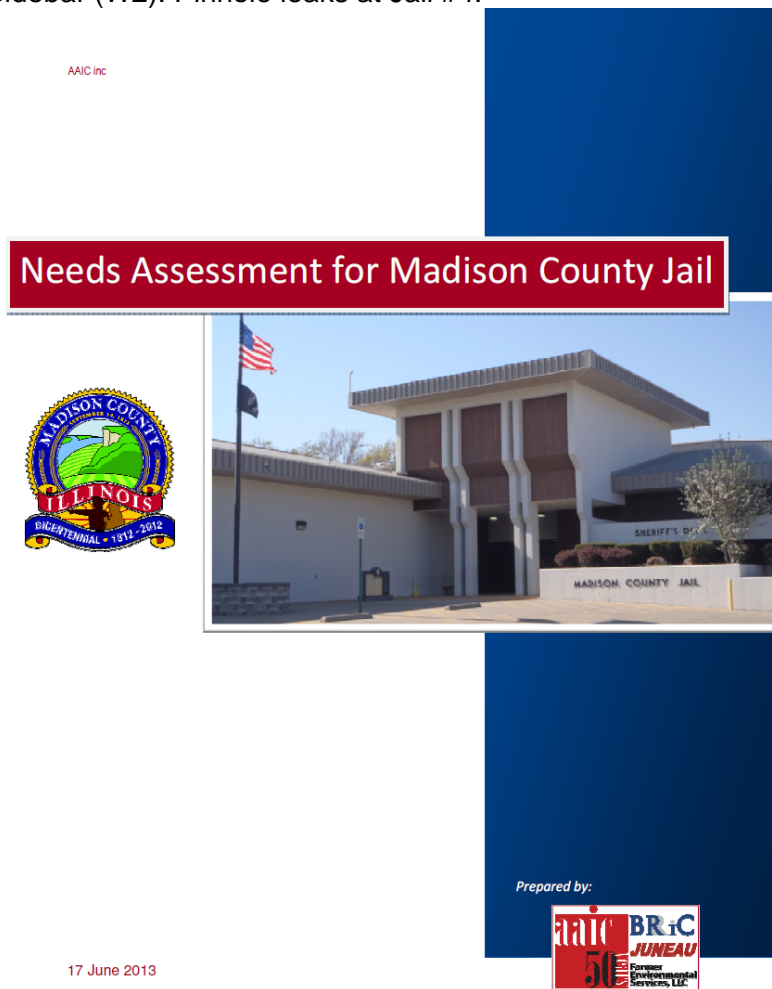
Figure (W2a): A view of the cover page for the 2013 report.

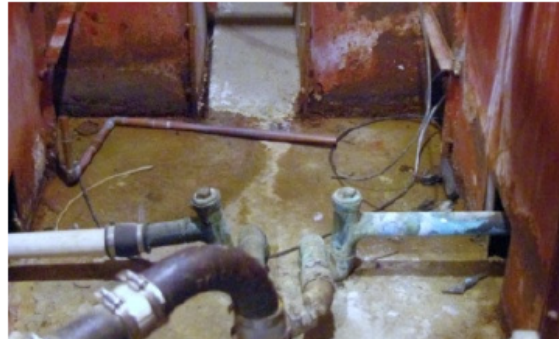
The domestic water system piping is comprised mostly of copper piping. There are some areas where galvanized steel piping was observed. It has been documented that the water supply from the City of Edwardsville contains microbes that can lead to the deterioration of water piping systems. It has been observed the copper piping will develop pin hole leaks which is the result of microbial influenced corrosion or MIC. We did witness where repair have been made and also witnessed areas where calcification at piping joints exists.

Deficiency: Many of the electrical water heaters are beyond their useful life. Electrical heating elements within the water heaters corrode and fail quickly. In part this may be due to the presence of microbes as well as overall water quality. If a cell block water heater fails, the cell block will be without hot water. The operational expense of electric water heaters is much higher than for high efficiency gas fired water heaters.

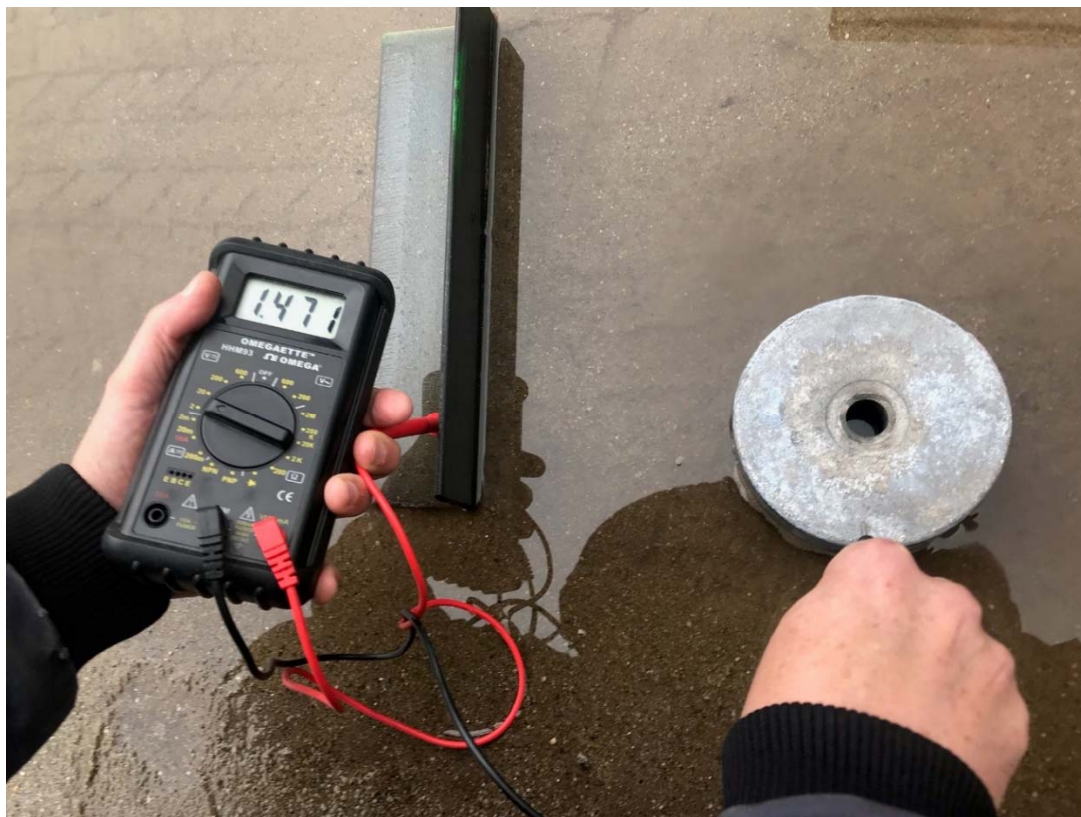
Figure (S1c): A view of a magnesium anode and a section of 2" steel angle iron (in a puddle) in an unpaved parking lot. The Omega volt ohm meter indicates 1.47 volts DC. This is the galvanic potential of magnesium above steel (magnesium at nominal 1.6 volts and rusted steel at nominal 0.13 volts). This magnesium anode is designed to be bolted into a chiller head. In practice the magnesium anode sacrifices to protect the cast iron chiller head.

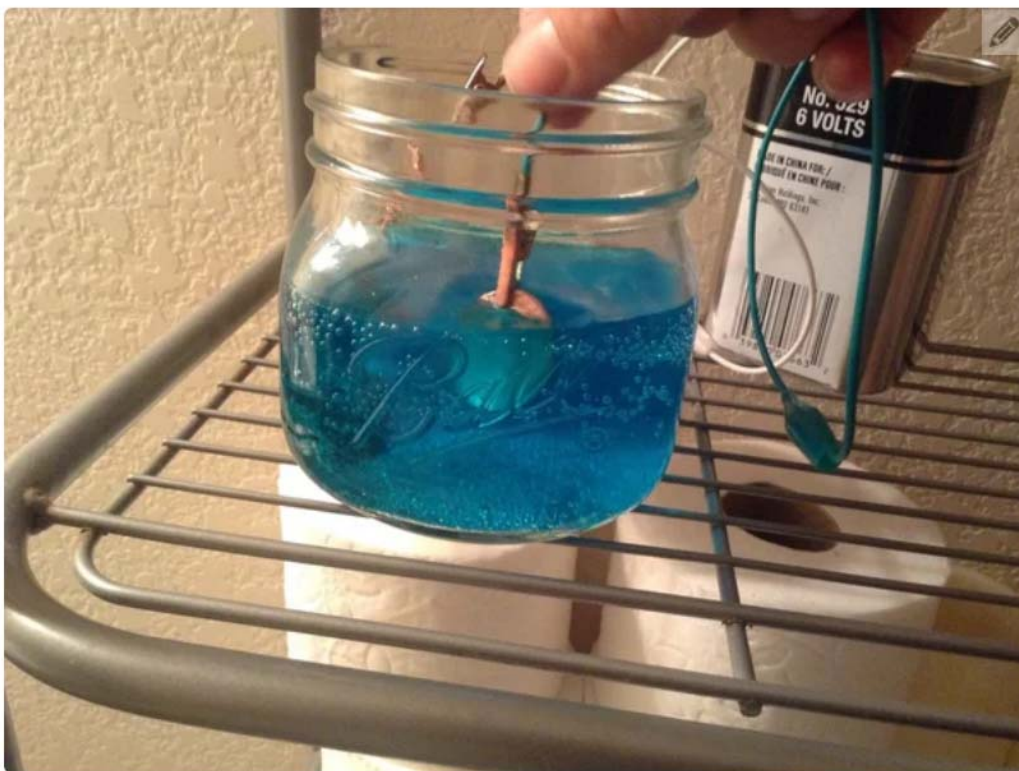
Figure (S2a): A view of the coin plating in action. A copper pot scrubber is used as the donor. The quarter is the recipient. A dry cell 6 volt DC battery is the driver. Note that AC (Alternating Current) will not cause metal transfer (AC will not cause pinholes).

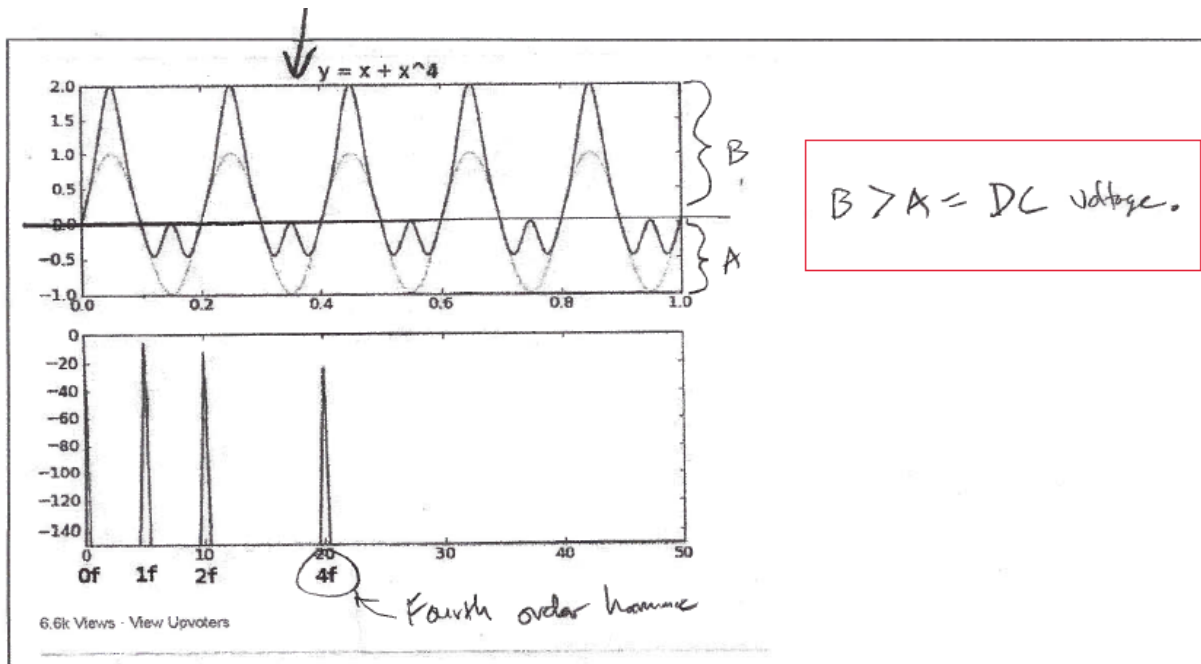
Figure (S3c): Another view of even order harmonics. Even order harmonics are not symmetric about the null axis. This creates the DC signature that is passed to the earth ground.

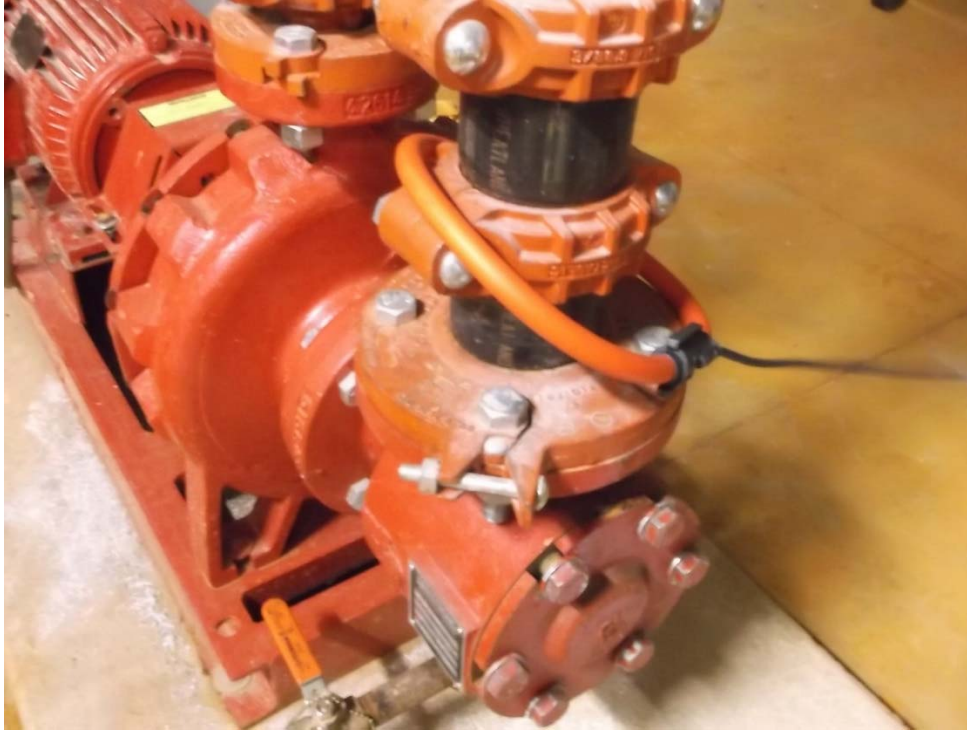
Figure (T1b): A view of the inductive donut sensor used on the HVAC piping (at the HVAC loop pump).
