Michigan Stray Voltage Protocols

Keith G. Tinsey, P.E., Truman C. Surbrook, P.E., and Jonathan R. Althouse
Agricultural Engineering Department
Michigan State University

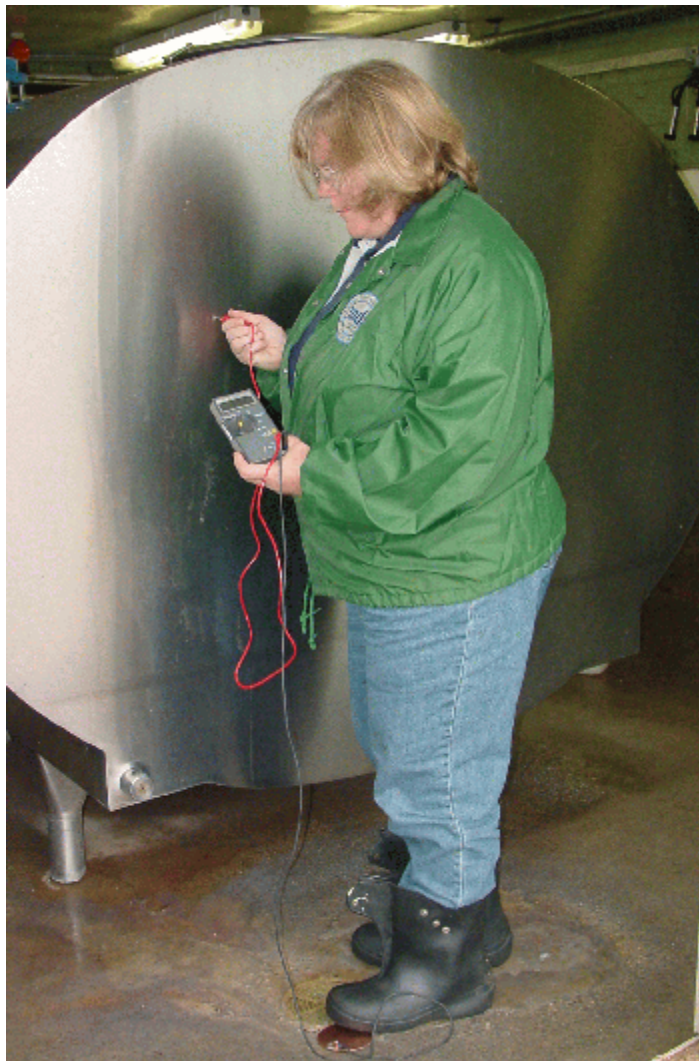
Figure 1 The electrical safety check program involved an open circuit voltage measurement from the milk tank to the concrete floor or floor drain.

The voltage measurements taken between the milk tank and the floor in the milkhouse were open circuit voltage measurements. It is a common practice at times to take a neutral-to-earth voltage measurement with a resistor with a value of approximately 500 ohms across the input of the voltmeter (shunt resistor). Taking neutral-to-earth voltage readings using a shunt resistor requires special training and can lead to measurement errors. All of the voltage readings taken as a part of the electrical safety check program are open circuit voltage measurements without the use of a shunt resistor. Open circuit voltage measurements are equal to or higher than measurements taken at the same location using a shunt resistor. A high open circuit voltage does not necessarily mean there is a safety problem, but this type of measurement is highly reliable at finding problems when they do exist.

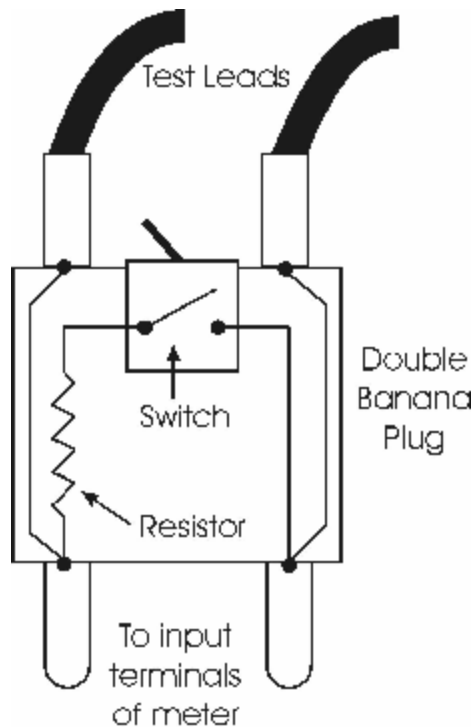
Figure 2 A double banana plug can be fitted with a 500 ohm resistor and a switch to make it easy to take an open circuit voltage and a shunted voltage reading at a livestock contact location.
