Stray Voltage Troublshooting Tips for Electric Utility

An orderly and systematic approach to Stray Voltage (SV) and Neutral to Earth (NEV) investigations ensures appropripate handling of customer inquiries. The timely investigation of requests and the documentation of the results will result in maintaining customer satisfaction.

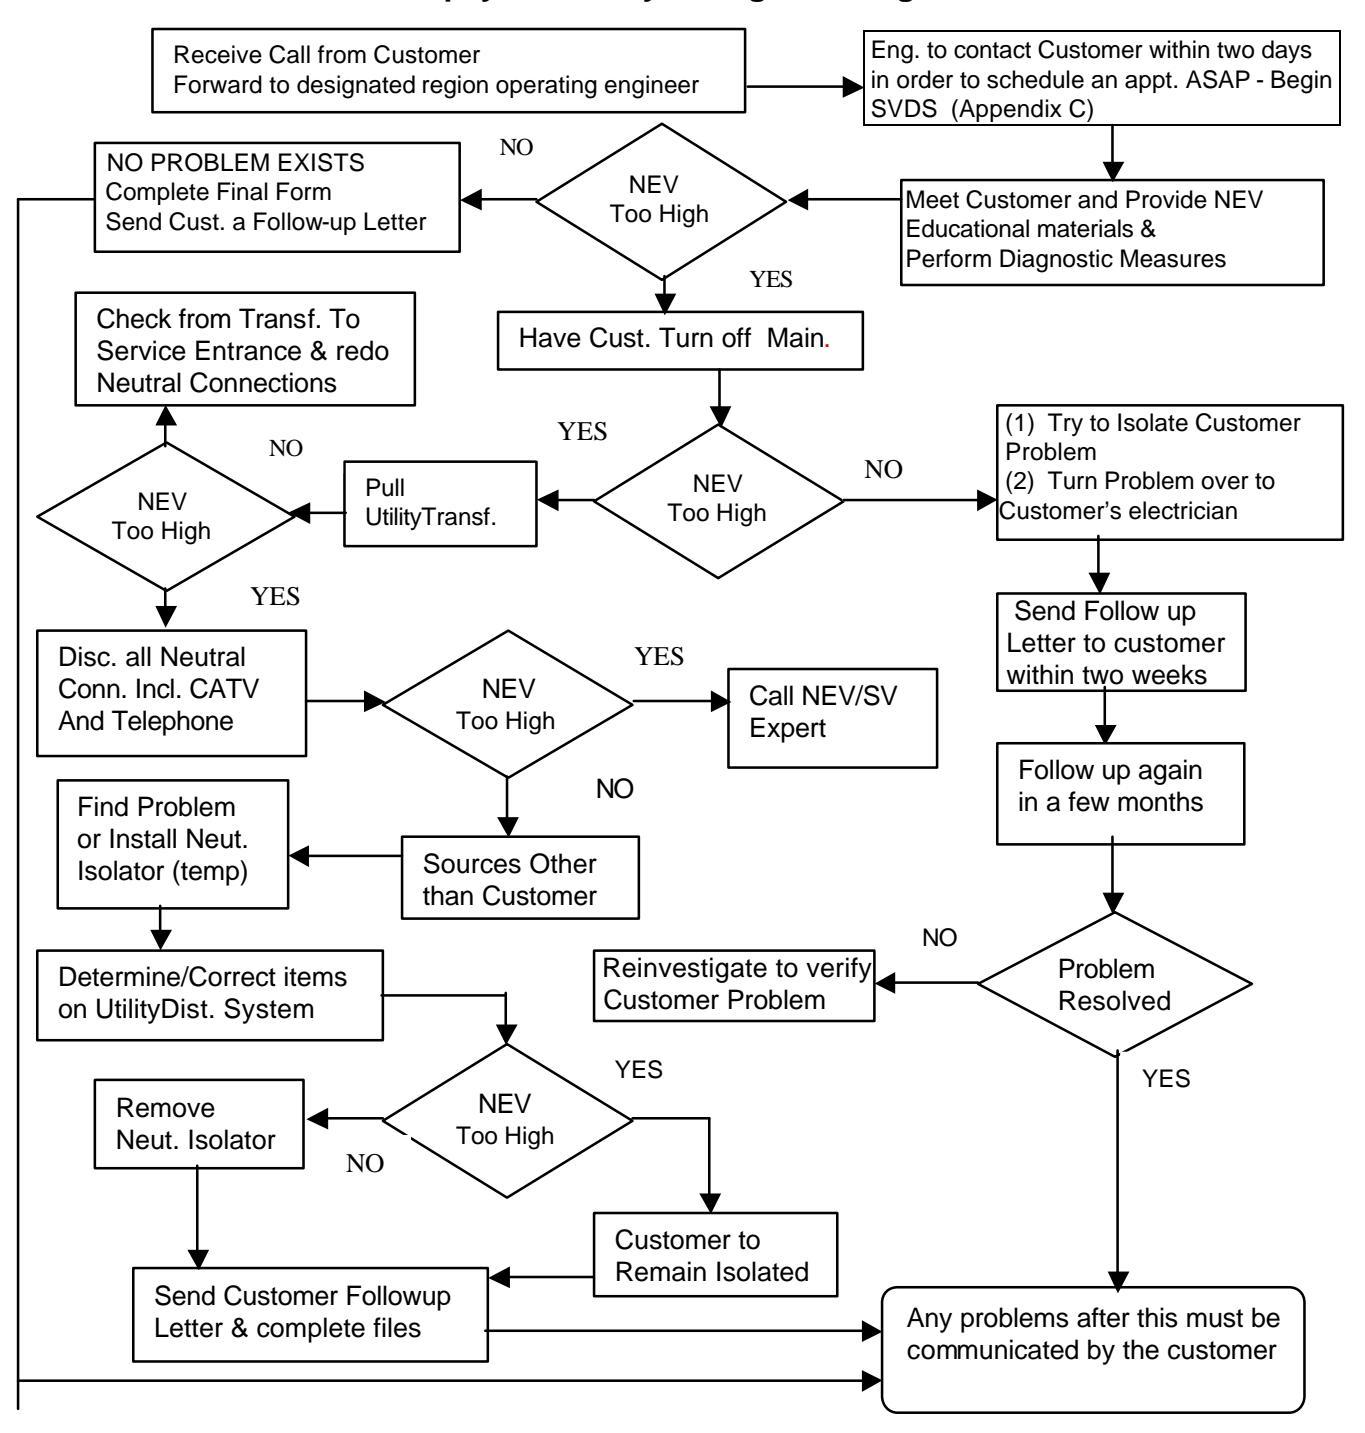
Power Compay NEV/Stray Voltage Investigation Flowchart

NEV/SV Investigation (See Appendix B Flowchart):

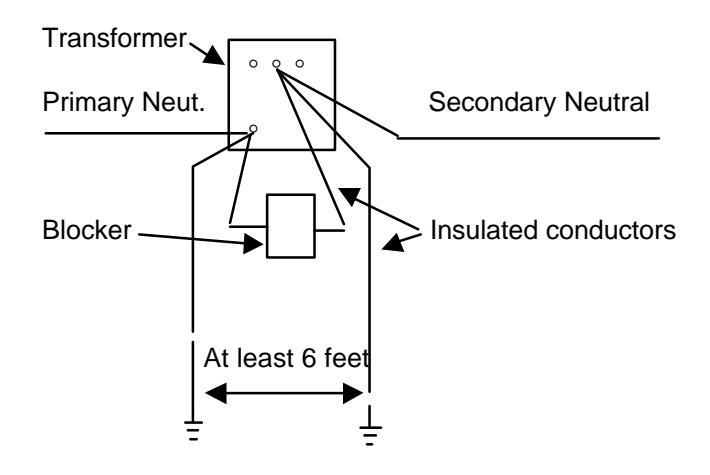
- 1. Ronk Electrical Industries Stray Voltage Isolator Blocker
 - P.O. Box 160 Nokomis, IL 62075-0160 Tel: 217.563.8333 Fax: 217.563.8336
- DEI (Dairyland Electrical Industries) Variable Threshold Neutral Isolator (VT/NI) P.O. Box 187 Stoughton, Wisconsin 53589 Tel: 608.877.9900 Fax: 608.877.9920
- A. Overhead Transformer Installation Diagram

- **C. Isolation** is the separation of the utility system neutral (primary side) from the customer (secondary side) neutral. Either a neutral isolator (blocker) or an isolation transformer can be installed. In the case of a blocker electrical separation does not occur unless telephone and CATV are also separated. Note that the telephone grounding MUST be separated on the primary side of the Utility transformer rather than the secondary side in order to comply with the NEC and to retain the best protection from lightning. The customer's neutral system may also require separation of sensitive animal areas from the rest of the system neutral (limited special case allowed by exception no. 2 of Section 547-8e. of the NEC.)

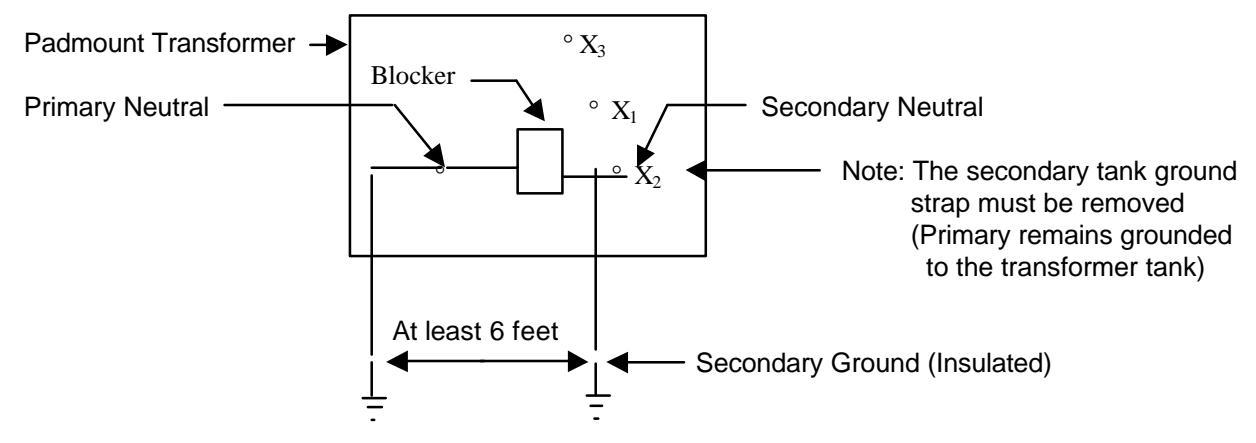
B. Underground Transformer Installation Diagram (The blocker can be installed either in the transformer cabinet or in a special pedestal/cabinet near the transformer. The exact location of the blocker will have to be determined in the field at the time of installation.)

Note: A sign shall be placed at each blocker location to indicate that the primary and secondary wiring to the transformer has been modified (on the pole near the blocker for overhead installations and inside the door at a practical location for padmount transformers). Typical Sign (provided by Corporate Distribution Department):
