**SPECIAL SERVICES INVESTIGATION**

**BRANCH/FEEDER ARC FAULT CIRCUIT INTERRUPTER  
INCORPORATING EQUIPMENT GROUND FAULT PROTECTION**

**Cutler-Hammer  
Technology & Quality Center  
170 Industry Drive, RIDC Park West  
Pittsburgh, PA 15275**

**Project 01NK12396**

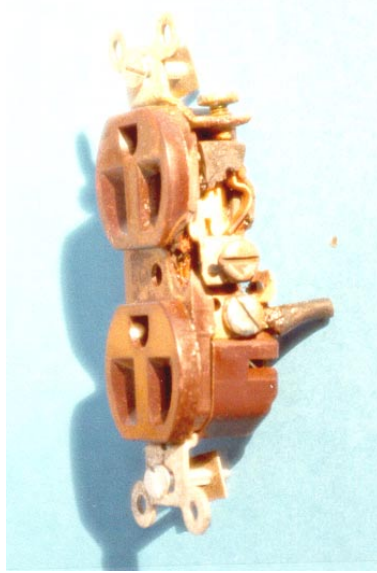
Figure 1 illustrates the damage to a receptacle caused by a glowing connection.

Figure 1 - A Receptacle Damaged by a Glowing Connection

A glowing connection is a loose electrical connection that has developed into a high-resistance connection. This connection is characterized by a point of intense heating. Several amperes through the connection can be sufficient to cause the connection to attain temperatures that cause a copper wire to glow -- hence the name glowing connection. A number of investigators have examined this phenomenon as reported below. Some have concluded that the glowing connection is the result of an oxide formation. Others have indicated that they believe "micro-arcing" to be the cause. It is quite possible that such micro-arcing precipitates the formation of an oxide boundary layer between the conductor and the head of the screw terminal. The semi-conductive nature of this boundary layer may then account for the glowing connection.

Having dissimilar metals in the connection like copper wire and a steel screw enhances joule heating. The heat from the arcing raises the temperature of the connection and within a few minutes, a low-pressure connection between the wire and the binding screw can begin glowing. Once established, a high-resistance terminal is fairly stable if it is not mechanically disturbed. The current through the high-resistance connection can be cycled without disrupting the high-resistance property. It will continue to glow when the current is high, but lower than the handle rating of a 15 A or 20 A overcurrent device.

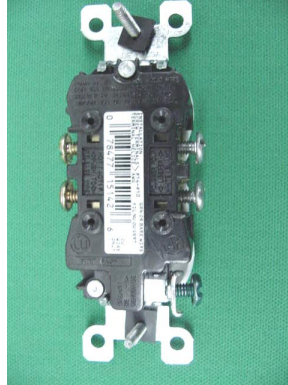
to use. Photos showing each type of wiring configuration are shown in Figures 2, 3 and 4. Figures 2 and 3 represent the same receptacle provided with both back wired push-in connections and side-wired screw terminals.

Figure 2 - Back-wired push-in

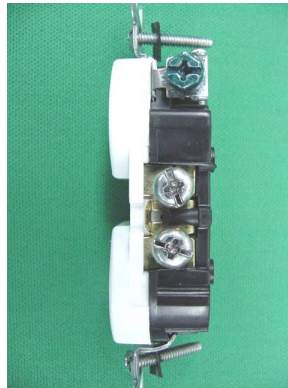
Figure 3 - Side-wired screw terminals

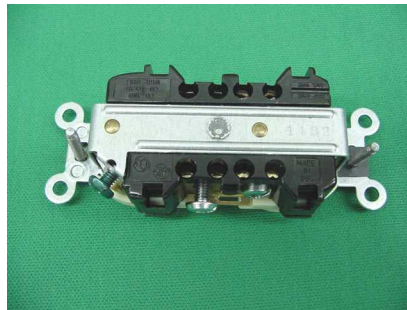
Figure 4 - Back-wired side clamp

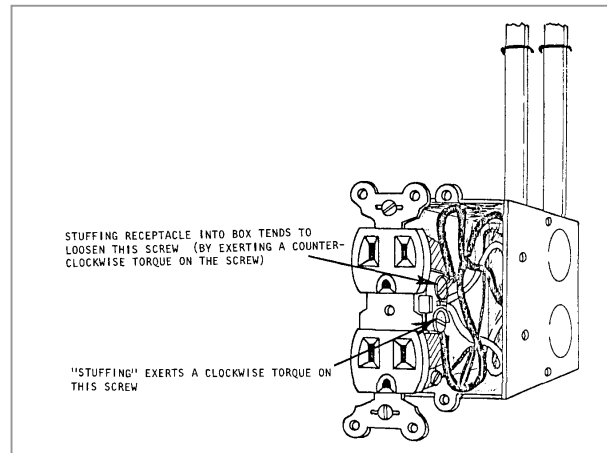
If the wire-binding screw is properly tightened when the building wire is attached to the receptacle, the wire-binding screw is intended to only hold the wire in good electrical contact with the terminal on the receptacle and the wire binding-screw is not a part of the current carrying path. However, in the event that the wire-binding screw is improperly tightened during connection, the screw may loosen if the receptacle is subjected to repeated vibration or other mechanical manipulation such as repeated plugging and unplugging appliance loads. As shown in Figure 5 below, one reference source contends that the mere act of pushing the wired receptacle into the electrical box after assembly exerts forces on the wire binding screws that may tend to loosen some of them. In the event that a wire-binding screw does become loosened such that the current carrying path includes the steel screw, the creation of a glowing connection is possible.

Figure 5 - Forces Exerted on a Receptacle<sup>5</sup>.

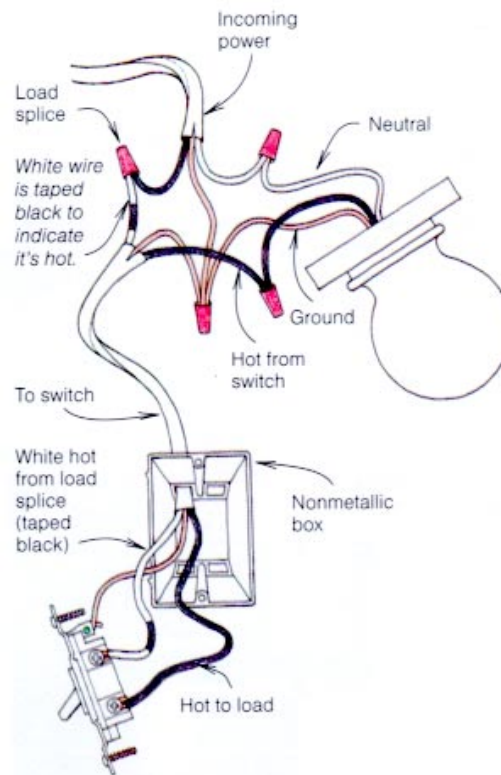
In accordance with the NEC the switch is always located in the "hot" conductor. Depending upon the branch circuit feed to the lighting outlet to be controlled, it may be necessary to wire the switch into a switch leg. The wiring to a switch leg is illustrated in Figure 6. In this case a grounded circuit conductor is not present in the switch box and the "white" conductor must be taped black to indicate it is "hot".

Figure 6 - Switch Leg<sup>6</sup>

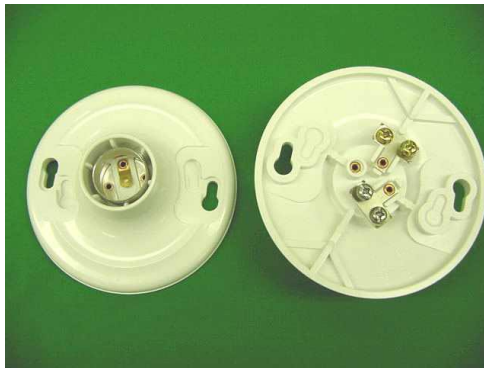
Grounding - The keyless lampholder supplied for this investigation as shown in Figure 7 was not provided with any dead metal and therefore had no means for terminating a grounding conductor to it.

Figure 7 - Keyless Lampholder (Front & Back)

Even though it was possible to create a glowing connection under the wire binding screw, without a ground reference, a ground fault was not possible. The use of this type of lighting outlet is typically used in attics, garages and unfinished basements which is a small percentage of all the lighting outlets installed in a new dwelling. As explained in Task 4, most lighting outlets (lighting fixtures) found in the main sections of a dwelling unit on bedroom and on other living areas branch circuits are provided with pigtail wiring connections. An evaluation of twist-on wire connections was not included as part of this investigation.

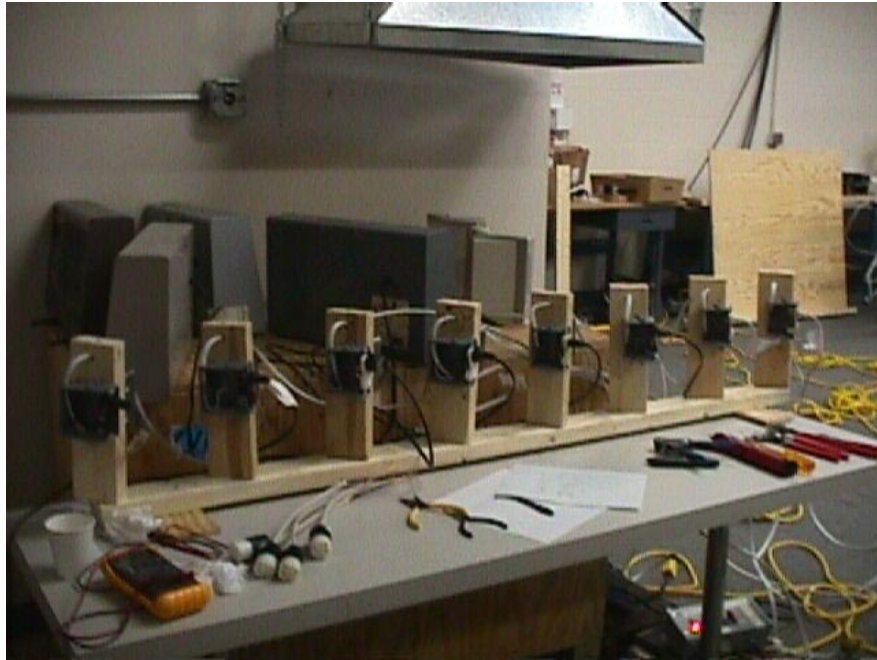
For this testing, each wiring device was connected to a branch circuit limited to an estimated available short circuit current ranging from 110 - 125 Amperes. A Branch/Feeder AFCI device in a circuit breaker configuration and incorporating equipment ground fault protection (30mA trip level) was located in each test circuit.

Each wiring device was mounted in a plastic outlet box having no grounded dead metal. NM-B wiring having a bare grounding conductor was connected to the ground lug provided on each receptacle and switch. In the case of the single lighting outlet tested, no ground lug was provided and the bare grounding conductor was left unconnected. Each conductor was carefully routed within the outlet box to the wiring device such that no two conductors were in contact with each other. The black and white insulated conductors were also carefully routed such that they did not contact the grounding member on the wiring device under test. A photo of the test set-up is shown in Figure 8 and an individual receptacle under test is shown in Figure 9.

Figure - 8 Test Set-Up

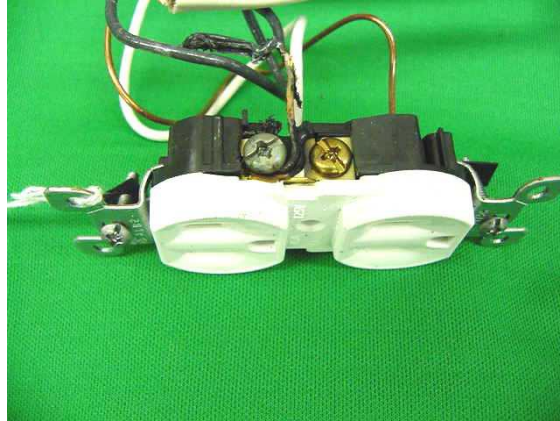
Representative damage observed with glowing connections is shown in Figures 10 and 11.

Figure 10 - Receptacle Damaged by a Glowing Connection

With reference to receptacle testing, a total of 16 tests were performed. In 6/16 tests the glowing connection terminated because the wire burned open. Of significance, however, in 9/16 tests the Branch/Feeder AFCI terminated the glowing connection and provided enhanced protection.

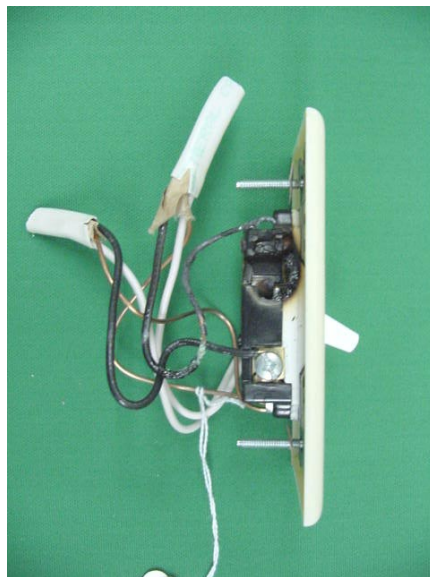
Figure 11 - Switch Damaged by a Glowing Connection

In the case of the switches tested, testing was frequently interrupted when heat deformation of the switch body (created by the glowing connection) caused the switch contacts to separate and interrupt the load. This opened the circuit to a safe condition. It was noted that the Branch/Feeder AFCI did respond to a ground fault on one of the switches tested.
